**Hazards presented by pyrolysis and combustion
products during laboratory experiments and real
incidents**

A thesis submitted in partial fulfilment for the requirements for the degree of
Doctor of Philosophy at the University of Central Lancashire in collaboration
with the Building Research Establishment

January 2015

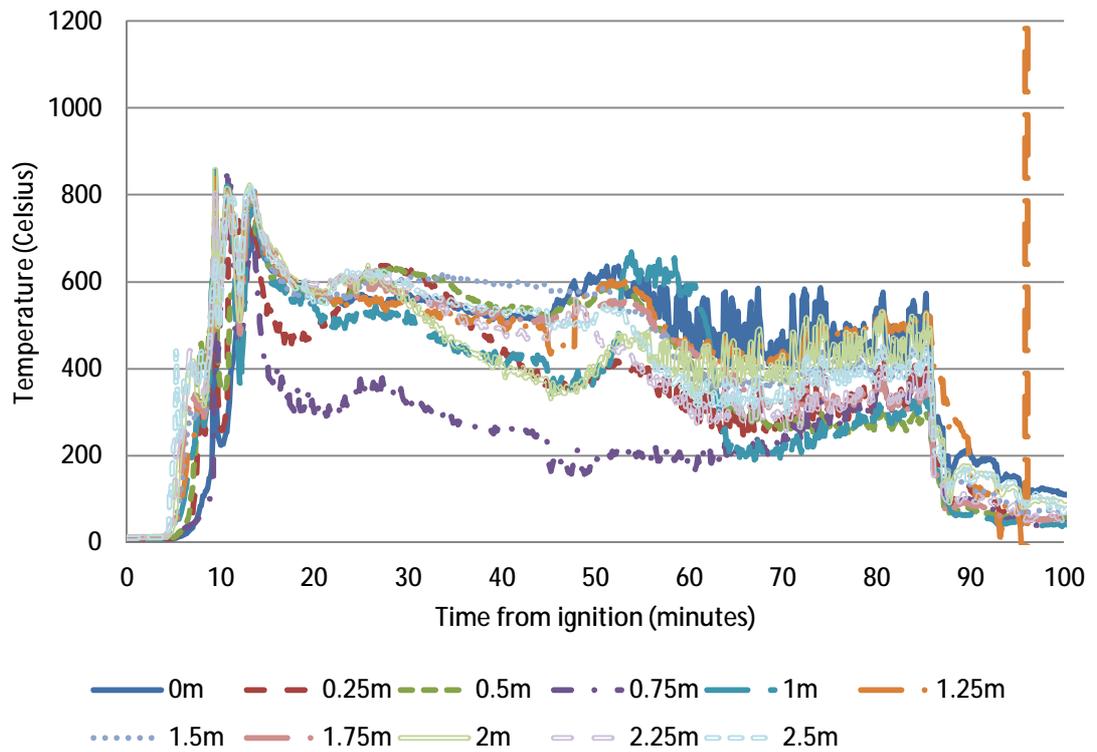
Figure 75 – Temperature data at thermocouple tree A. The sharp peak at 97 minutes is an open/short circuit error, likely the result of damage to thermocouple leads and/or application of water¹⁴⁰

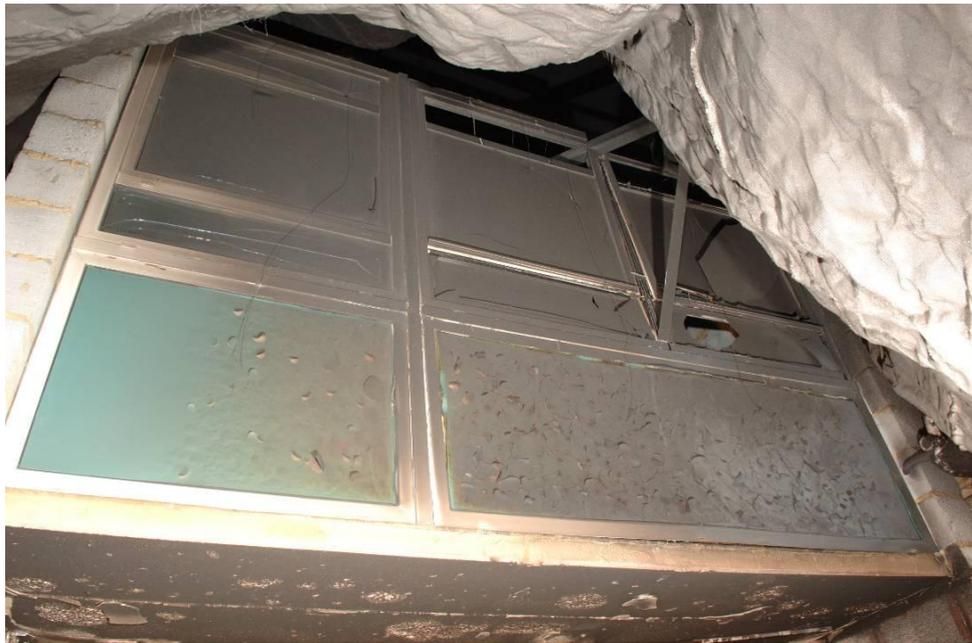
Figure 91 – Upper floor window set showing damage to glazing plus scorching and distortion of window panels. Photograph courtesy of MPS (see Appendix B) ¹⁴⁰
