# A New Method for Monitoring Gears Surface Failures Using Enhanced Image Registration Approach

Ahmed Onsy and Mohamed Fouad  
MTC

## ABSTRACT

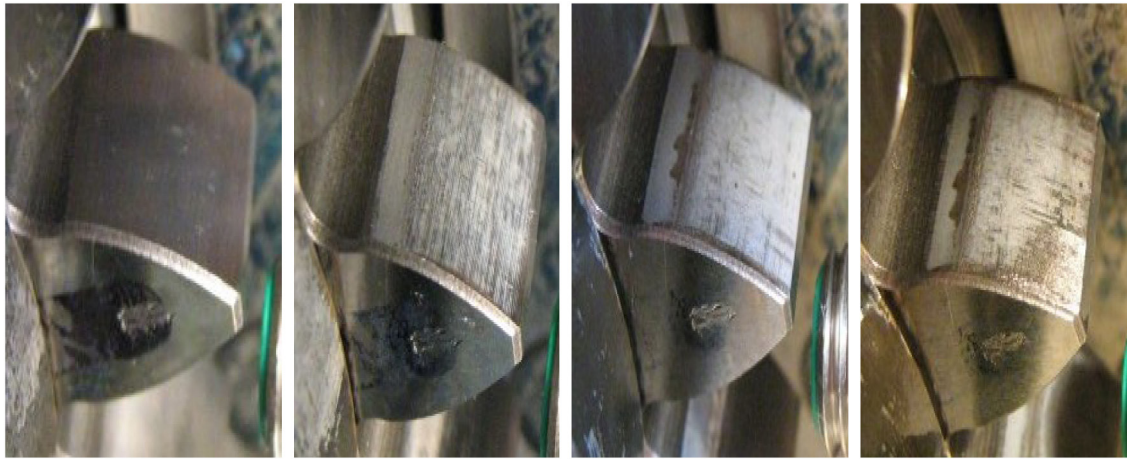
Figure 3. Pinion flanks showing: (a) Before gear test (b) Micro-pitting after testing at 210 Nm ( $13.7 \times 10^6$  cycles) (c) Micro-pitting after testing at 310 Nm ( $75.76 \times 10^6$  cycles) (d) Micro-pitting, small-scale macro pitting and scuffing after testing at 350 Nm ( $75.78 \times 10^6$  cycles)

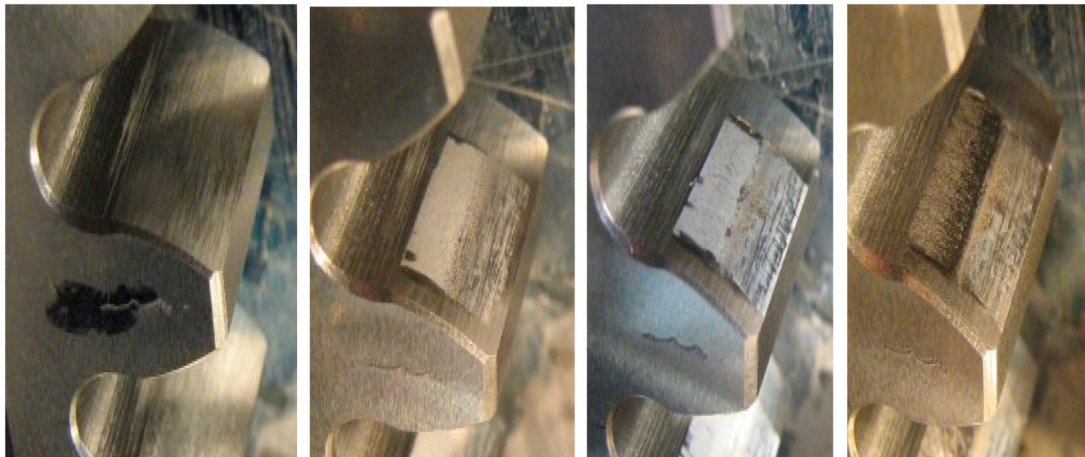
Figure 4. Wheel flanks showing: (a) Before gear test (b) Micro-pitting after testing at 210 Nm ( $13.7 \times 10^6$  cycles) (c) Micro-pitting small-scale macro pitting after testing at 310 Nm ( $75.76 \times 10^6$  cycles) (d) Micro-pitting, small-scale macro pitting and scuffing after testing at 350 Nm ( $75.78 \times 10^6$  cycles)

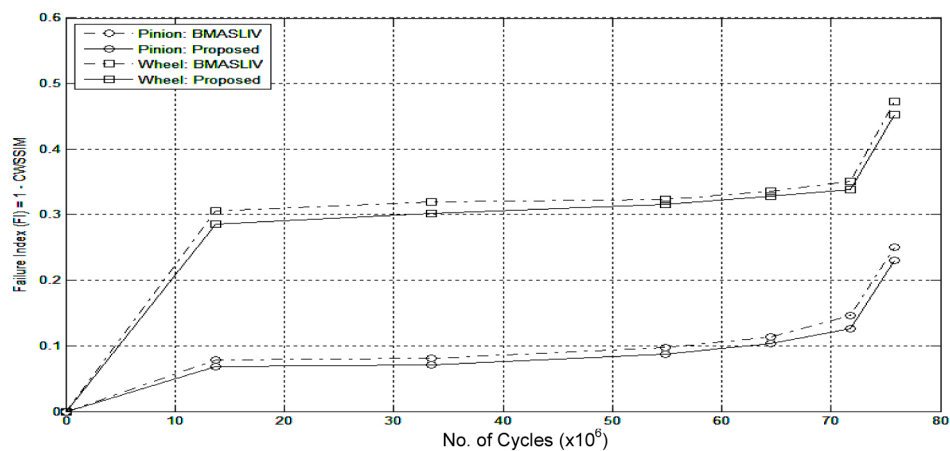
A Matlab algorithm has been developed to apply the image registration approach used in this paper and to then compute the FI, shown in (2), using an array of images as shown in Figures 4 and 5. The algorithm computed the FI at  $13.7 \times 10^6$  cycles for the pinion gear of 0.08 while for the wheel gear of 0.16, which is higher than the pinion FI value. Also, at  $75.78 \times 10^6$  cycles the FI value for the pinion is 0.25 while for the wheel is 0.35, which is again higher than the pinion FI value. Figure 5 illustrates the FI versus number of cycles, showing that the micro-pitting progressed gradually during the testing period using the proposed approach is more closer to the vibration and oil debris analysis results, compared to that of the BMASLIV approach [11] that uses the IR approach in [7]. The FI results are confirmed by the gear metrology results as shown in Figures 6 and 7.

Figure 5. Failure Index (FI) values for both pinion and wheel over test period

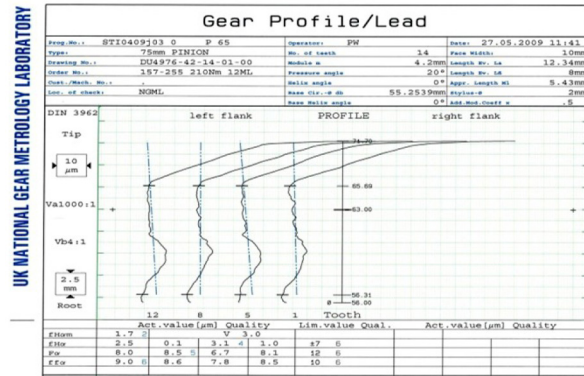
It is evident that the flanks of the test gears scuffed significant as a result of surface fatigue during continuous running at relatively high torque/contact stress. To quantify the damage on the gear flanks, profile deviation was measured on 4 teeth per gear using a gear measuring machine. The records of gear profile measurements at the end of stage 1 of the test and at the end of stage 3 respectively are shown in [Figures 6](#) and [7](#). The gear involute measurements confirm the results of the IR approach.

Figure 6(a). Pinion profiles of 4 teeth after test day 3. The maximum profile deviation caused by micro-pitting is evaluated as around 10 µm.

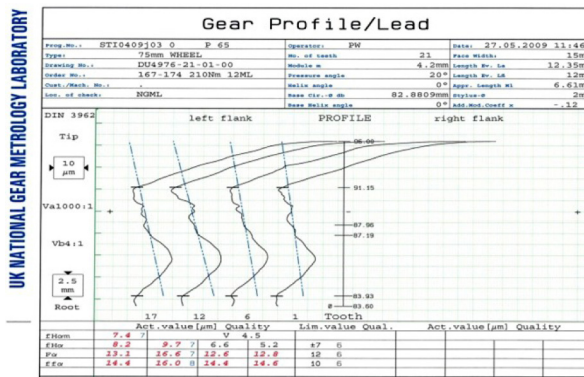
Figure 6(b). Wheel profiles of 4 teeth after test day 3. The maximum profile deviation caused by micro-pitting is evaluated as around 15 µm.

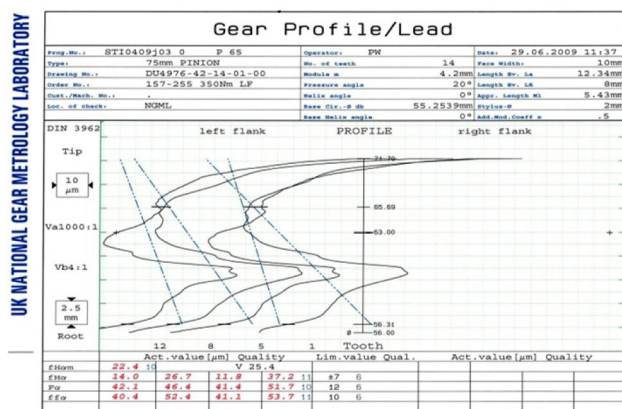
Figure 7(a). Pinion profiles of 4 teeth after test day 18. The maximum profile deviation caused by micro-pitting and macro pitting is evaluated as around 50 µm.

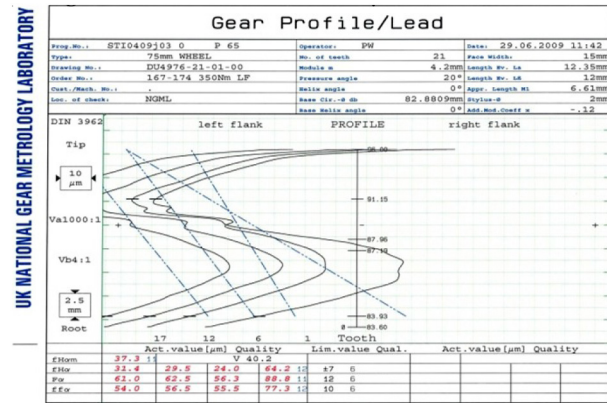
Figure 7(b). Wheel profiles of 4 teeth after test day 18. The maximum profile deviation caused by micro-pitting and macro pitting is evaluated as around 70 µm.
