Burning behaviour of rainscreen façades

Nicola Jones¹, Gabrielle Peck¹, Sean T McKenna¹, Jim L. D. Glockling², John Harbottle², Anna A. Stec¹, and T. Richard Hull^{1*}.

Abstract

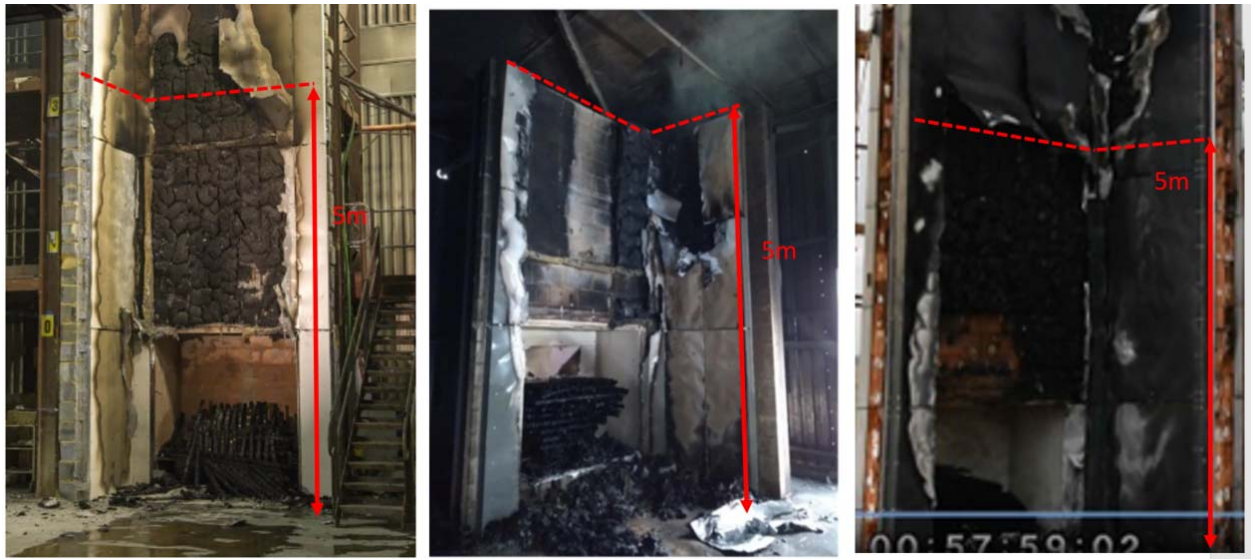
Figure 13 PIR/A2 comparison of burn area DCLG (left), FPA (centre) and Čolić (right) [17, 19]

The photographs in Figure 13 show the burn areas for the FPA, DCLG and Čolić tests for PIR/A2. The burn areas show that the panels have burnt or fallen from the wall and failed to protect the underlying insulation from fire. The burn areas for all tests show that the damage is most severe in the area directly above the combustion chamber. In this area, the ACM panels are missing up to the 5 m point in all three tests. In the case of the DCLG test, charred PIR remains attached to the wall, suggesting more resilient mountings were used, whereas for our tests and the Čolić tests some PIR is missing and the masonry wall can be seen. Damage has occurred to the wings of all walls, most severe for our test where some of the ACM panels are damaged and partially missing, despite the lowest wing temperatures. The ACM on the wing of the DCLG and Čolić tests has been damaged on the surface, but has remained intact. The DCLG and Čolić test walls show that the damage to the wall, and missing ACM, above the combustion chamber extends beyond 5 m.

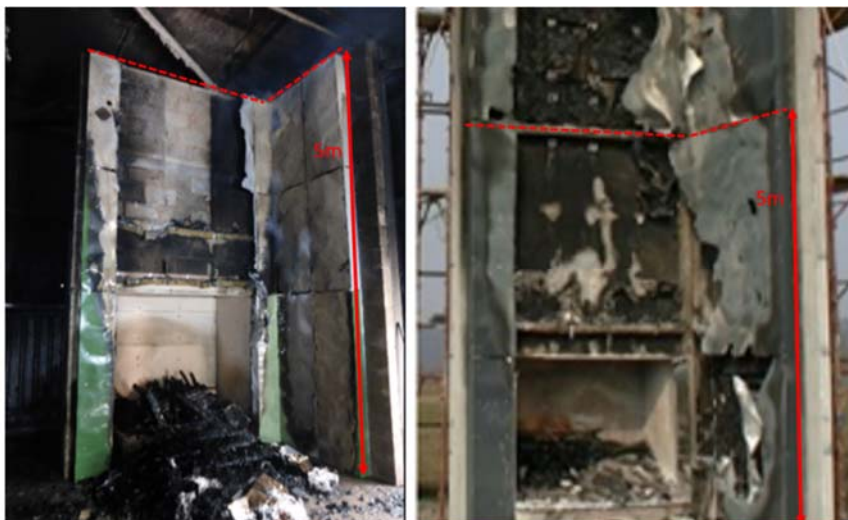
Figure 17 PF/A2 comparison of burn area Čolić (left) and FPA (right) [17]

The photographs in Figure 17 show a similar pattern of damage to both façades. The area directly above the combustion chamber has suffered the most damage, with ACM panels and PF insulation having fallen from the walls during the tests. The Čolić façade shows the damage extending well above the 5 m mark. The FPA wing has been damaged but the ACM has remained in place, however, some of the ACM has started to detach from the wing of the Čolić façade.
