Modelling, identification and structural damage investigation of the Neoria monument in Chania

The structural behavior of Neoria masonry monument is studied here. The determination of structural and material properties of a partially collapsed monument and the evaluation of existing damages and their importance for further restoration studies are not trivial tasks. The investigation has been based on detailed geometric data, collected from sources and in-situ measurements. For the mechanical analysis, finite element models have been created with different level of detail, including simplified description of documented damages. Modal analysis is assisted by micro-tremor measurements. Comparison of the predictions with the experimentally measured quantities, allows the determination of material parameters with higher accuracy. A least square technique assisted by the modal assurance criterion has been used, by driving the model from a Python script. A comparison of collapse predictions based on modified pushover analysis, with classical modal analysis has been performed. An explanation of existing damages is attempted, based on the numerical models.

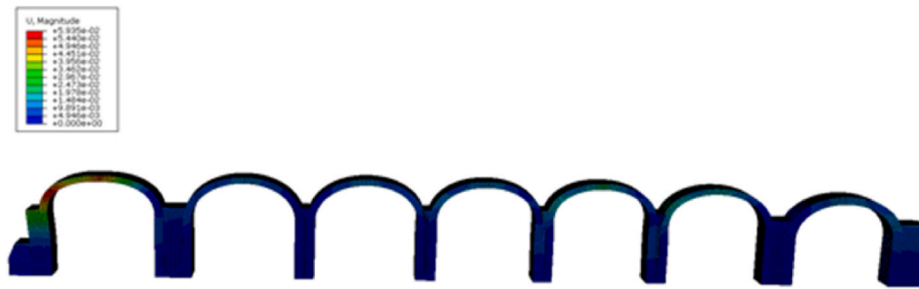
Fig. 19. The displacement contour of the whole structure under gravity loads.

closure and sticking-slipping along the masonry stone interfaces. The models were developed with a fixed support and the self-weight was incorporated in the loading condition. Two steps were used to create the models: the first step was a pure gravity load to simulate the state of inertia of the structure and to stabilize the model. The second step has an increased gravity load by 0,5g which was incrementally applied on the structure. This is used to provide a preliminary indication of the effect of the vertical component of an earthquake to the structural system. The results from these models are shown in Figs. 18–20.

The failure mechanism presented are shown in Figs. 18–20 correlate with the longitudinal cracks observed on the structure in-situ and the
