**An investigation into marine biofouling  
and its influence on the durability of  
concrete sea defences**

PETER HUGHES

A THESIS SUBMITTED TO THE UNIVERSITY OF  
CENTRAL LANCASHIRE IN PART FULFILLMENT FOR  
THE AWARD OF DOCTOR OF PHILOSOPHY

FEBRUARY 2014

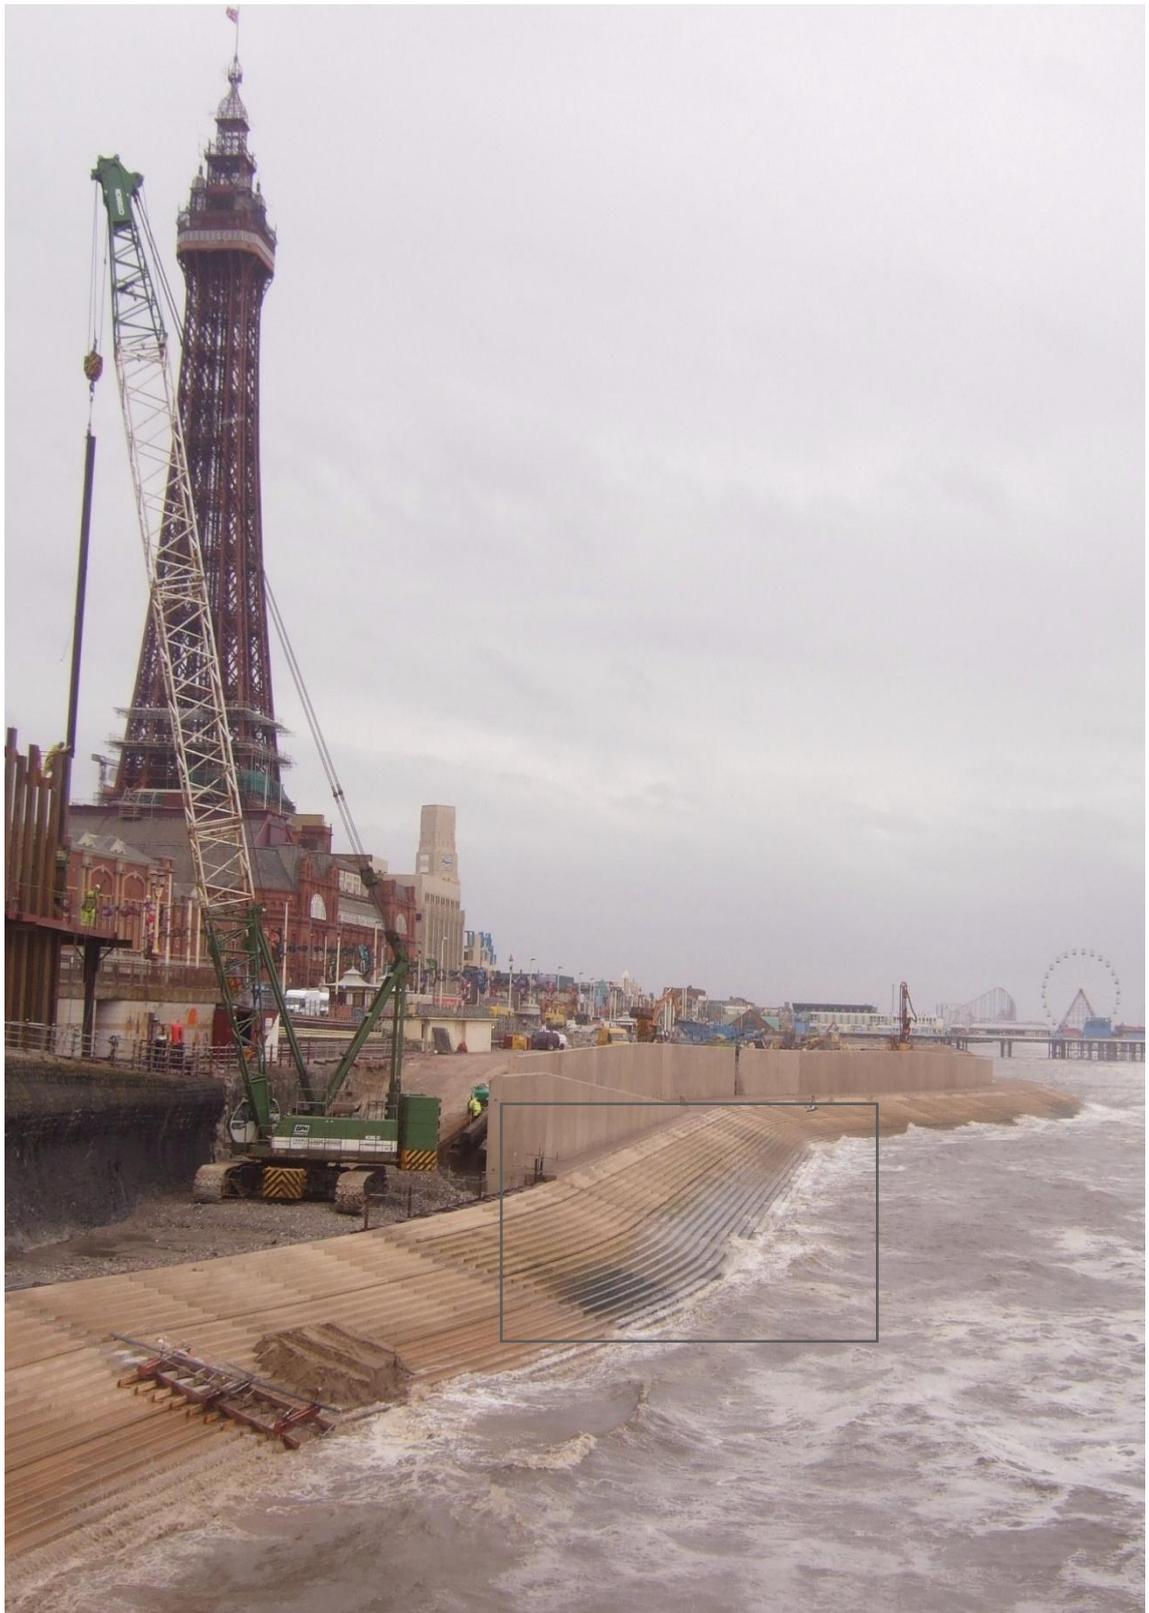
**Figure 1.1** The study site for this research; Blackpool's Central Area Coast Protection Scheme (2010). Recently placed revetment armour units (pH 12 and historically considered not to be bioreceptive at this time) are colonised by *Ulva* (inside rectangle) within weeks.

when fouling of structures and surfaces begins (Figure 1.1) although it is simply a transitional moment in the lifecycle of most species.

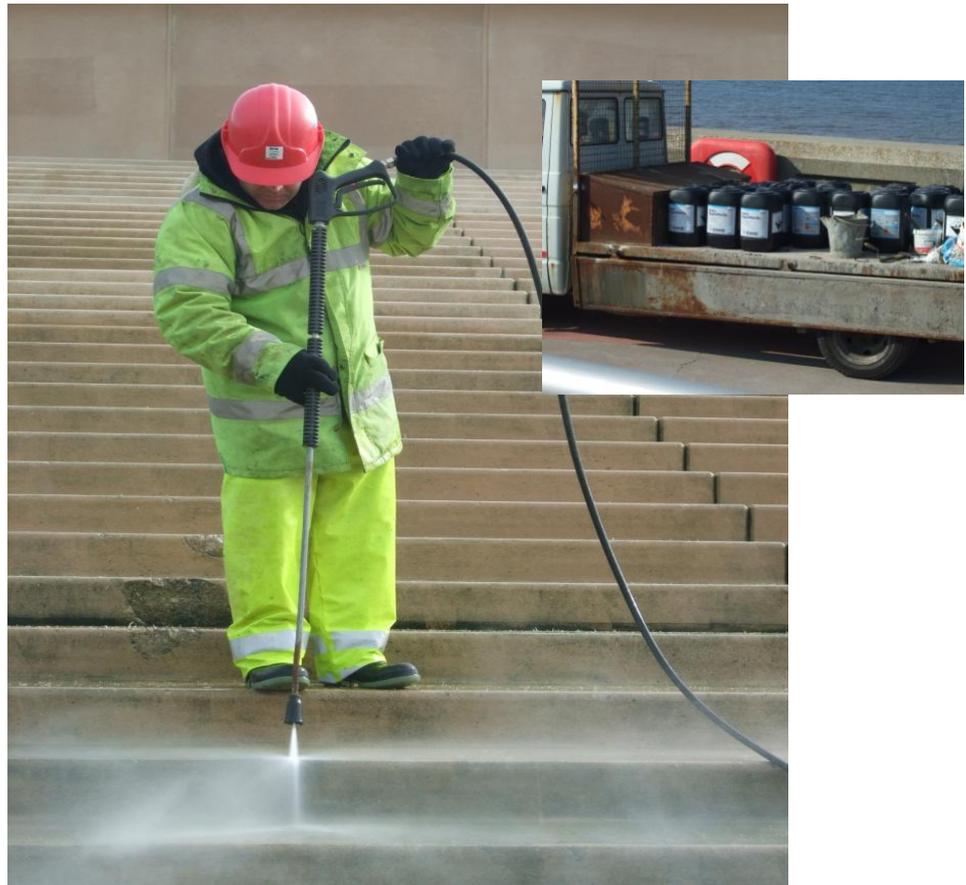
**Figure 3.1** Operative with hand held water jet controlling biofouling with power washing at the study site; inset, dairy hypochlorite (chlorine-based disinfectant) used at the site, video on CD in appendix.

Current practises employed by the local authority in biofouling management at the study site include power washing, initially with hand held apparatus (Figure 3.1) the use of dairy hypochlorite (Figure 3.1. inset), and more recently specially adapted vehicles (Figure 3.2).

Surface roughness ( $S_a$ ) doubled from 12.29  $\mu\text{m}$  to 24.67  $\mu\text{m}$  in three years on the revetment steps. These steps had been power washed on approximately 150 occasions at 1200 psi (Figures 3.1 and 3.2). The risers of the steps are not power washed and obviously are subject to the same tidal impacts, but showed a smooth erosion pattern; reducing in  $S_a$  from 12.29  $\mu\text{m}$  to 6.67  $\mu\text{m}$  (Figure 3.10). Laboratory tests by other workers confirmed the implication of roughness on the biofouling rate (Tran *et al.* 2012). When numerous anchorage points are offered, the adherence of algae is promoted (Tran *et al.* 2012). Thus the latency time is shortened and the rate of colonization is increased. Particular attention has to be paid to a surface finish: a slight increase in roughness might abruptly increase the susceptibility to colonization by microorganisms (Tran *et al.* 2012). The replication techniques, not usually associated with concrete surfaces have proved to be extremely useful and adaptable (Figure 3.8). The ability of polymers to provide a visual microscopic picture of 3 dimensional surfaces whilst at the same time, yielding accurate dimensional data, has been useful as a permanent record for subsequent reference or monitoring purposes and lays the foundation for the development of a new non-destructive testing method for concrete surface analysis (Hughes, 2011). Replicating compounds used have a resolution better than 0.1 microns (Rollins, 2001). One of the main concerns when working with replicas

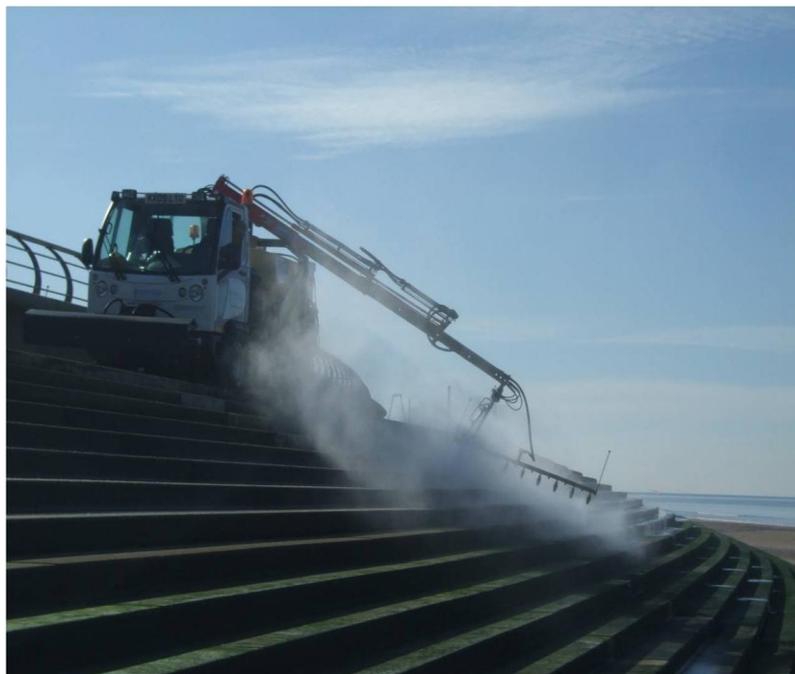
**Figure 3.2** Specially adapted motorised vehicle at the study site, cleaning algae from the revetment armour steps.

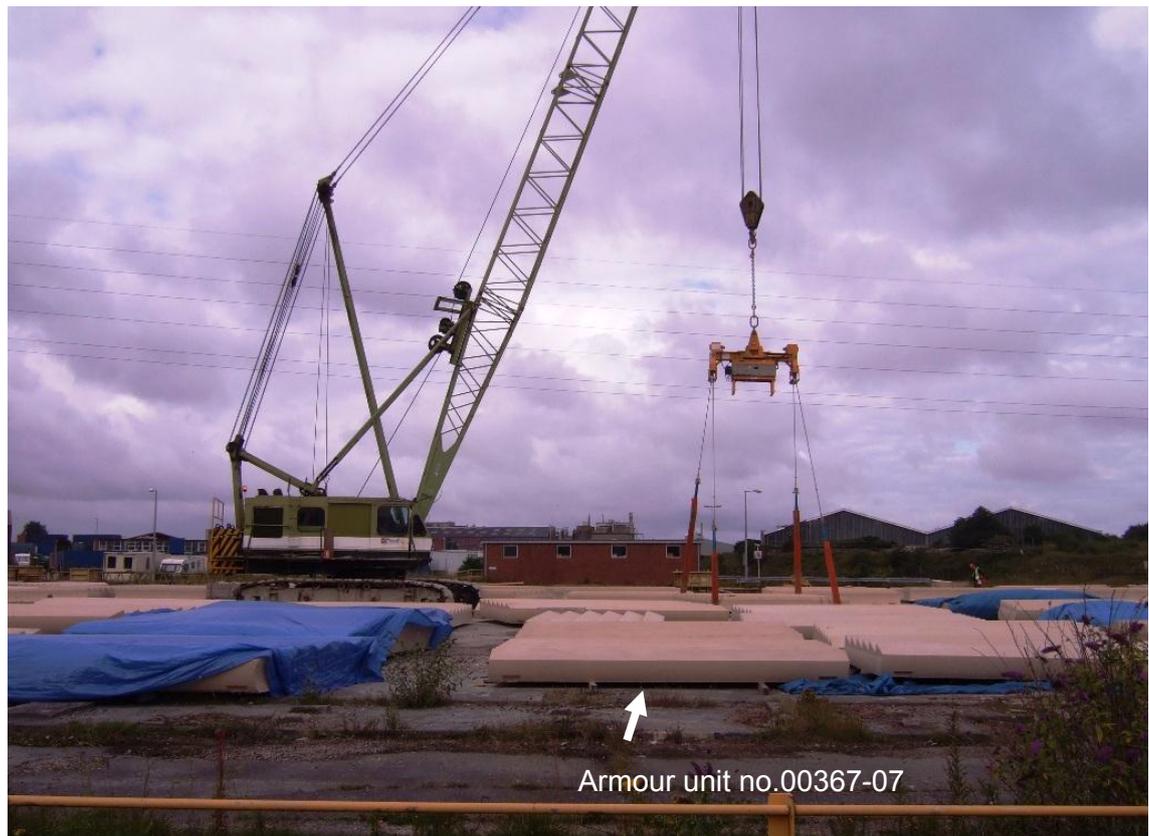
**Figure 3.3** Four point lifting revetment armour at the casting yard. Cast unit number 00367-07 (arrowed) membrane cured, for 28 days at the casting yard (north west England) in 2007.

The 10 Revetment armour units tested are located at 53°46'37"N, 3°03'27"W, 2.8 m above Irish sea level, and have been monitored from casting in August 2007 (Figure 3.3) to placement six weeks later (Map reference, Figure 6.5). The precast units are produced in four-step sections, 2,791 of which are needed over the 3.3 km stretch of beach between the toe beam and the promenade level.

The units are 5 m by 3.5 m, weigh 20 tonnes and contain 8 m<sup>3</sup> of macro and micro synthetic fibre reinforced concrete. It is probably the first time in the world, that this technology has been employed for major precast concrete elements in marine coastal defences (Rieder, 2007). Further details on manufacture and mixing within the concrete are reported elsewhere (NCE., 2006; Perry, 2006) The current 'flagship' project (Figure 3.4) has involved the placing of 65,000 m<sup>3</sup> of ready mix concrete with 44,000 m<sup>3</sup> of

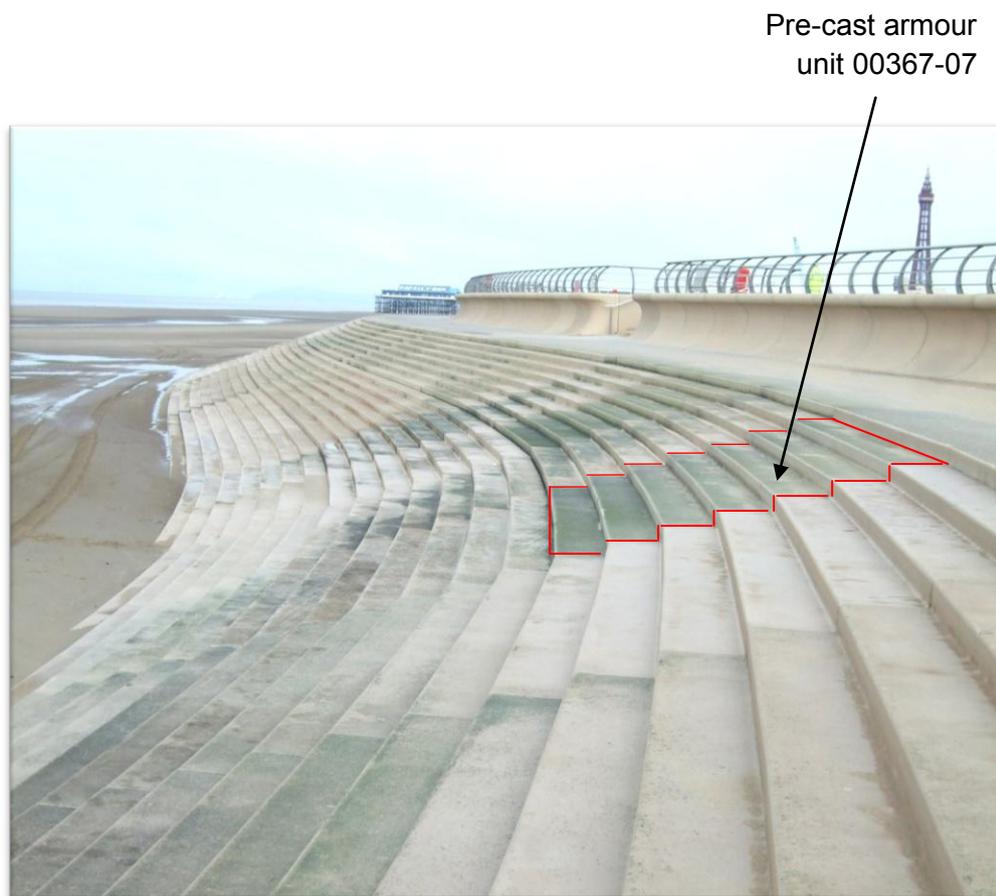
**Figure 3.4** One (of ten studied) of the revetment armour units (arrowed) number 00367-07 set at the study site (Blackpool, north west coast, England) in October 2007.

precast concrete elements (Figure 3.5). The 'as struck' units are steel cast in a horizontal, 'upside down' position. The revetment is formed from fill material, placed at a slope of 1:3, and capped with a concrete blinding layer (Perry, 2006). Behind this stepped apron is a flat, cast *in situ* berm and precast wave wall. The fully exposed units face westwards, into the prevailing wind. The climate in the region has been recorded between mild and moist. The temperature at the study site varied between -7° and 26° over the three years of study (own data).

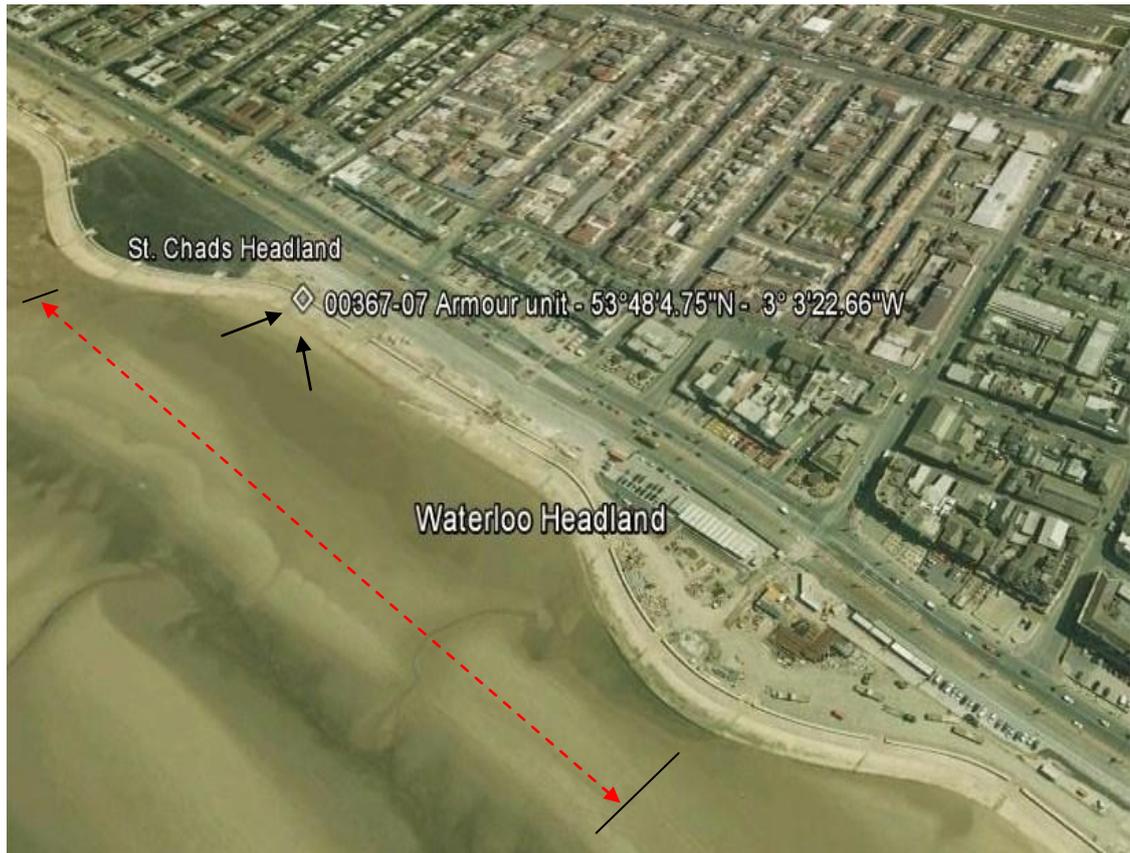
**Figure 3.6** Position (St. Chads Headland) of a monitored unit at the study site (arrowed). Hammer and UPV test on other units were also undertaken at Waterloo Headland. The red line indicates the area of the study site for this phase of work. Video of site on disc in Appendix.

The test site has been surveyed and monitored by the author for 8 years which includes 4 years outside the scope of this project (Figure 3.6). The original casting of armour was monitored and the same units have been examined over the years *in situ*. The seawall and revetment armour is subject to cyclic wetting and drying conditions, with a six hour tidal window within which measurements were conducted.

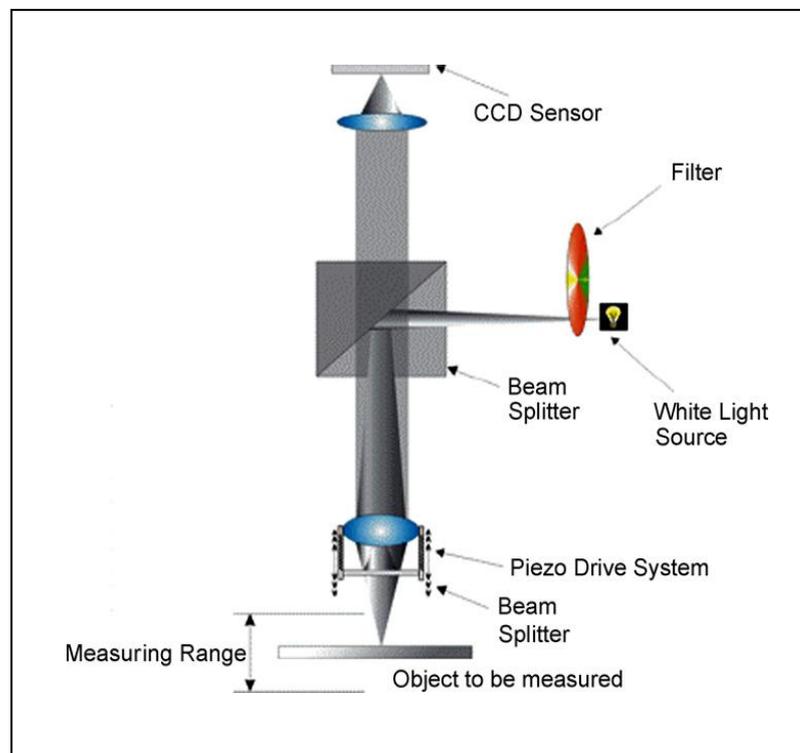
**Figure 3.7** Schematic of white light Interferometry used for measuring surface roughness in this project.

An Omniscan Microxam 5000B, 3D ADE Phase Shift Interface Contrast Optical Profiler was used (Figure 3.7). In this system light from a common monochromatic source is reflected by a beam-splitting device from the observed surface and from a standard plane reference surface. The combination of these two beams gives rise to a pattern of interference fringes, which are in effect contour lines that indicate the relative height of the surface (Veeco Instruments Inc., 2004). One limitation of this technique is that it only allows viewing of a small, and perhaps unrepresentative, sample of the surface. Vertical resolution is 0.1 nm, minimum lateral resolution is 0.11  $\mu\text{m}$ .

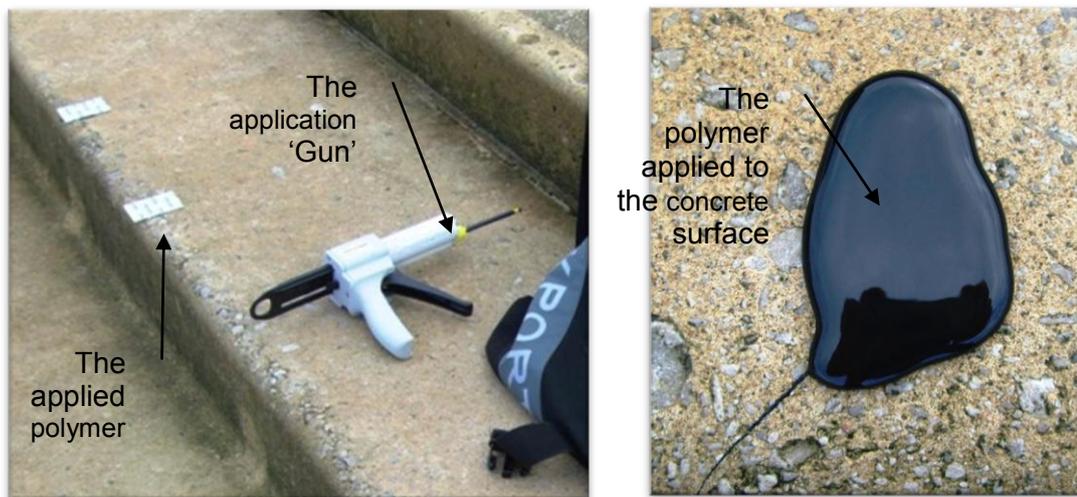
**Figure 3.8** Equipment used for the surface replication technique at the study site.

The replica technique originally used in the aerospace industry, produces a copy of the surface which can be peeled away and examined microscopically in the laboratory.

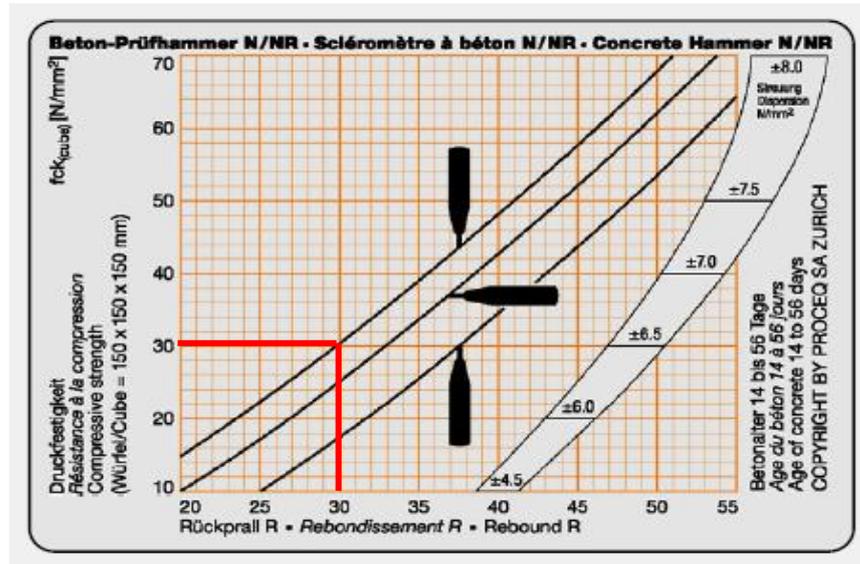
**Figure 3.12** Manufacturers conversion curve, which will enable the average rebound value to be converted to an estimated concrete strength in N/mm<sup>2</sup> (red line), 30 being the reading for the first two years (Fig. 3.11), a reading of 17 in the final year is off the scale. Source: SA ZURICH (Manufacturers) graph on the instrument.

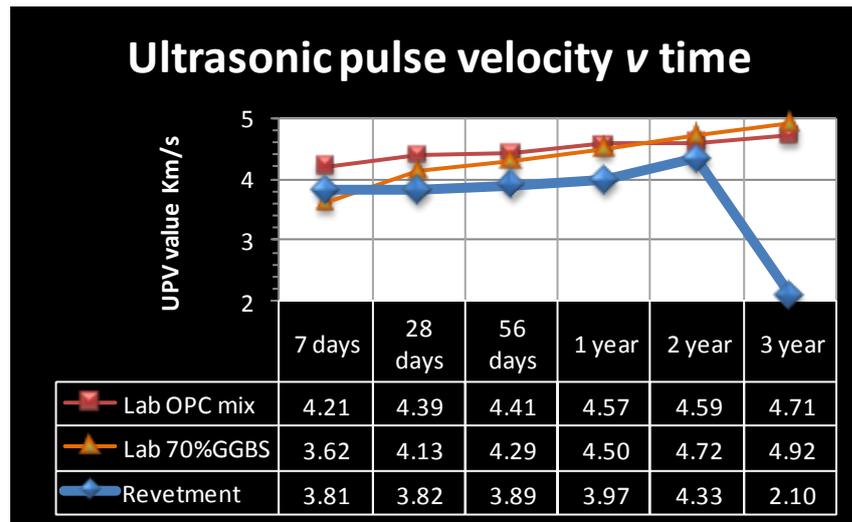
Variability in UPV 7 days	
mean of 10	3.81
standard deviation	$\sigma$ 0.43
variation	0.18
confidence limit	95% $\pm$ 0.26

High pulse velocity readings are generally indicative of good quality concrete. As the revetment units are subject to a 6 hour tidal window consideration must be made to account for seawater within the units, as moisture, normally present in concrete will encourage a reading up to 5% higher. A plot of pulse velocity contours has given a clear picture of variations (Figure 3.13).

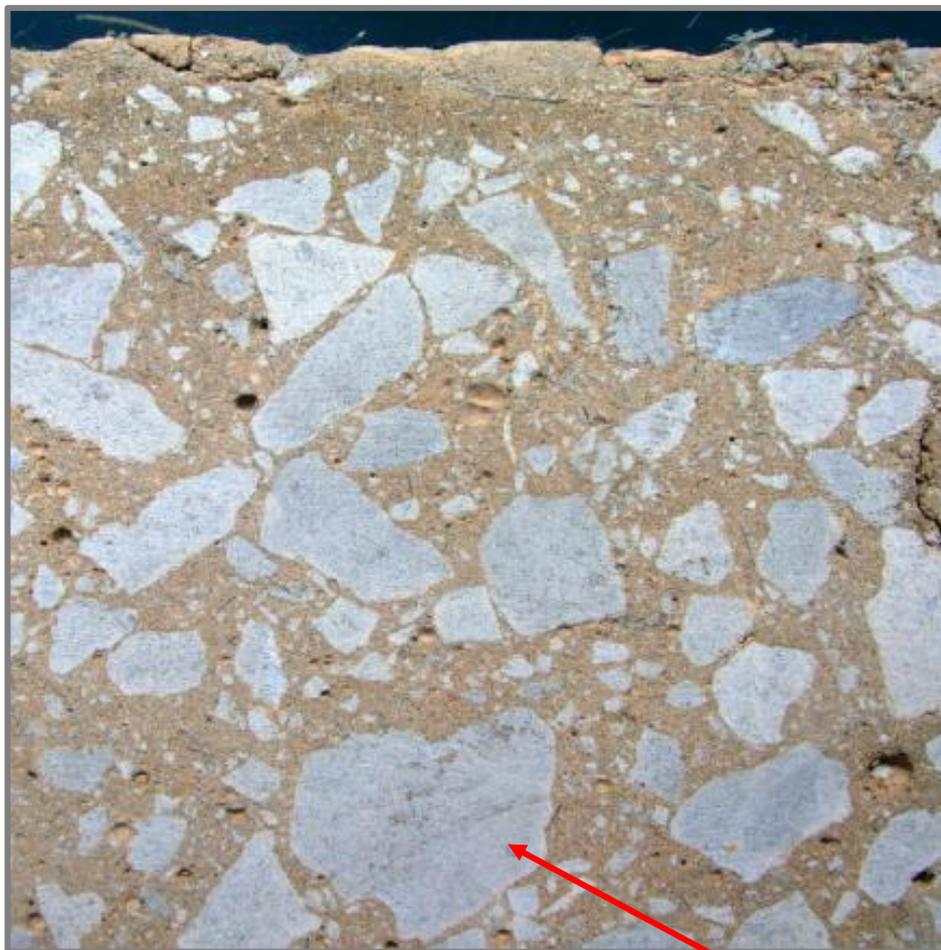
Limestone aggregate

Figure 3.14 illustrates a typical example of a concrete sample, indicating how larger aggregate tends to settle towards the bottom of the mix. Figure 3.15, a graphical representation of the segregation, shows how the bottom of the cast specimen now becomes the surface. Segregation of aggregate, in the manufacture of the revetment armour units, occurs towards the bottom of the form during compaction, which then becomes the exposure surface, reducing the thickness of cement matrix over the aggregate and increasing the risk of its removal by hydrodynamic forces.

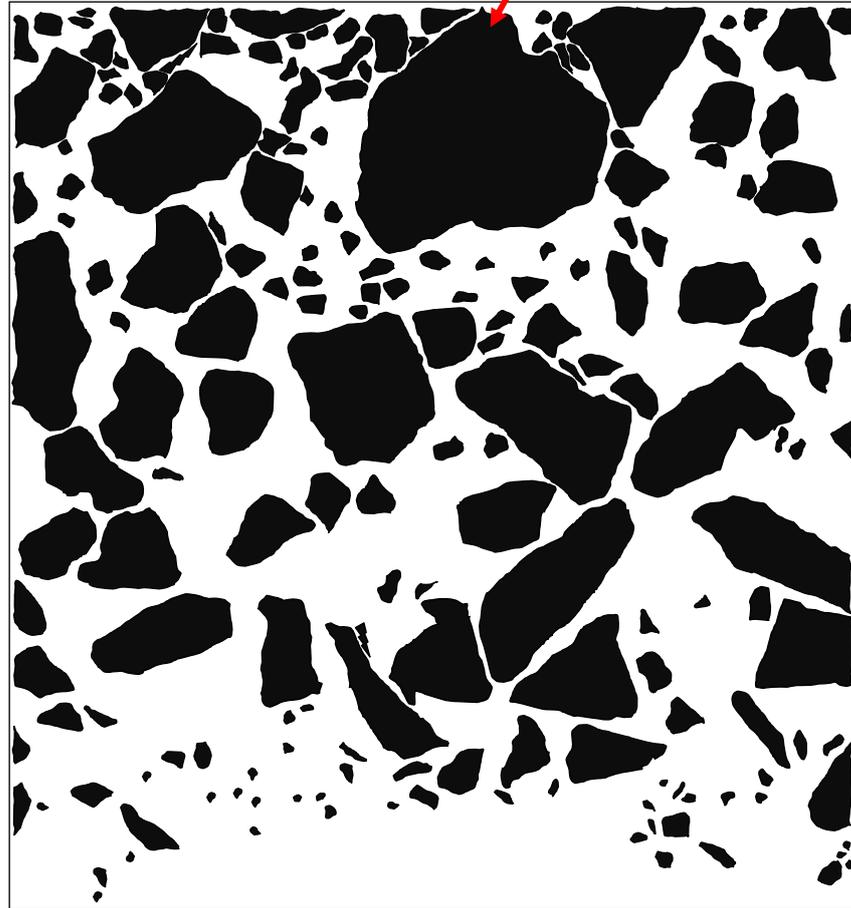
The revetment units are cast upside down, what was originally the bottom of the form (cube) now becomes the surface of the unit with 1mm protection/surface zone.

**Figure 3.15** Binary representation of inverted specimen detailed in Fig. 3.14 The tightly packed and overlapping limestone aggregate now at the exposed surface of the unit. Figure 3.16F is a typical example of aggregate tightly packed at the surface of the armour unit at the study site, particularly at the nose of the step.

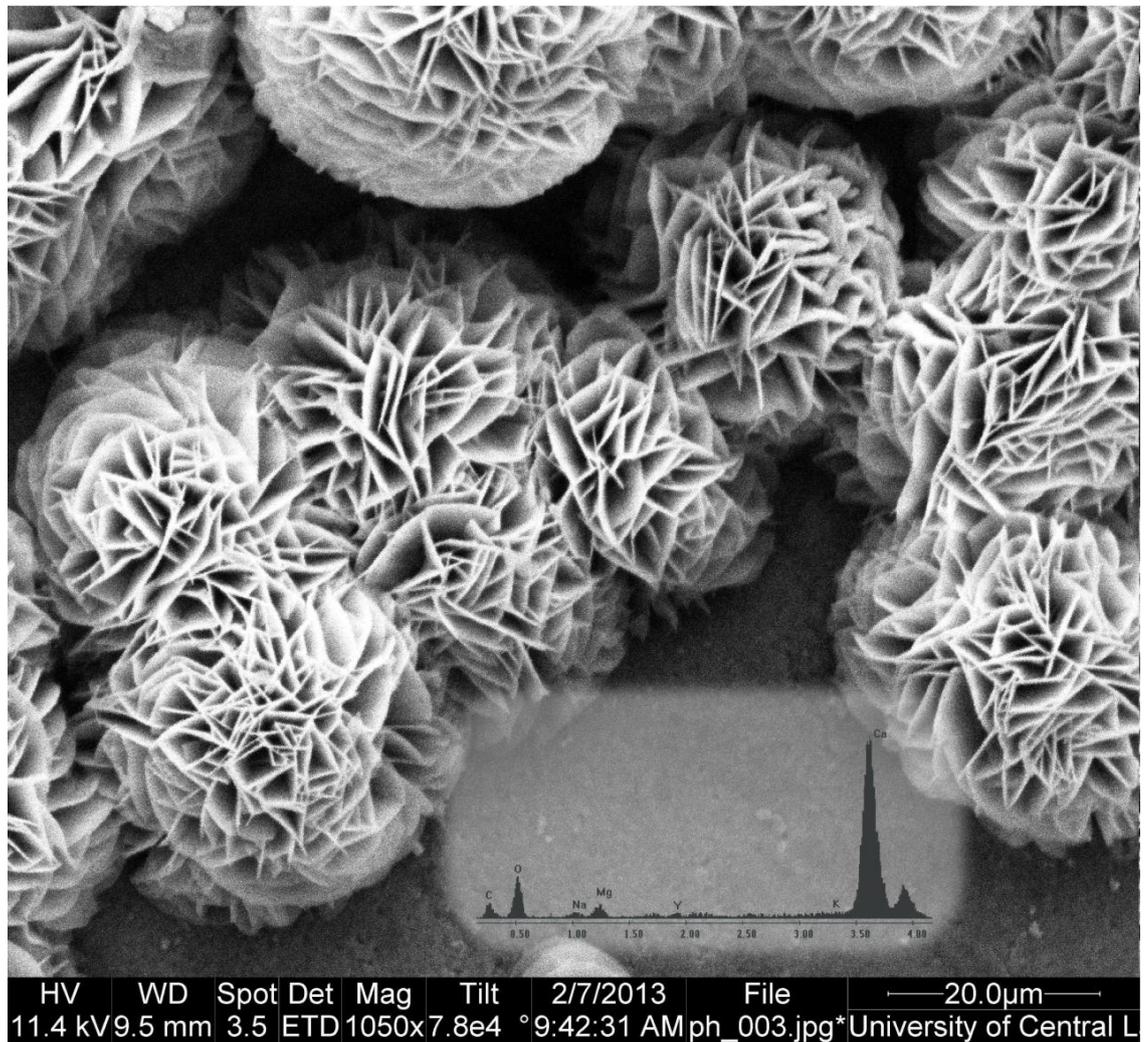
**Figure 3.17** Scanning Electron Microscope Micrograph: Clusters of fully formed  $\text{CaCO}_3$  crystals of 'rosette' habit within the cement matrix. Energy dispersive X-ray analyser data (inset) indicates that the 30.22% Ca. (weight), 13.35% C., 48.96% O. and 3.53% Mg. were consistent with  $\text{CaCO}_3$

The Scanning Electron Microscope micrographs reported here confirmed the formation of crystals and are representative images of growth within the concrete matrix examined (Figure 3.17). Methodology for the scanning electron microscope (SEM) and energy dispersive X-ray analyser (EDAX) is detailed in Chapter 4, Section 4.2.5. Structures observed on direct examination were small clusters of CaCO<sub>3</sub> crystals attached to micro synthetic fibres within the matrix of the cement to a depth of 20mm from the surface (Figure 3.18). The individual crystals often formed uniform collections, in some places several µm thick, localised at the surface of the concrete armour. Figure 3.19 shows the typical robust attachment of CaCO<sub>3</sub> to the micro fibres within the surface of armour concrete.

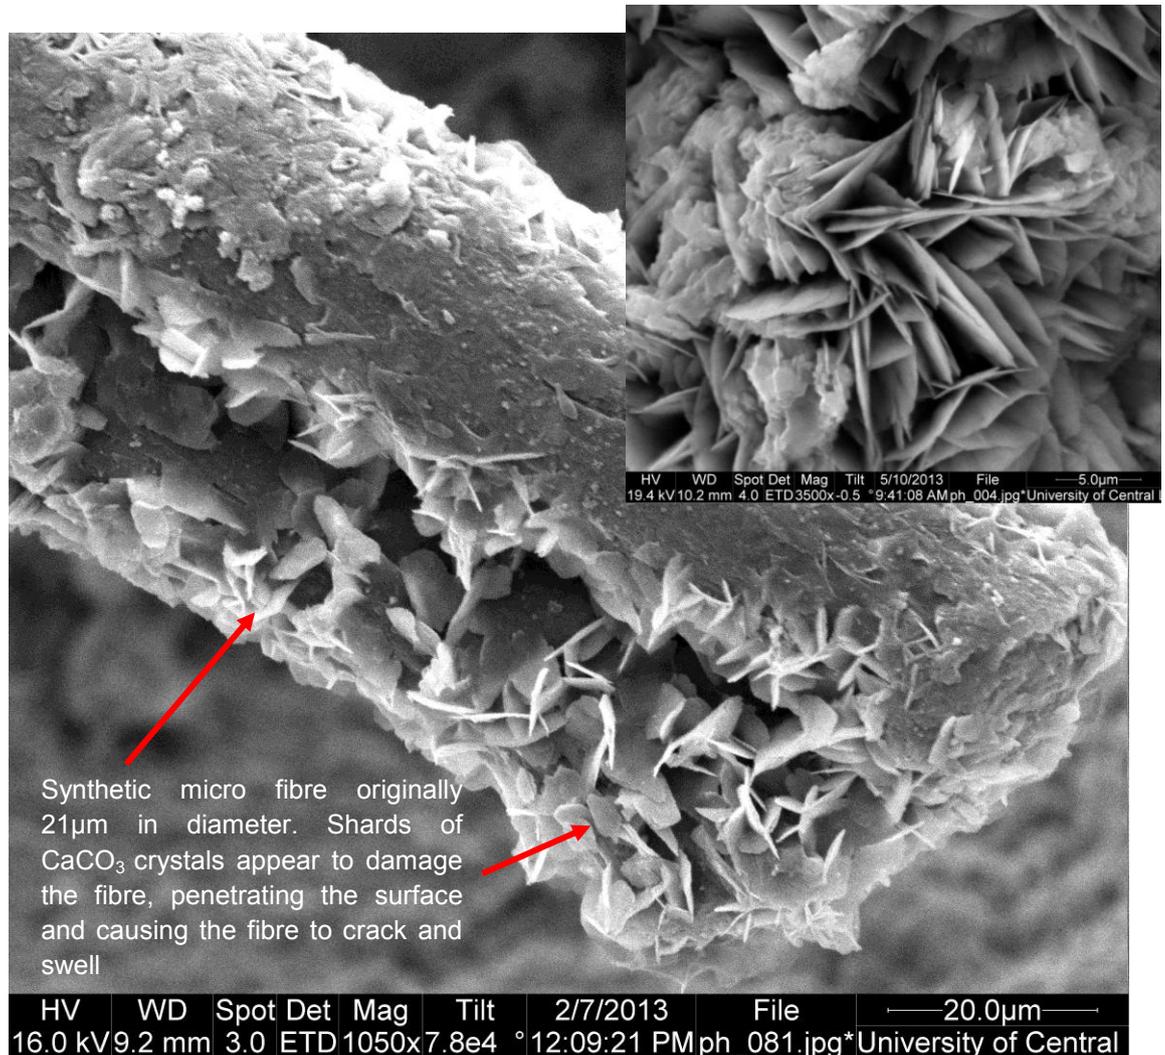
**Figure 3.19.** CaCO<sub>3</sub> crystal attachment within micro fibre, original size of 21 µm. Due to splitting and subsequent attachment the fibre has increased in diameter by approximately 50%. Inset: Clusters of fully formed CaCO<sub>3</sub> crystals at the base of the micro fibre shown in the main image.

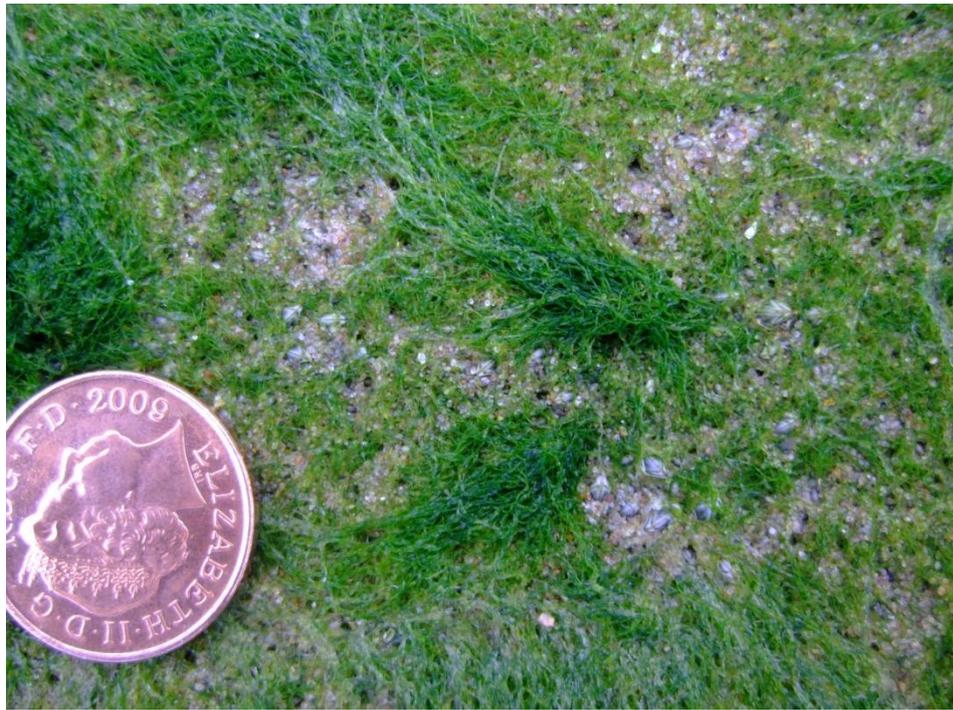
**Figure 4.1** *Ulva* firmly attached to armour surface (after 2 years exposure) in the splash zone (Two pence coin).

Current algal fouling at the study site (Figure. 4.1), is the focus of this chapter, there now follows a review, specific to this phase of the study.

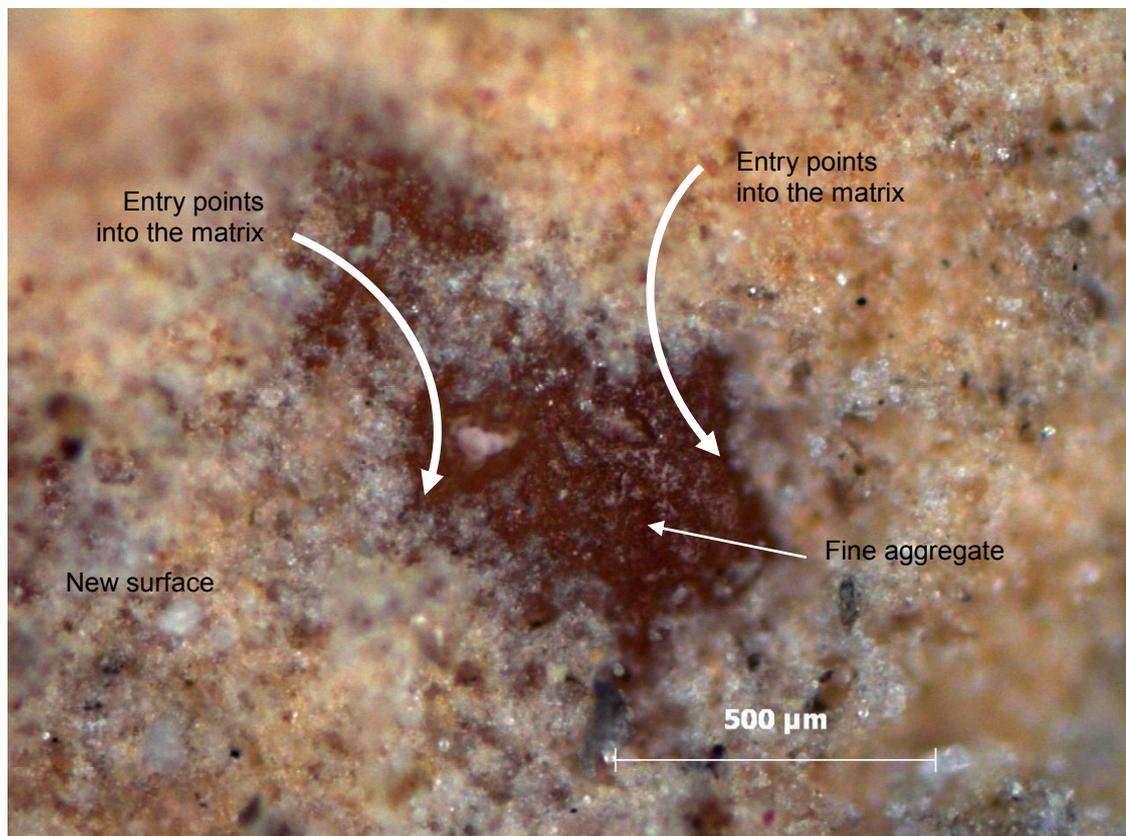
**Figure 4.3** Typical representation of a new surface of the revetment armour. The white arrows depict possible entry points for microorganisms into the matrix.

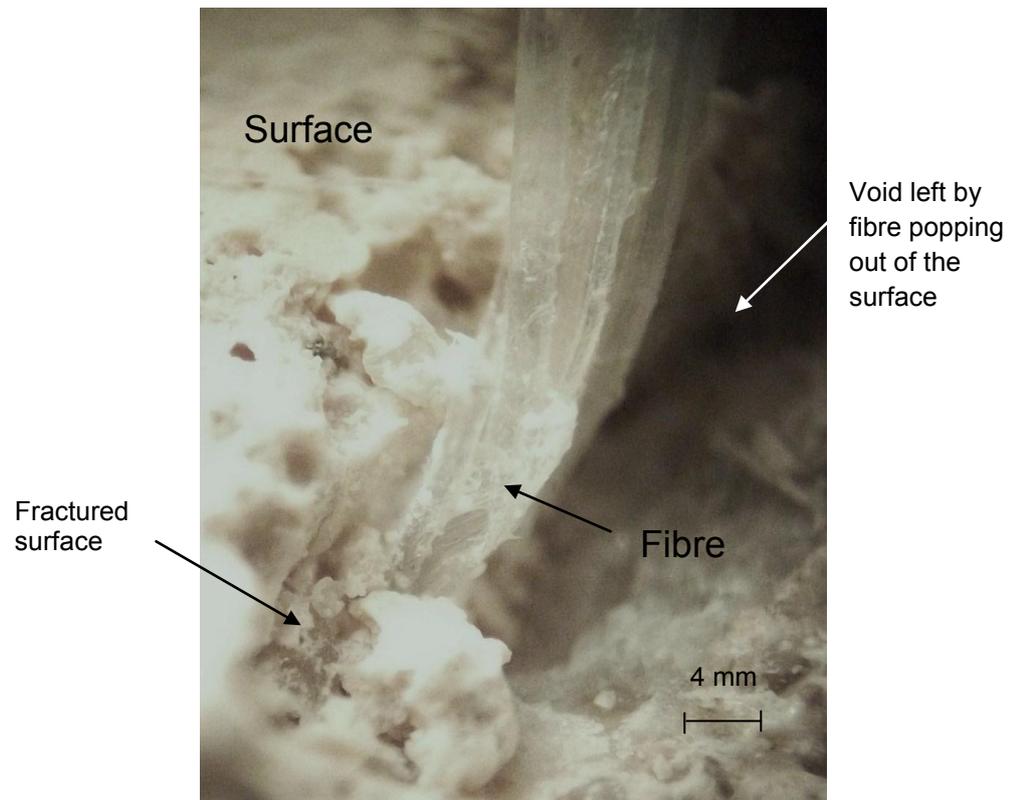
**Figure 4.4** Macro synthetic fibre at the surface of new concrete in vertical orientation. Many fibres at the study site were observed to be exposed at the surface of the armour. (Digital image).

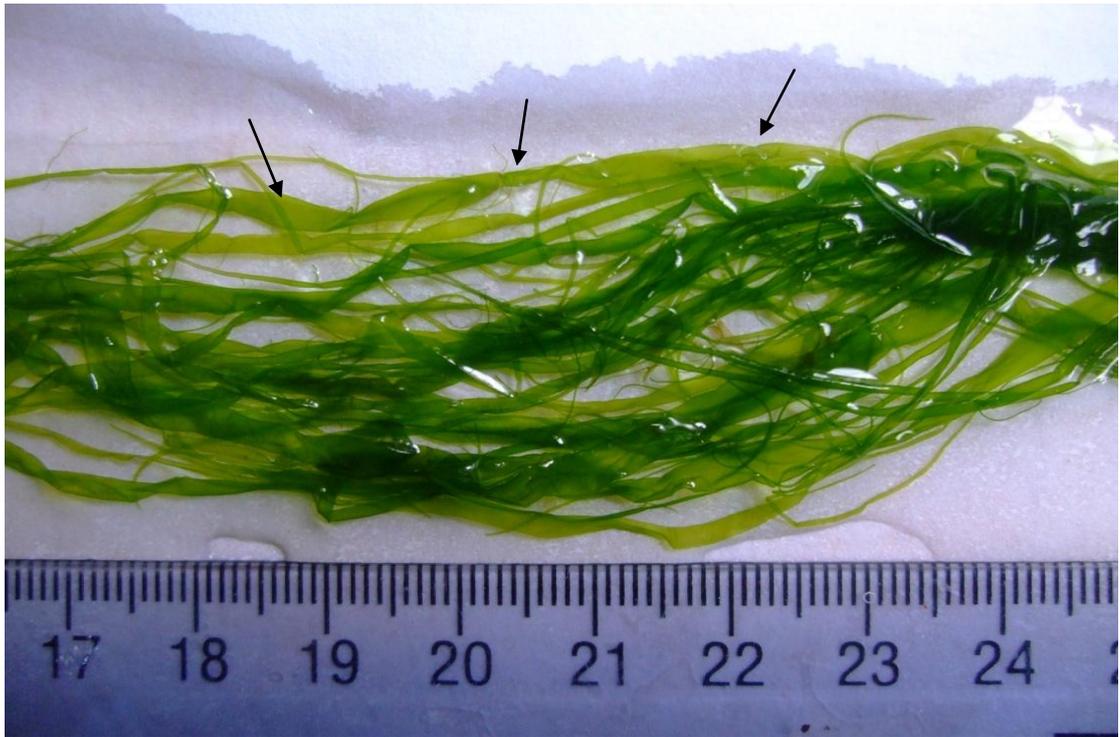
**Figure 4.5** *Ulva* filaments (un-branched, fresh-from the study site) in a flattened, deflated condition. Arrows depicts a large healthy mature filament in a deflated state, approximately 280mm in length and 2 mm in diameter, suspended in a saline solution.

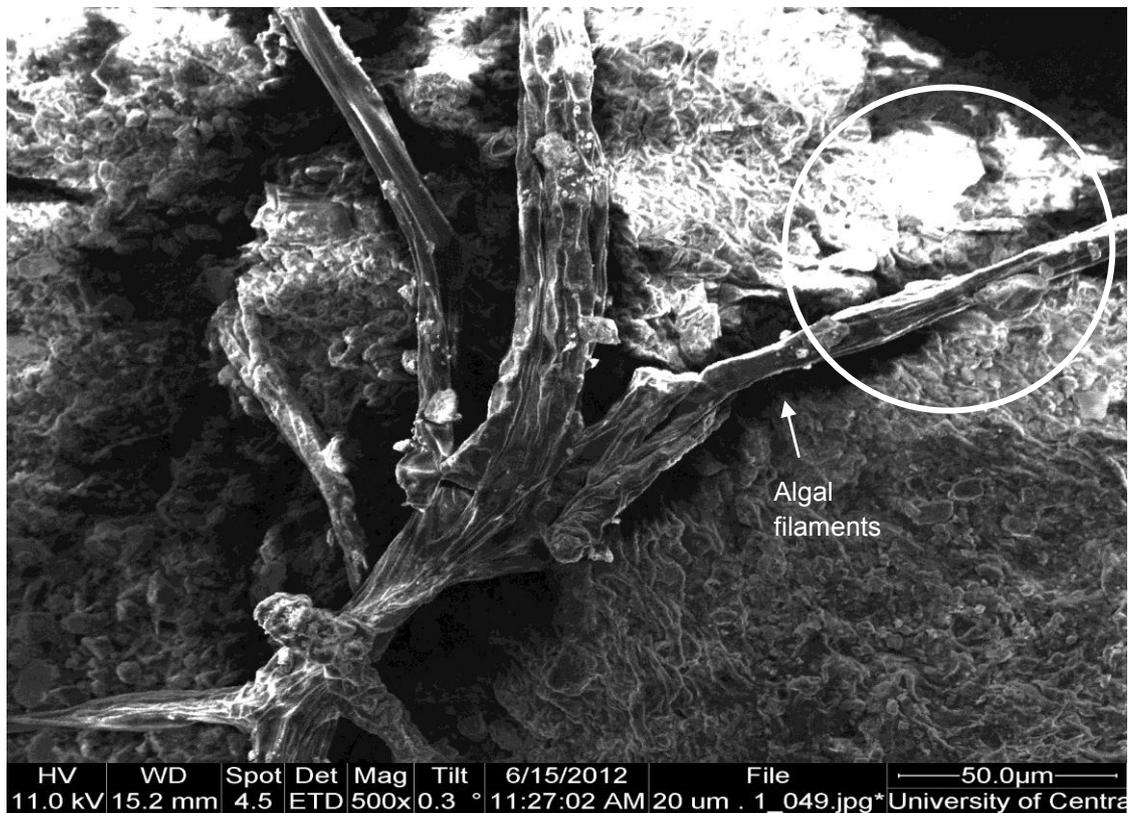
**Figure 4.9** Network of algal filamentous growth intertwine over the limestone aggregate within the matrix to a depth of approximately 25 mm. Filaments appear to cut into the surface of the aggregate surface (circled).

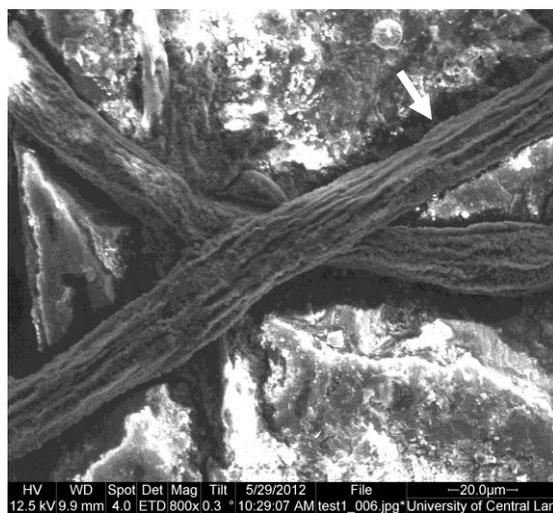
**Figure 4.15** Growth cutting into fibre

Surface microorganisms are often cleared by power washing; as investigated in Chapter 3, however penetration into the surface, particularly under fibres, offers refuge from hydraulic forces. Their presence at the cement interface (Figure 4.14), disrupts or distorts the fibre by growth. Fibres having just been cleaned at the surface starts the process of breaking away. This gives microorganisms the opportunity to penetrate under the fibre and quicken the degradation. This colonisation is observed in Figure A4.1 Appendix 4), where the majority of growth is on the surface, however filamentous growth from the underside of the fibre in contact with the concrete. It is also important to note that algae can act as the focus for other biofouling organisms such as fungi, bacteria and diatoms (Figure A4.2 Appendix 4) so that the deterioration process may gain momentum after the structure's condition has become suitable for the survival of one or more such organisms. The filaments shown in Figure 4.15 absorb and store seawater and associated nutrients during periods of submersion and from moisture found within the concrete. Figure 4.15 shows the filamentous growth cutting the actual

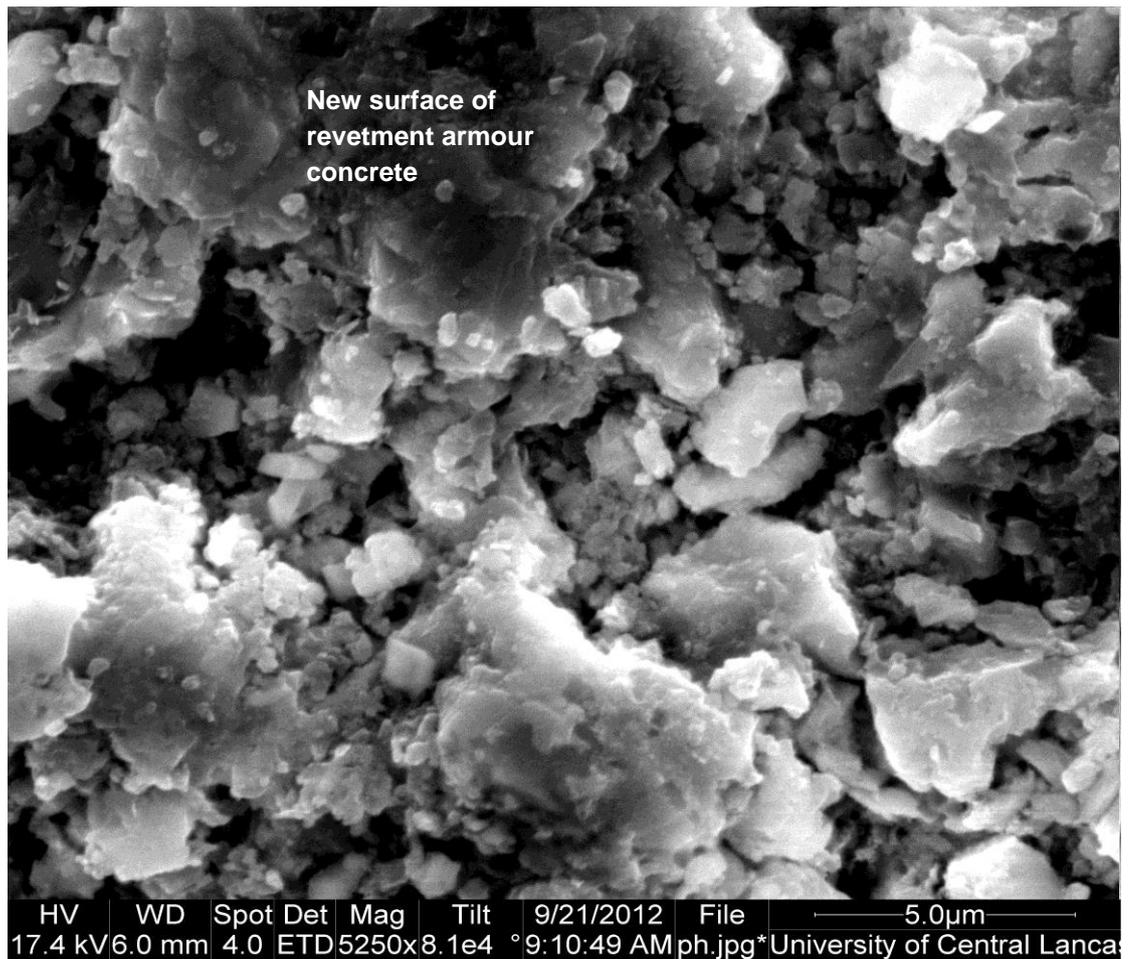
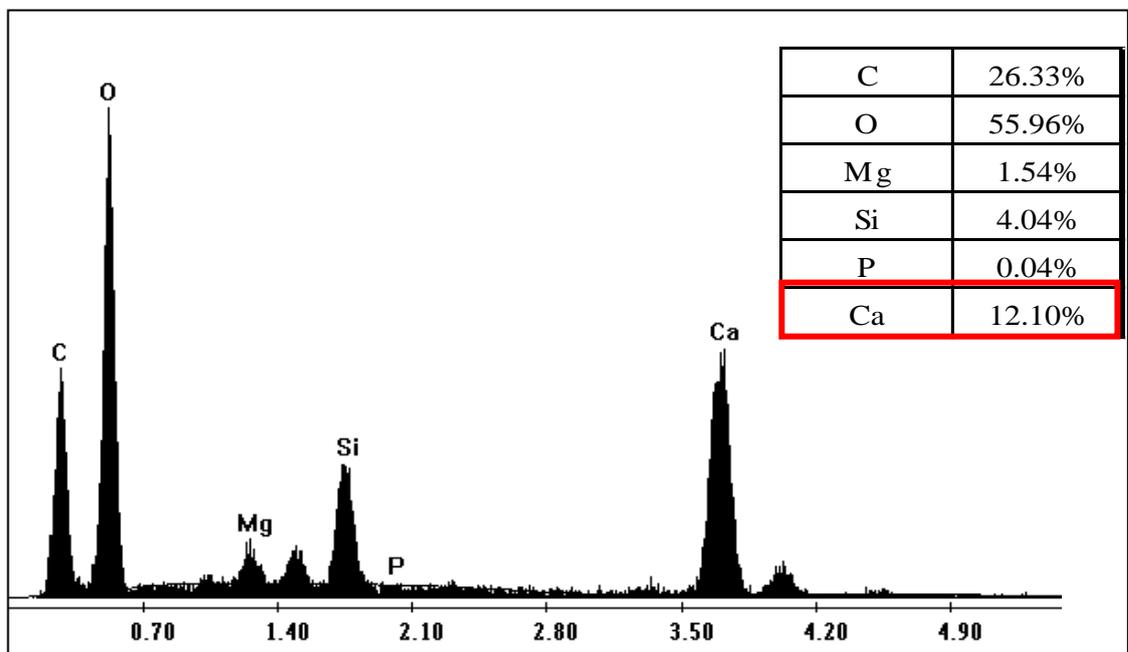
Figure 4.17 SEM micrograph and EDAX spectrum analysis of new concrete surface.

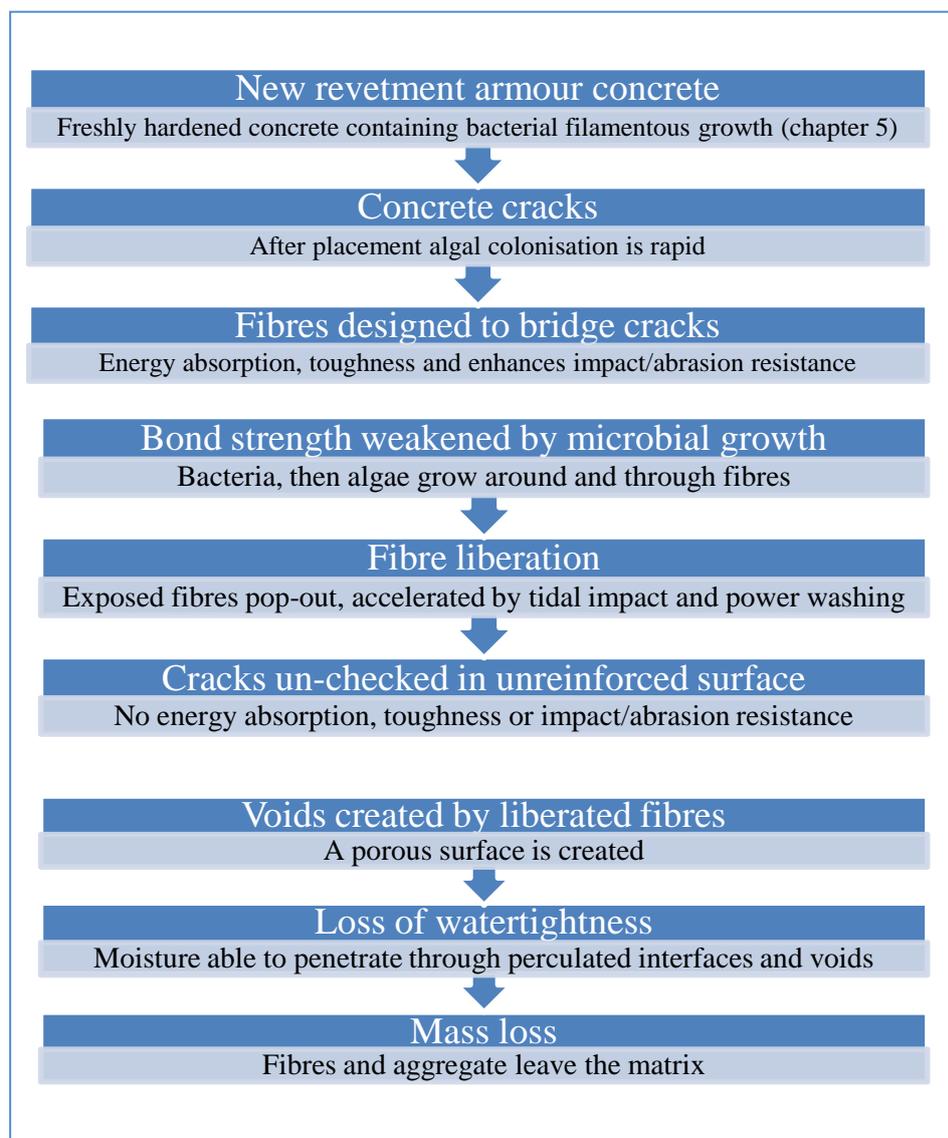
**Figure 4.22** Schematic of fibre performance at the study site.
