**An investigation into marine biofouling  
and its influence on the durability of  
concrete sea defences**

PETER HUGHES

A THESIS SUBMITTED TO THE UNIVERSITY OF  
CENTRAL LANCASHIRE IN PART FULFILLMENT FOR  
THE AWARD OF DOCTOR OF PHILOSOPHY

FEBRUARY 2014

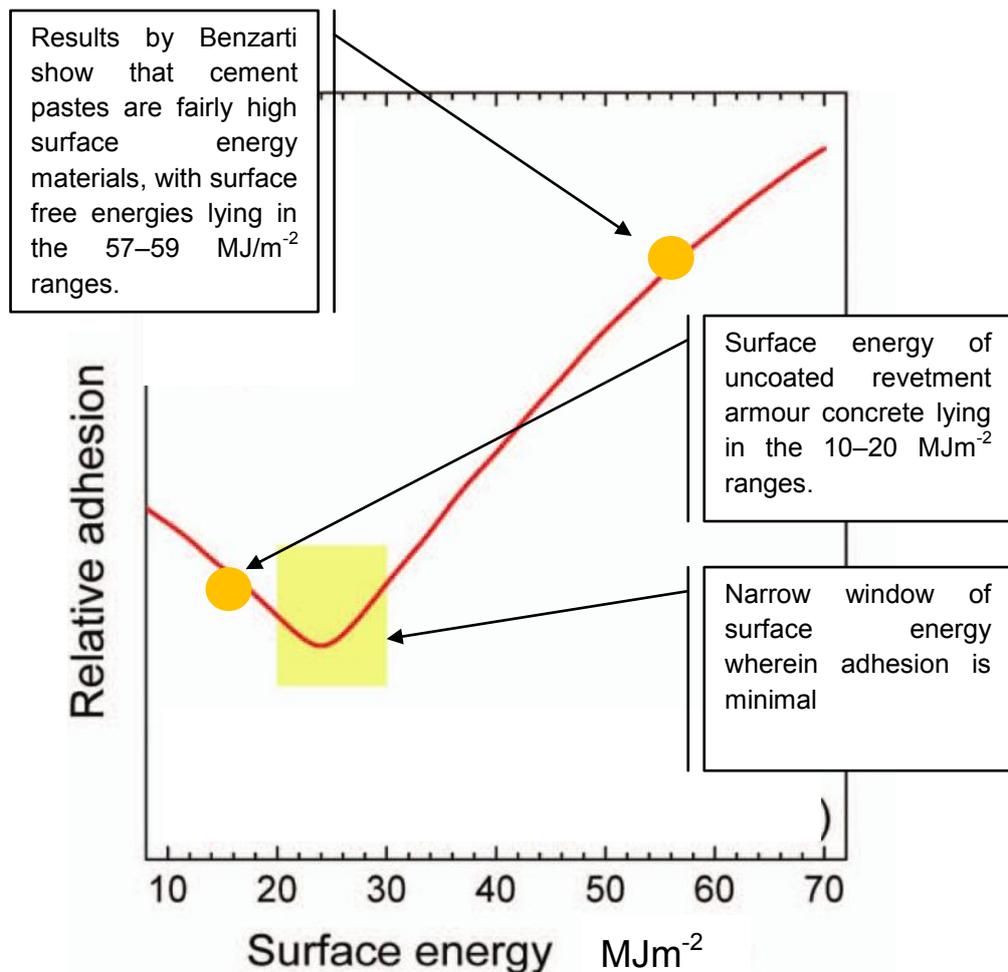
**Figure 4.23** Surface energy results from this research plotted against the Baier curve.

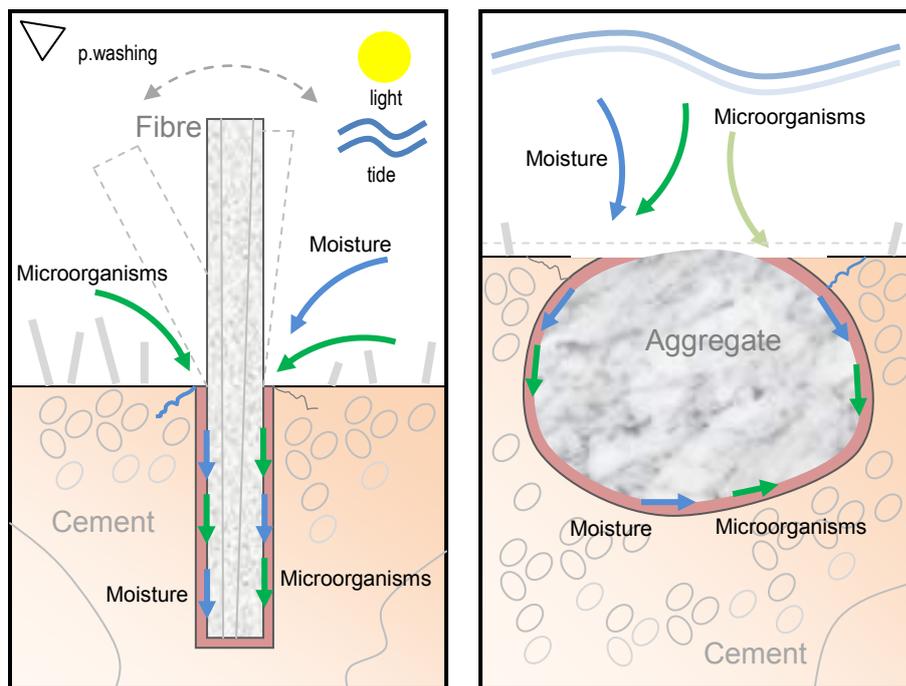
**Figure 4.24** Schematic representation of interface around inclusions.

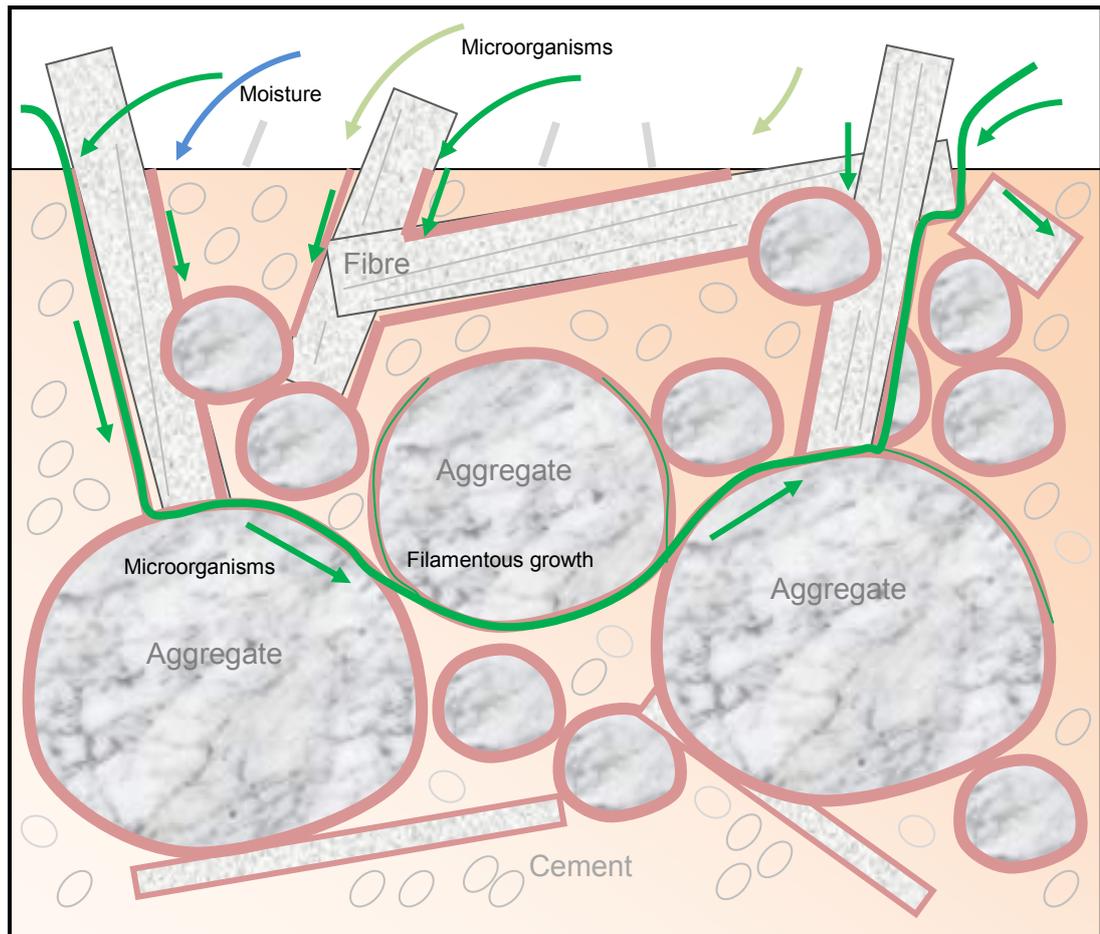
**Figure 4.25** Percolated interfaces leading to the development of an integrated pathway for microorganisms. This schematic depicts inclusions within the concrete, illustrating how an integrated pathway could have facilitated the transportation of waterborne microorganisms.

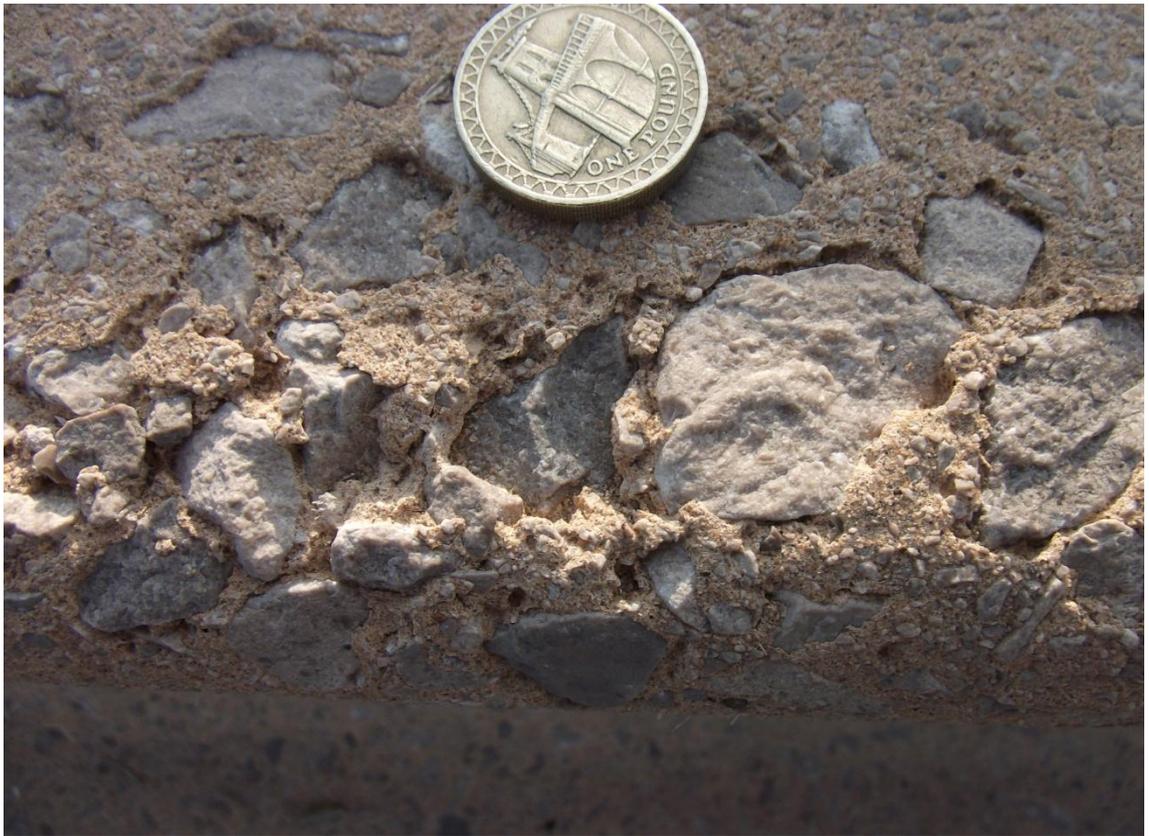
**Figure 4.27** Noticeably imperfect after five years exposure

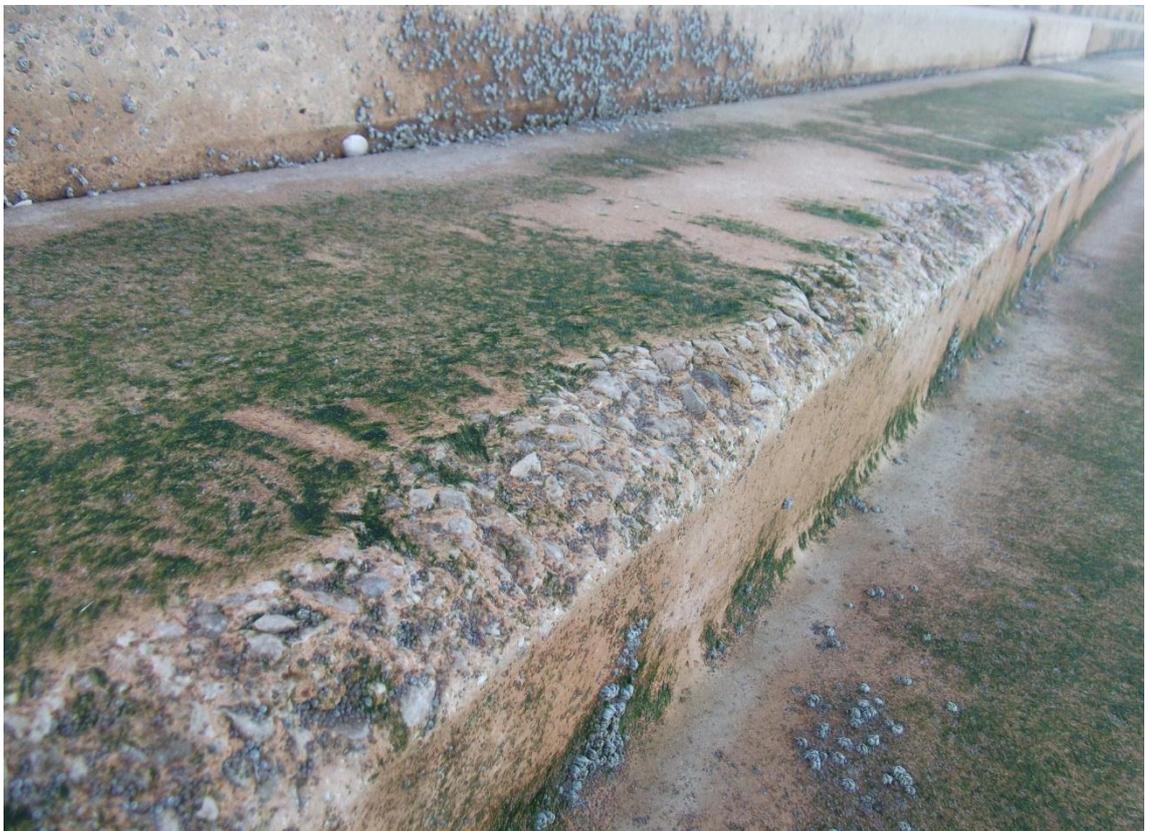
**Figure 4.28** Material loss after five years exposure

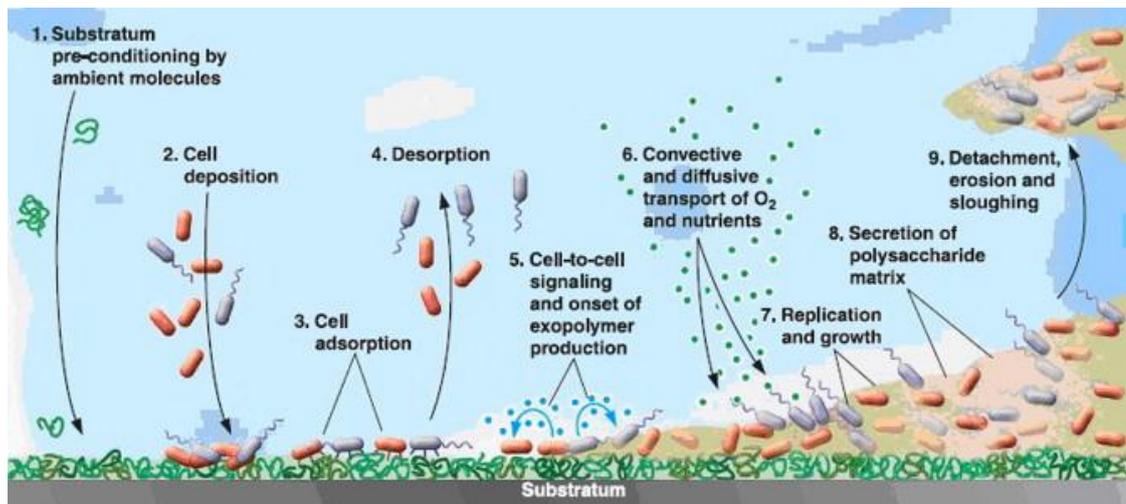
**Figure 5.1** A schematic: 'Classical' biofilm formation, (Breyers and Ratner, 2004)

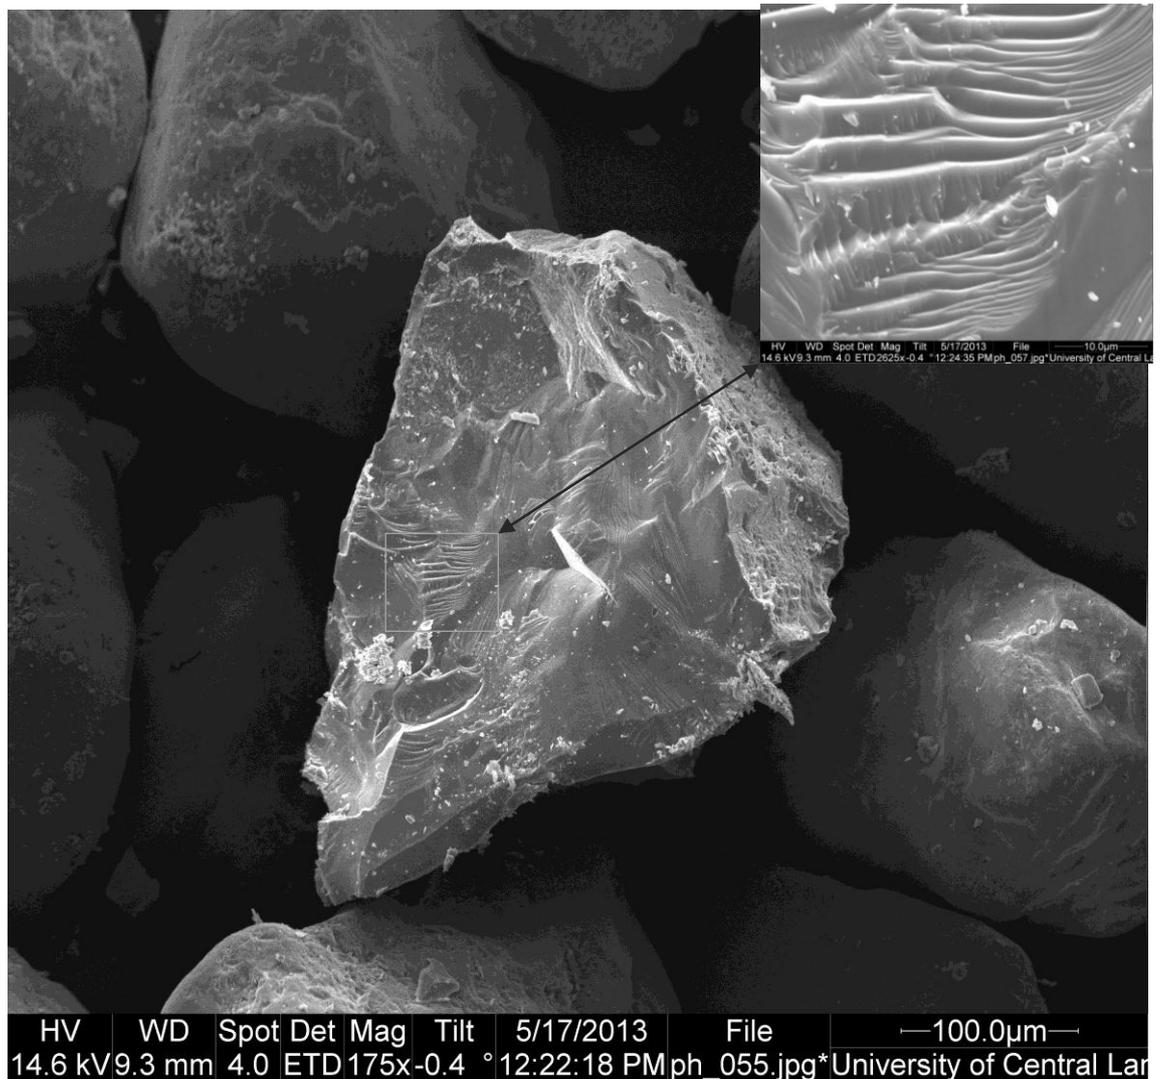
**Figure 5.2** Quartz sand particle. EDAX confirmed the primary component was silica ( $\text{SiO}_2$ ). Beach sand used in the production of concrete can harbour bacteria. This specimen was collected from the dredging area used for the manufacture of the armour concrete, cracked in half to show its compressed, rippled core structure (inset).

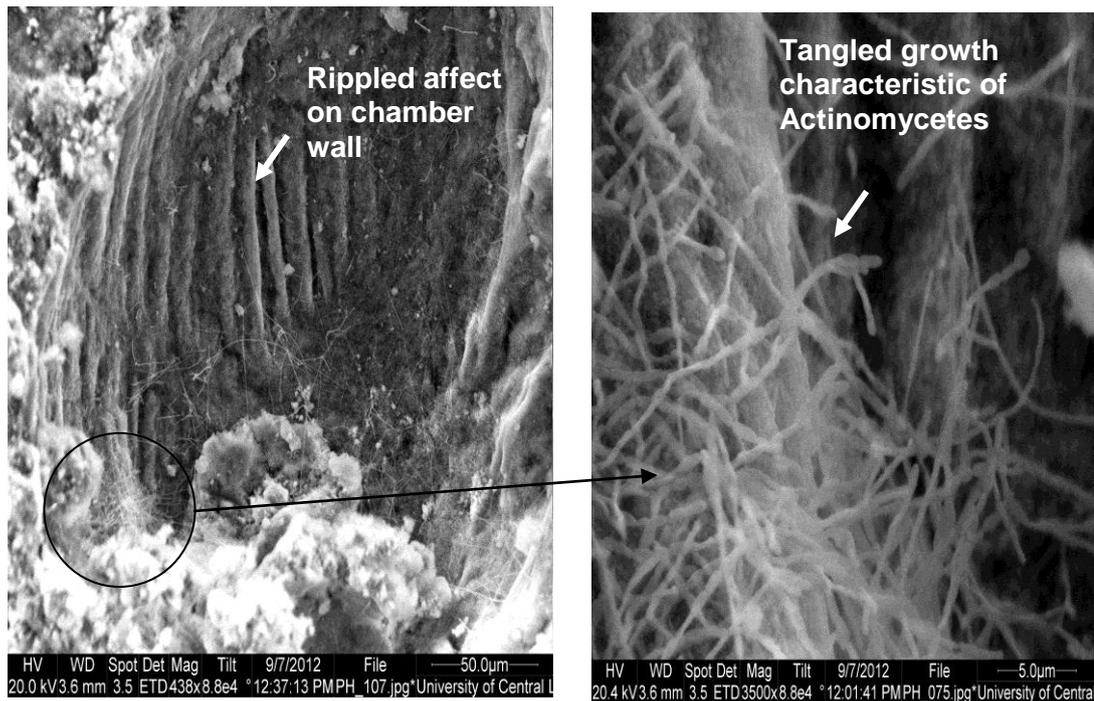
**Figure 5.3** Possible water void in new concrete. **Figure 5.4** Biofilm formation in the void.

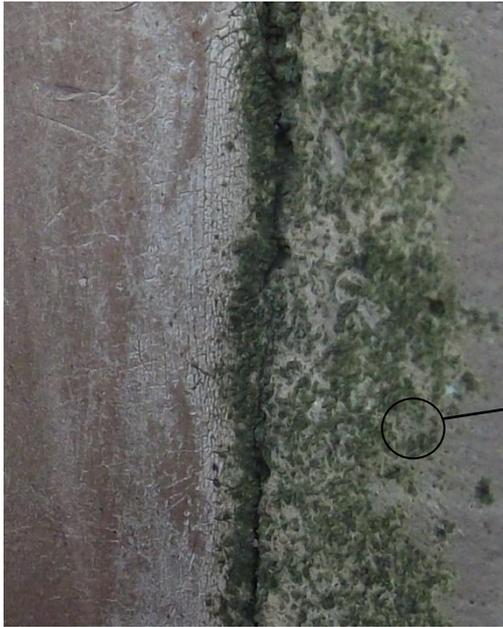
**Figure 5.11** Concrete sealant interface

Photomicrographs show biodeterioration of hybrid polymer silicone sealant samples from the study site, electron microscopy showed evidence of microbial growth at the surface and within the matrix of the sealant (Figures 5.11 to 5.15).

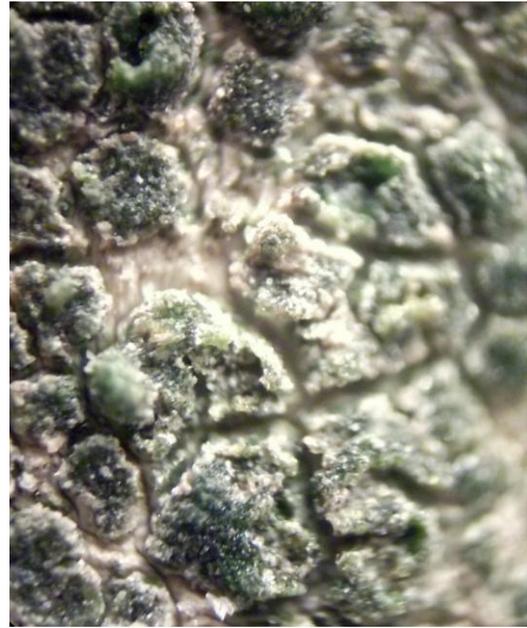
**Figure 5.12** Surface of sealant at 2 yrs exposure.

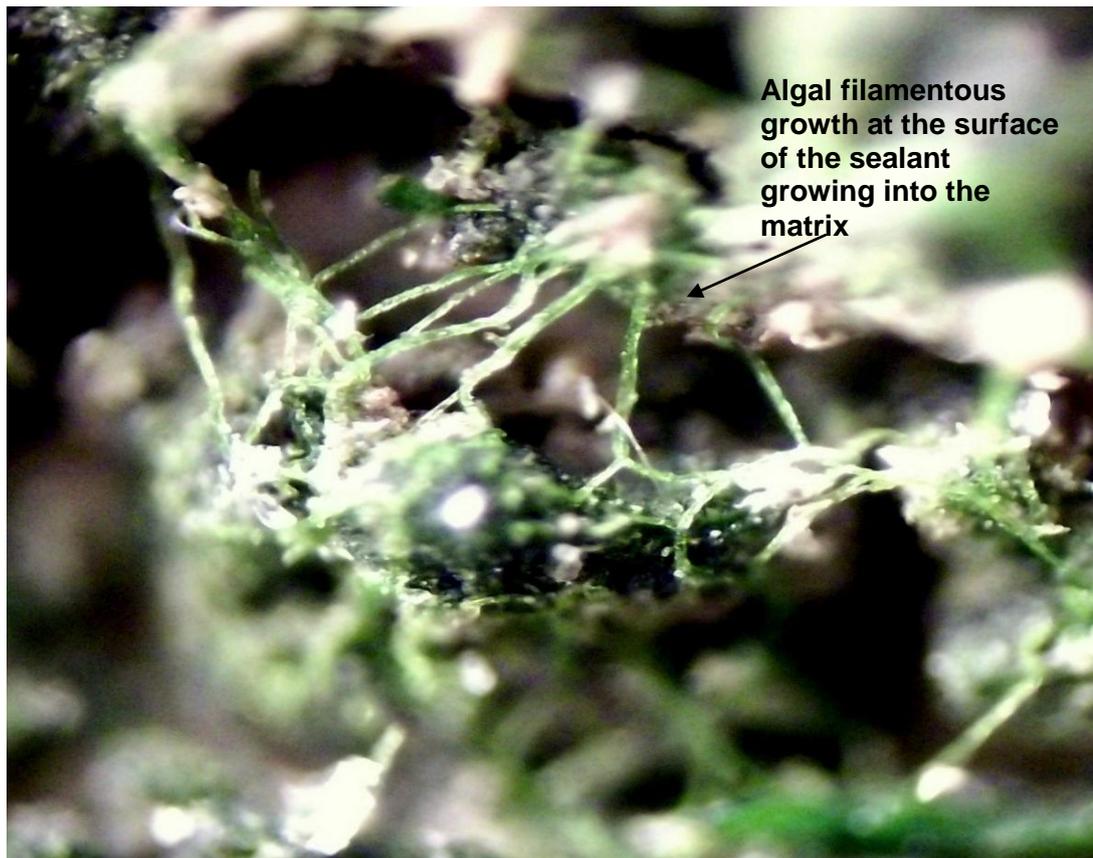
**Figure 5.13** Algal colonisation on the surface of the sealant after 2 years exposure.

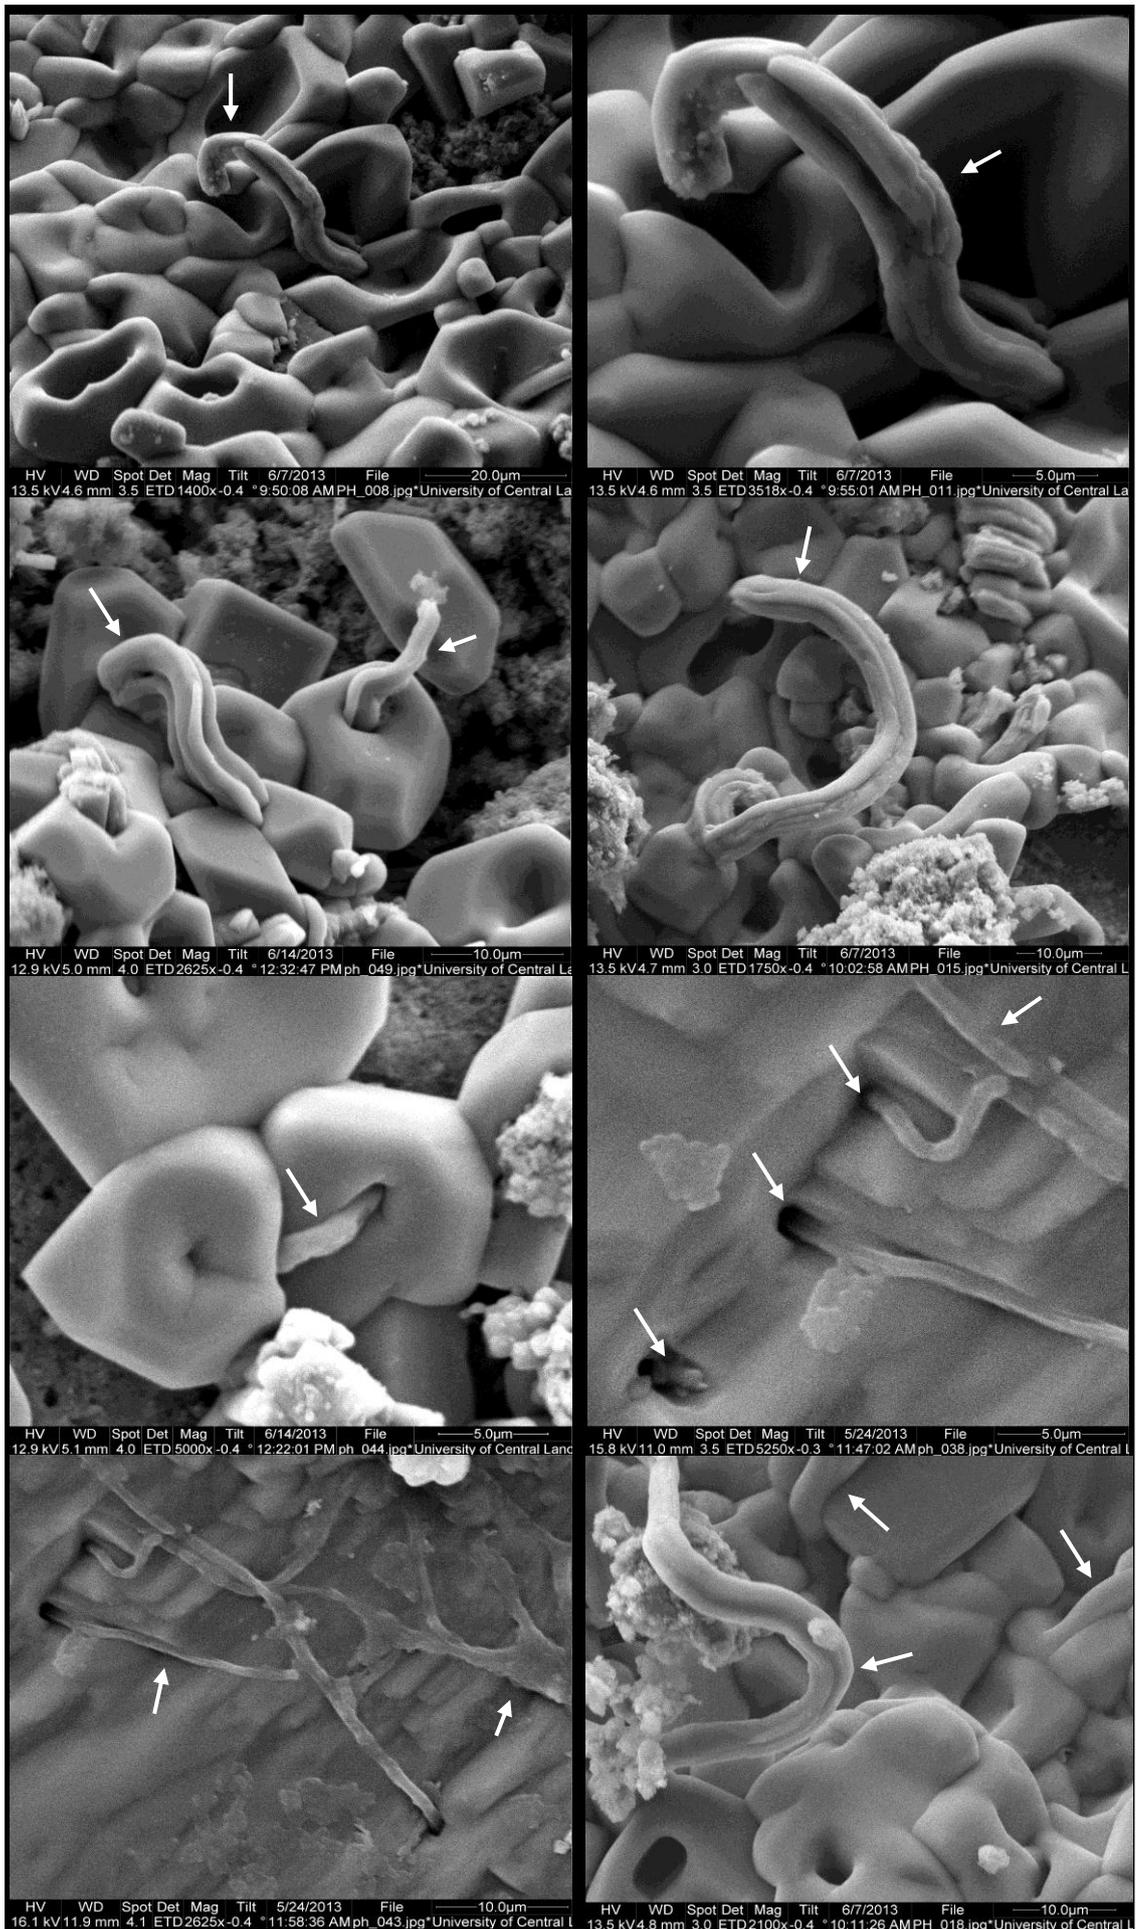
**Figure 5.16** Filamentous growth (arrowed) from sodium chloride (NaCl) crystals

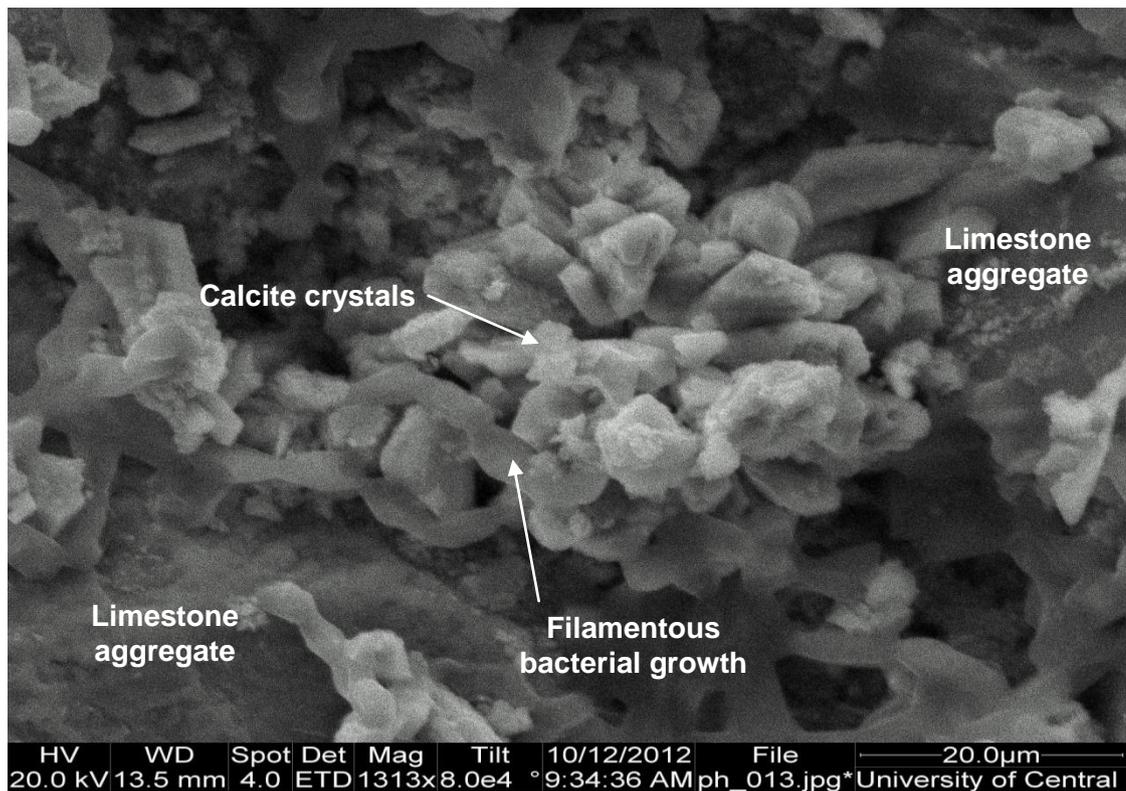
**Figure 5.17** Precipitation of calcium carbonate in fresh concrete, filamentous bacterial growth and calcite crystals at the cement limestone interface.

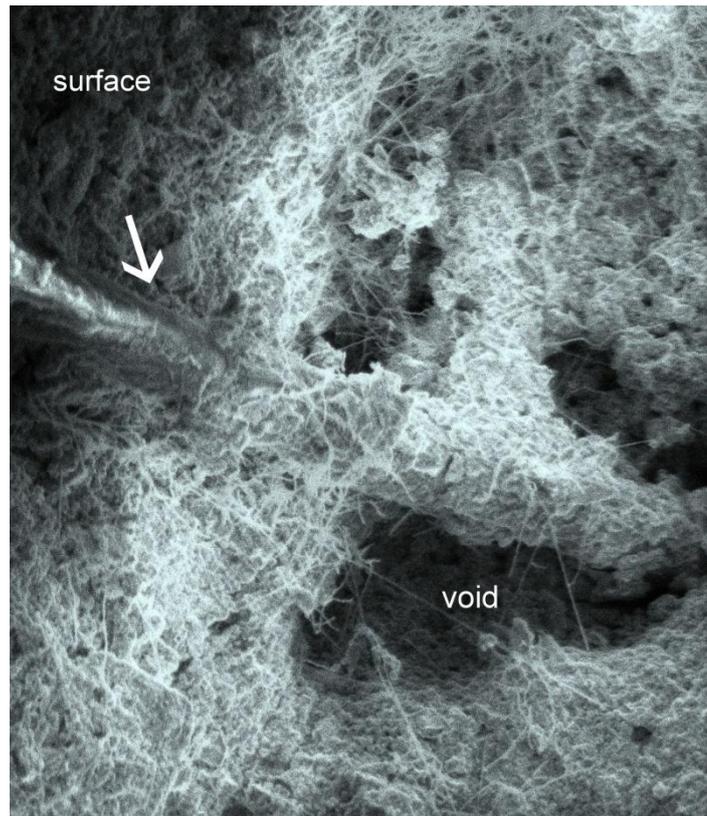
**Figure 5.18** A micro-fibre within revetment cement matrix (22  $\mu\text{m}$  in diameter) with bacterial biotenacious growth (350 nm in diameter).

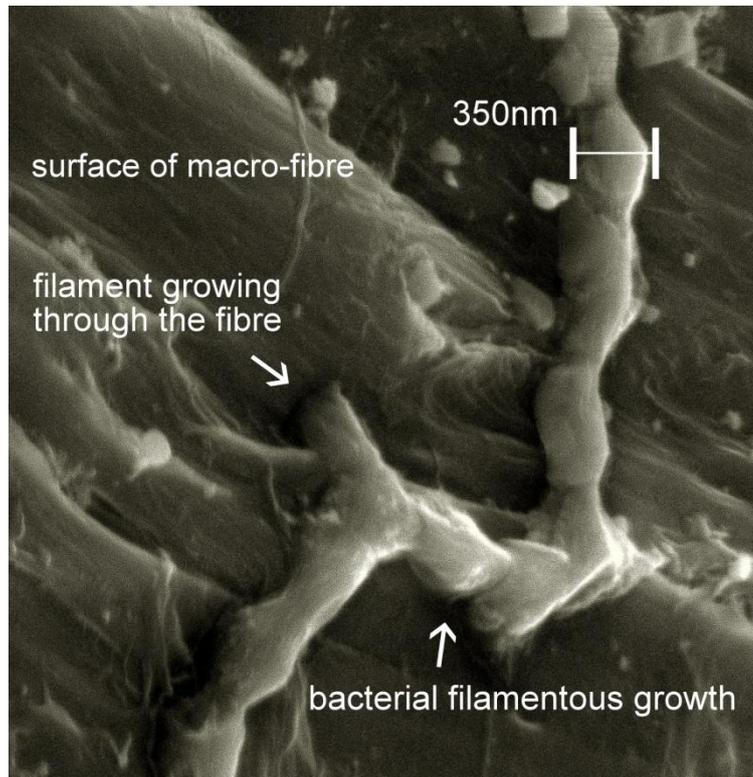
**Figure 5.19** A macro-fibre within revetment cement matrix with filamentous growth through the polymer.

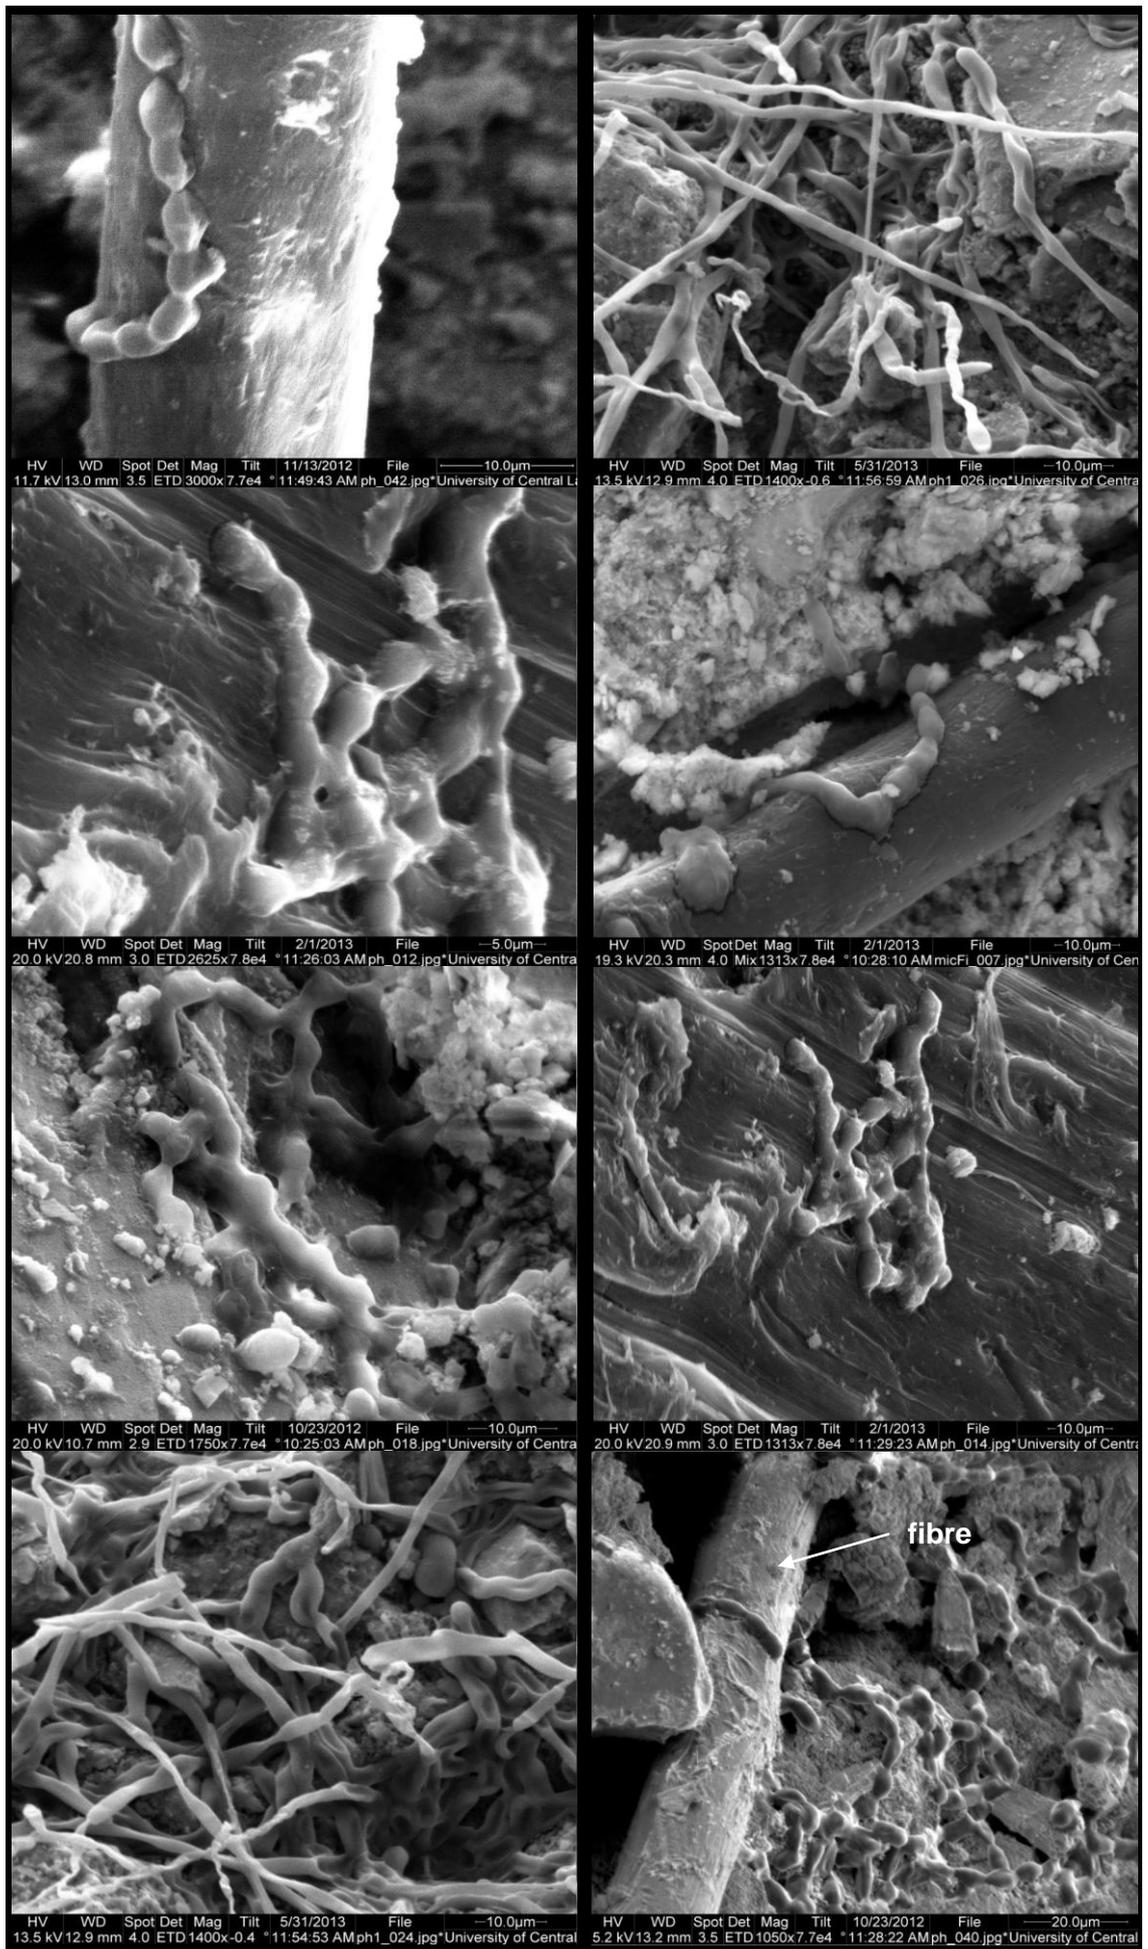
Figure 5.20 Examples of bacterial filamentous growth on synthetic fibres

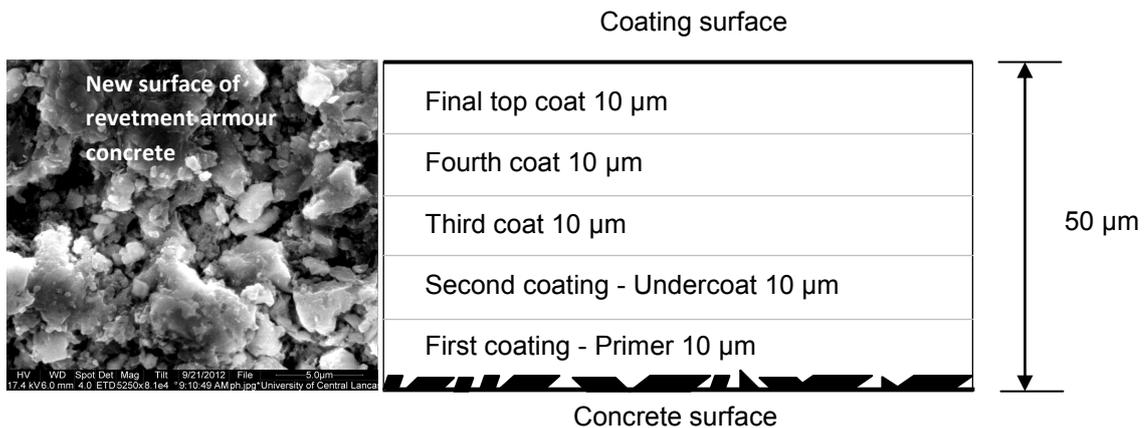
**Figure 6.2** TiO<sub>2</sub> 50 µm coating layer formation, primer coat bond was vital because of the nature of the surface of the concrete (inset).

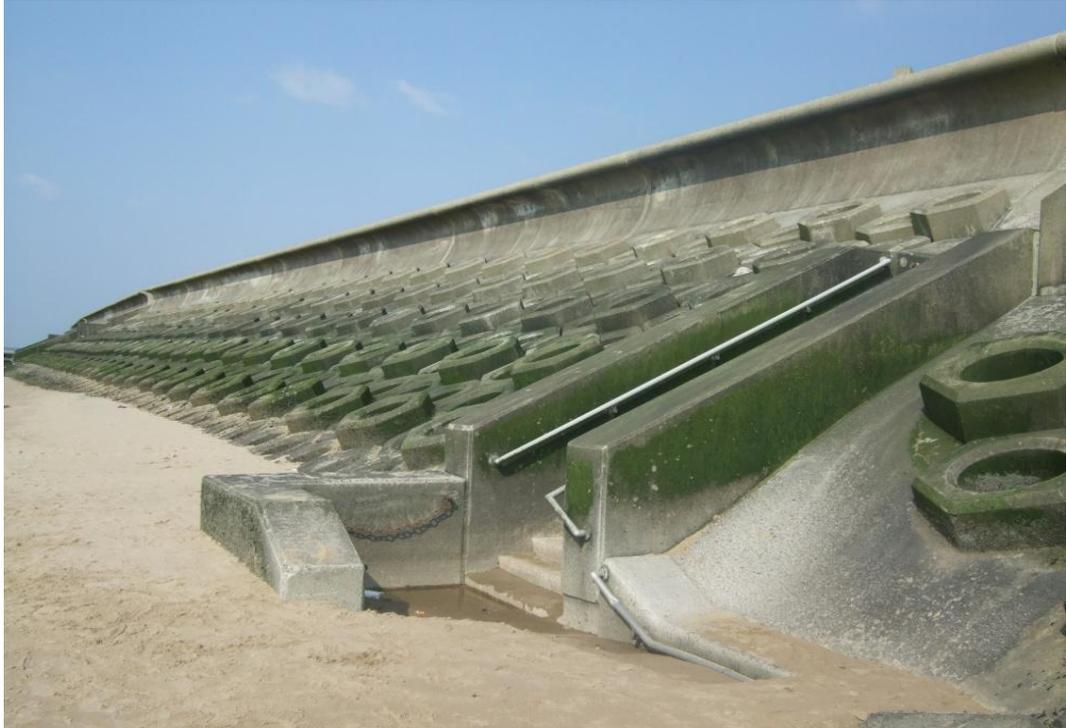
**Figure 6.3** Study site 1 (Stargate steps). Lat. 53° 46' 37.13" N – Long. 3° 3'27.64"W before the application of the coating (Figure 6.7), video in Appendix.

The seashore at the study site is characterised by a plain and flat surface covered with sand and with a small amount of rocks in a marine environment characteristic of a temperate climate (Evans, 1962) (Figures 6.3, 6.4 and 6.8).

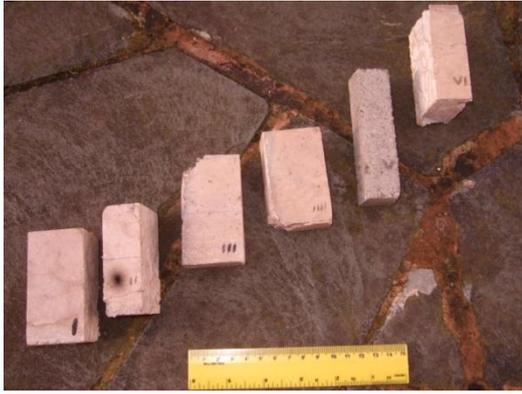
**Figure 6.6** Revetment concrete tiles

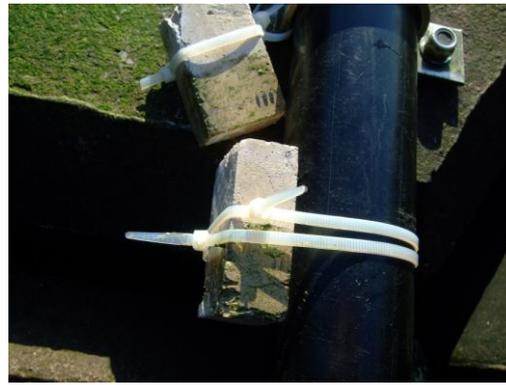
**Figure 6.7** Revetment tiles secured to pipe

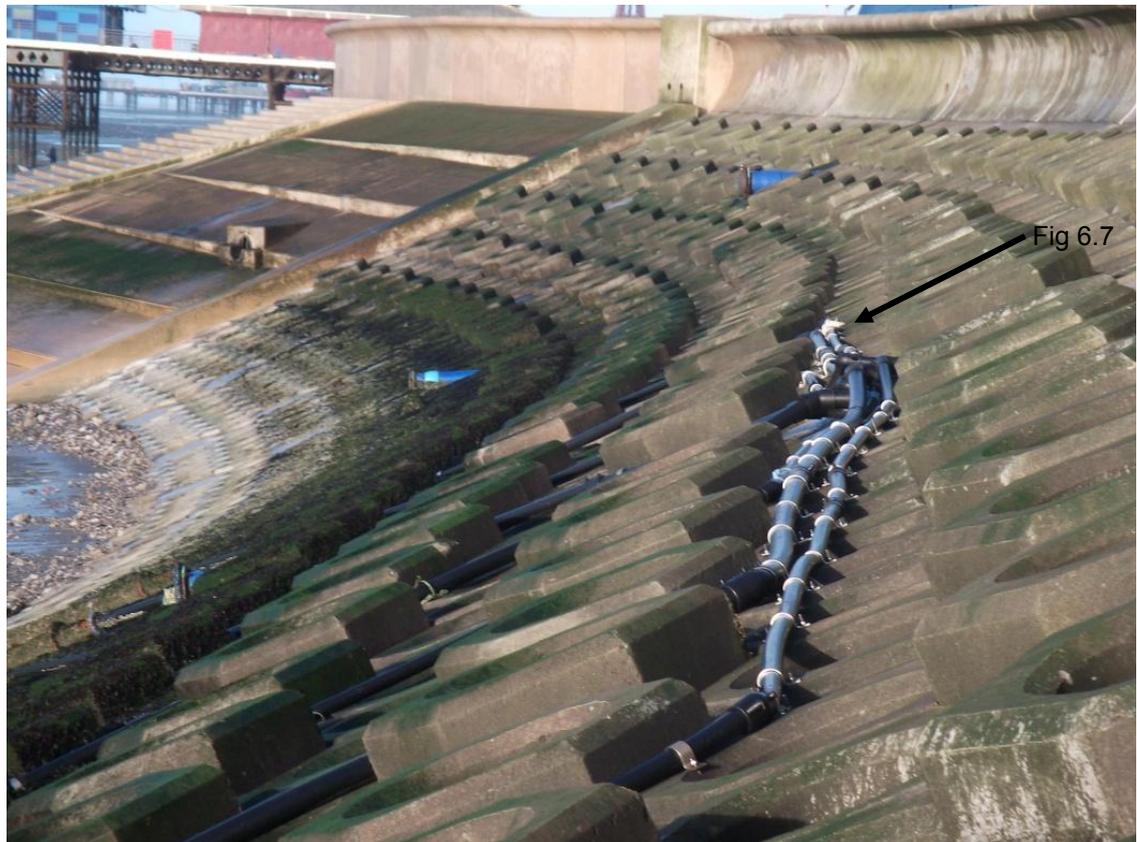
**Figure 6.8** Study site 3. (Tide organ) – revetment armour concrete and OPC cement (control) coupons Lat.  $53^{\circ} 47'30.85''N$  – Long.  $3^{\circ} 3'31.16''W$ . This location was difficult to access however, and vandalism was avoided, video in Appendix.

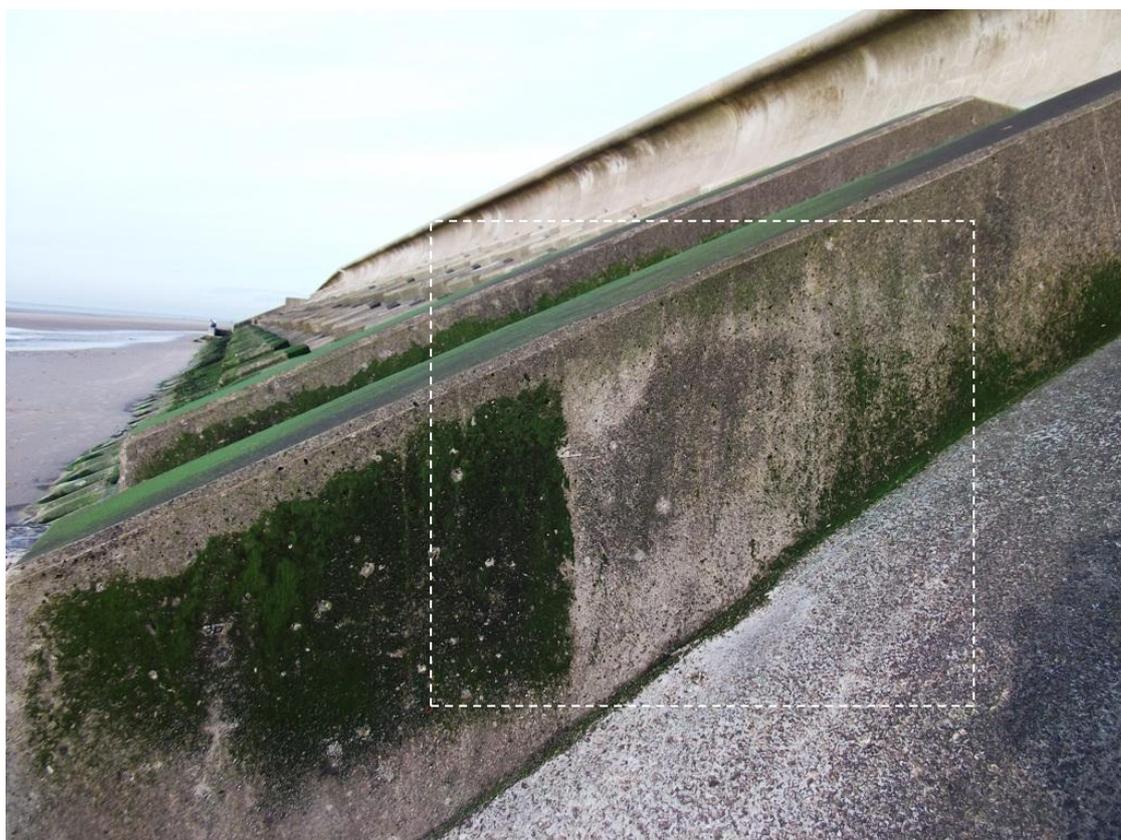
**Figure 6.9**  $\text{TiO}_2$  coated area at study site 1 shows anti-fouling capabilities, image taken April 2011.

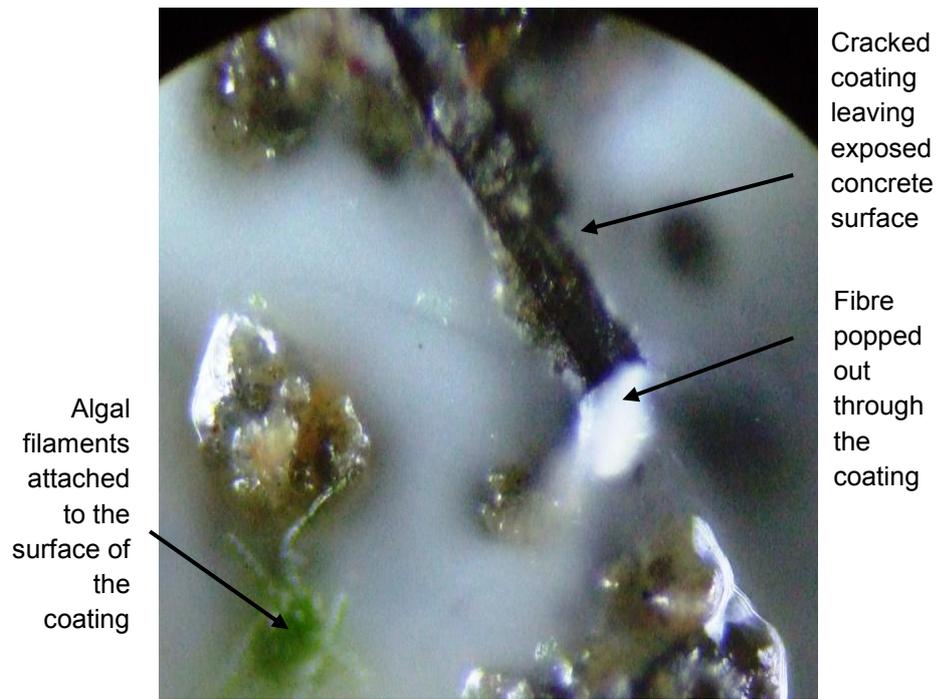
**Figure 6.13** Light microscopic digital image of revetment concrete tile, site 3. Note a lifting macro-fibre has broken through the coating (arrowed).

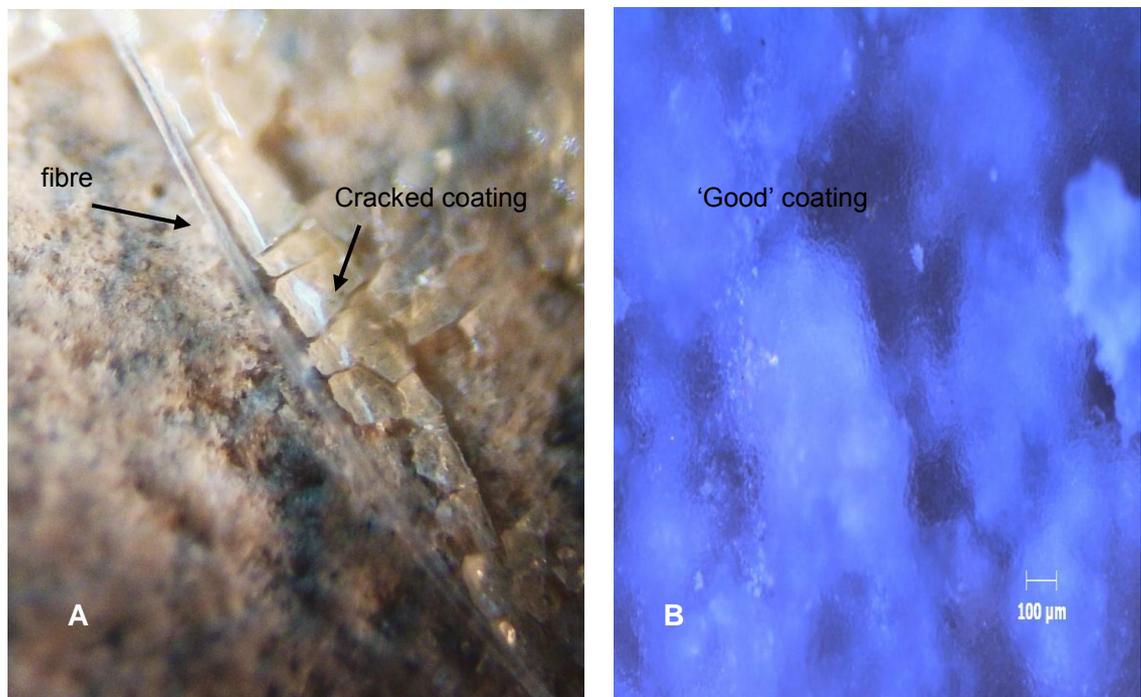
**Figure 6.14 A:** Light microscopic digital image of a micro-fibre (21  $\mu\text{m}$  diameter) at the surface of revetment tile, site 3, under the coating (arrowed). **B:** Durable coating on fibre free concrete surface from site 2, classed as 'No. 1' in criteria set for these trials.

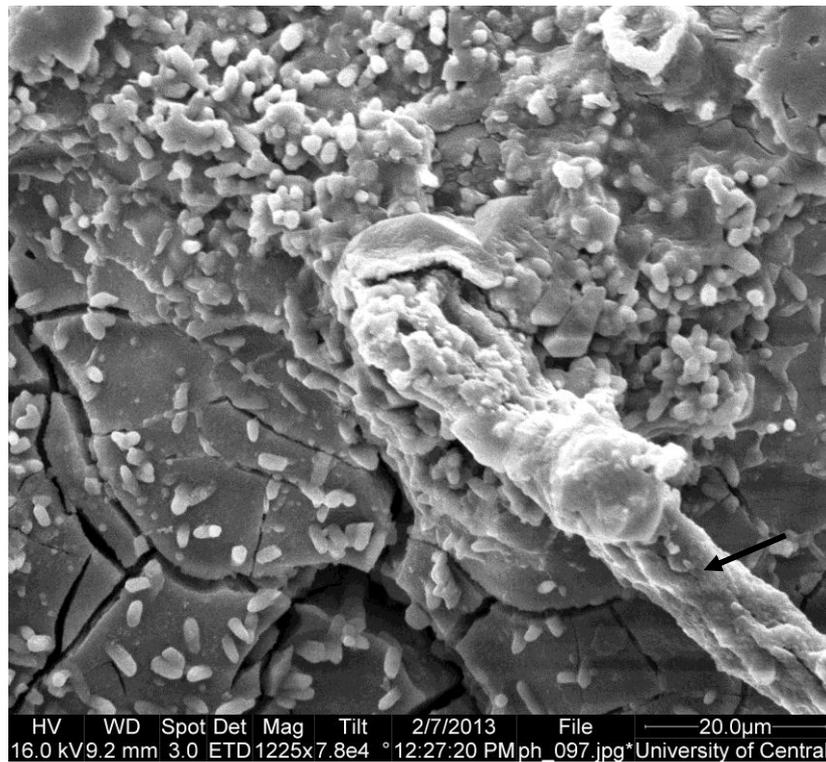
**Figure 6.18** Coating of revetment tile after 2 months exposure at site 3. Algal filament (arrowed) is shown attached to the surface of the coating.

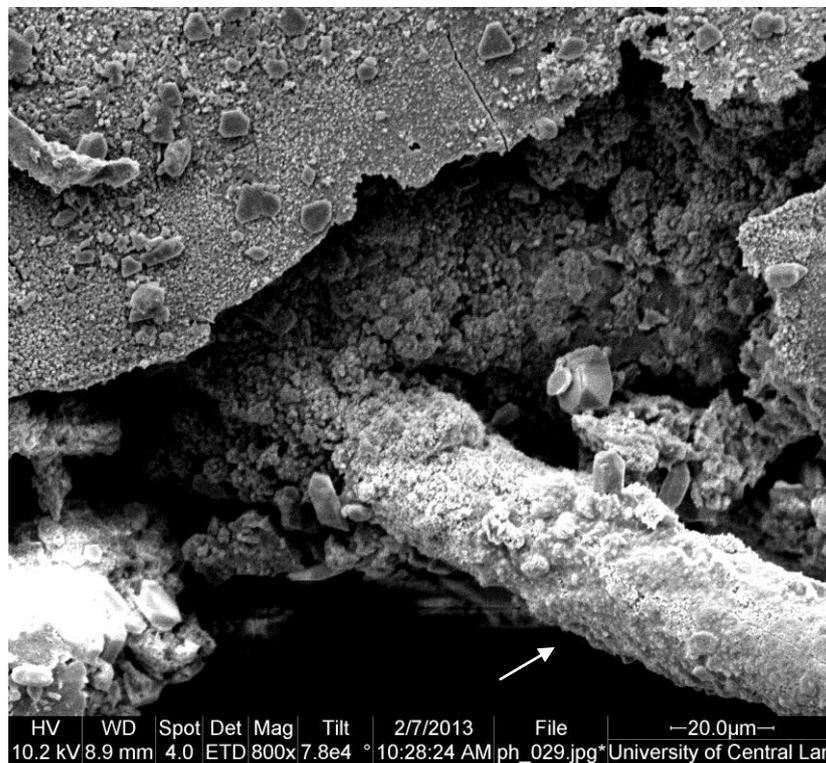
**Figure 6.19** Micro-fibre (22 µm in diameter) is shown (arrowed) lifting out of the cracked coating surface of a revetment concrete tile, site 3, after 3 months exposure.

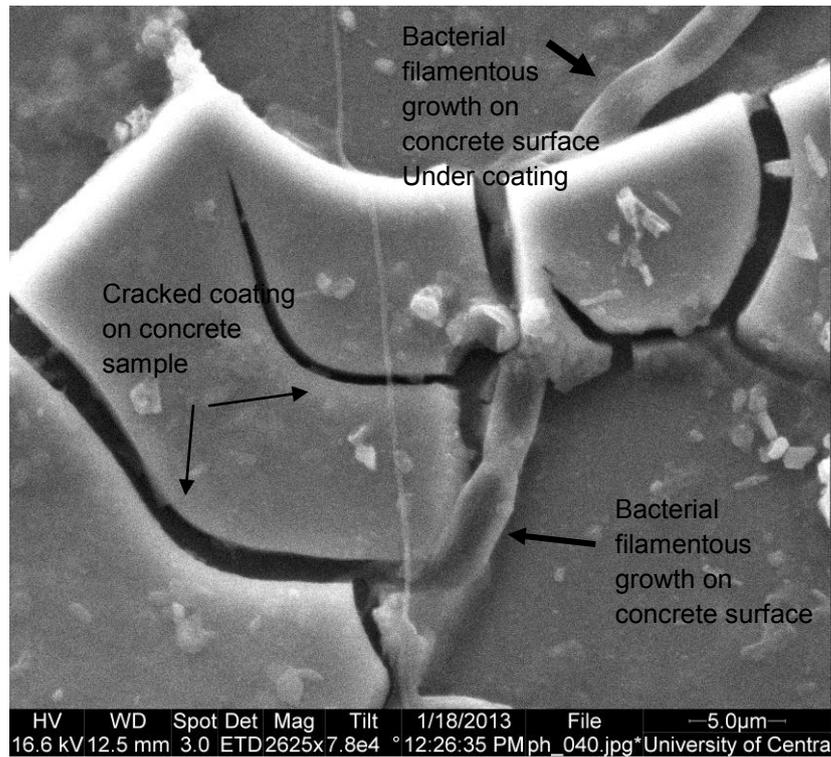
**Figure 6.20** Bacterial filamentous growths (arrowed) beneath the coating, site 3.
