**An investigation into marine biofouling  
and its influence on the durability of  
concrete sea defences**

PETER HUGHES

A THESIS SUBMITTED TO THE UNIVERSITY OF  
CENTRAL LANCASHIRE IN PART FULFILLMENT FOR  
THE AWARD OF DOCTOR OF PHILOSOPHY

FEBRUARY 2014

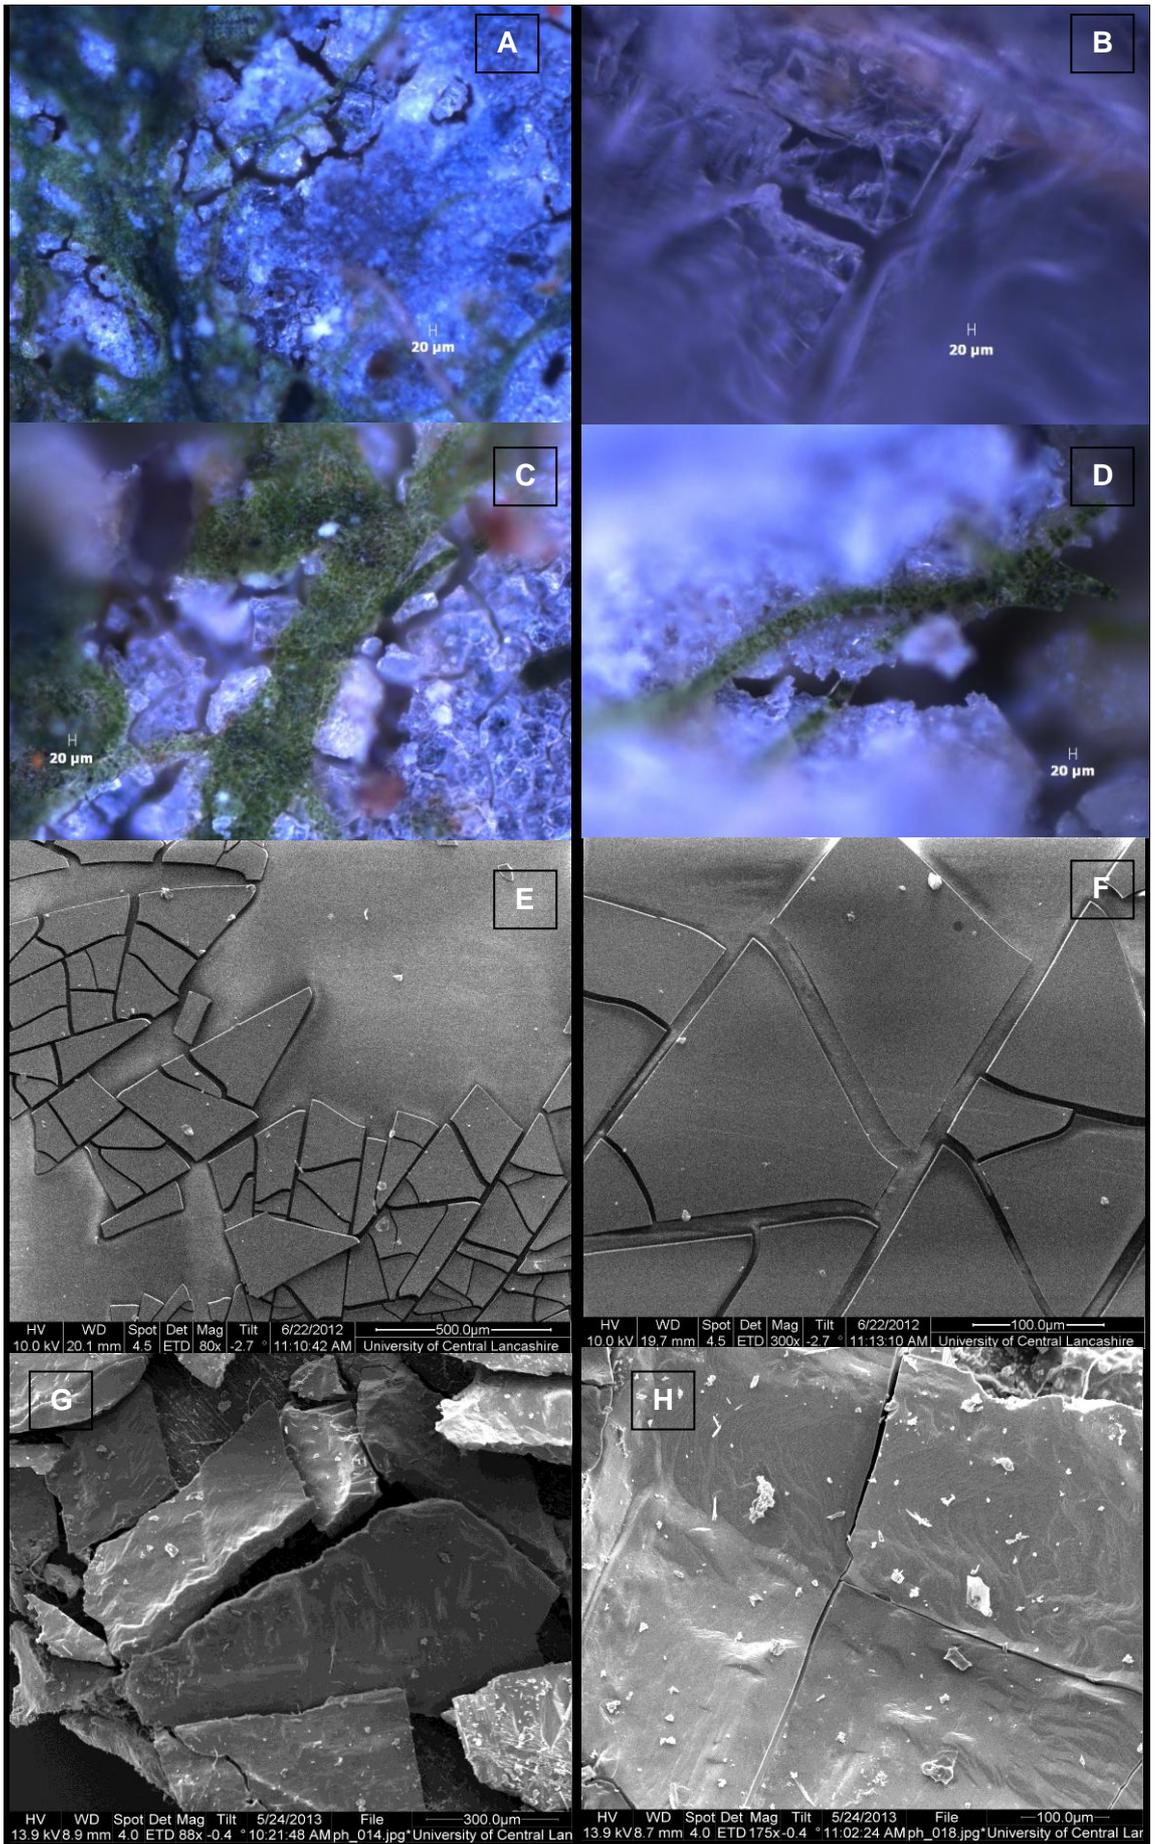
**Figure 6.22** Coating modes of failure. A, C & D are examples of algal attack, B, C, E, F & H are examples of cracking, G & H are the effects of three months site exposure.

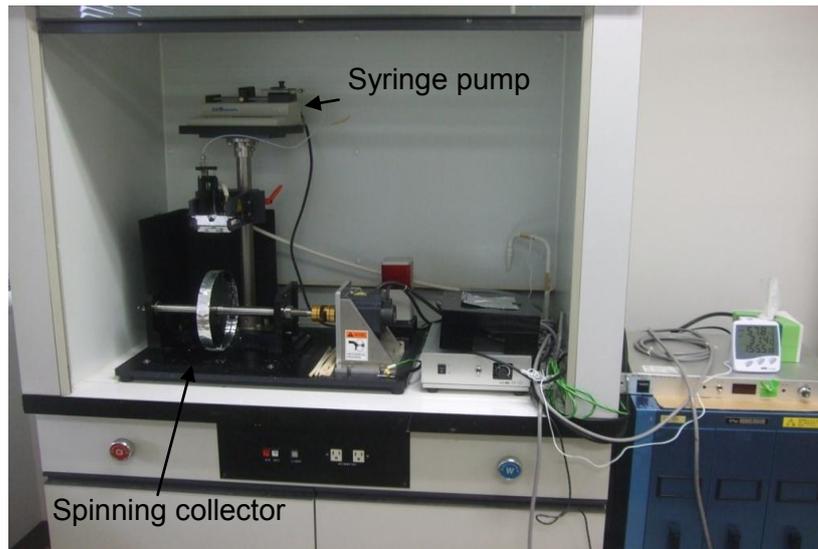
Figure 7.1 Electrospinning apparatus.

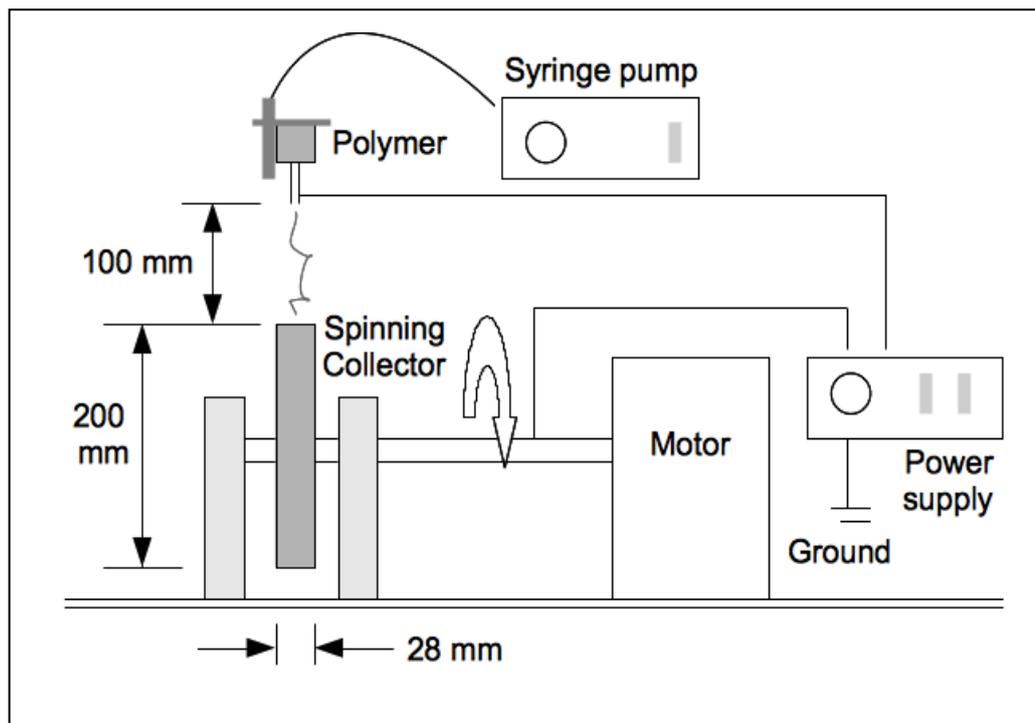
Figure 7.2 Electrospinning schematic of major components.

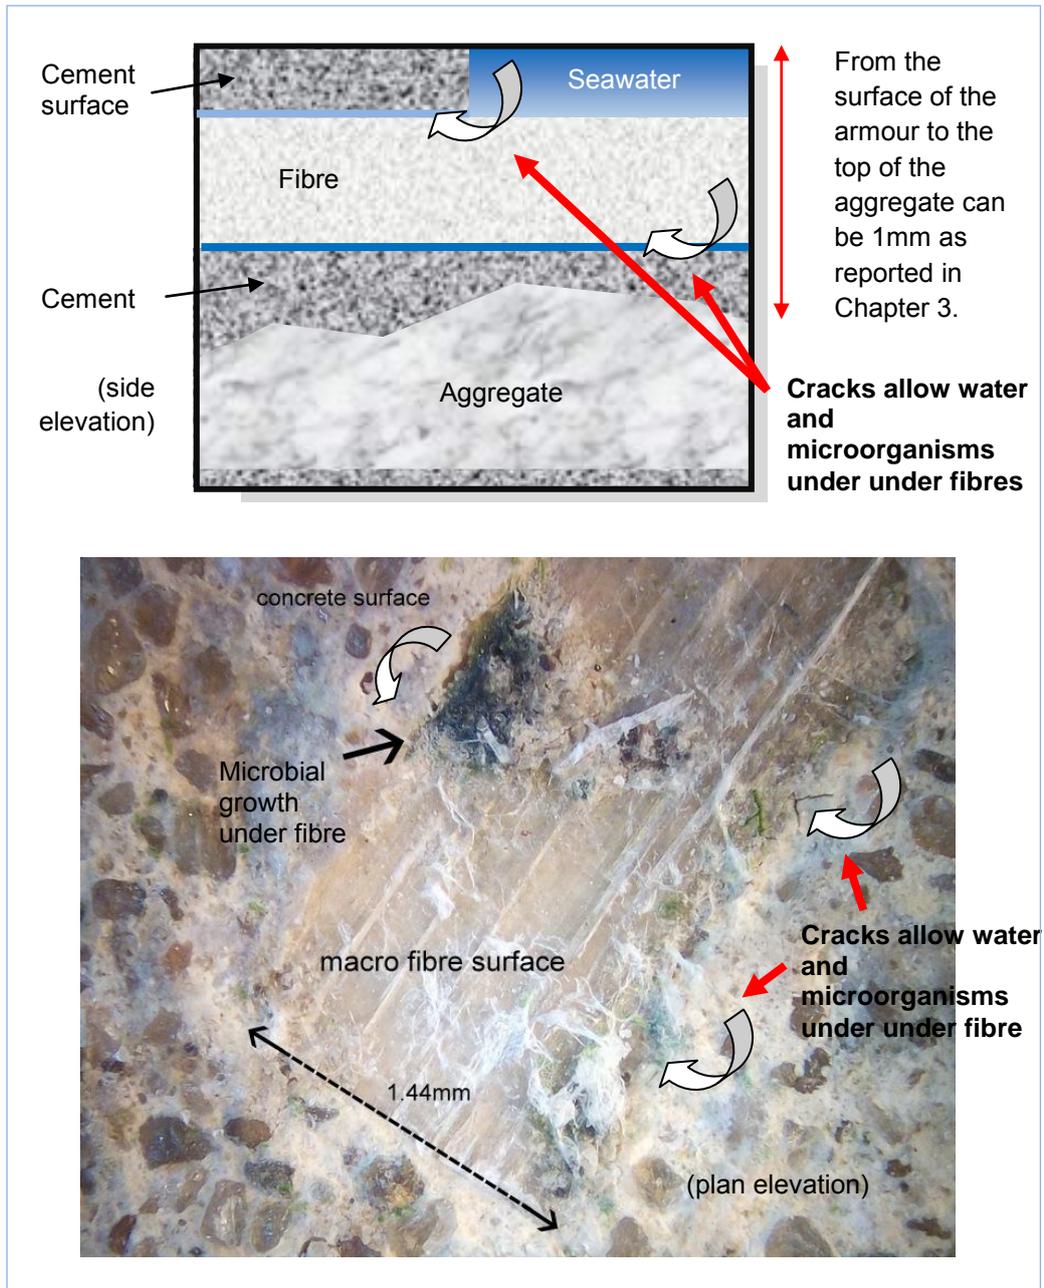
**Figure 8.1** First element of the holistic model; schematic and digital image showing the new surface of the revetment armour concrete.

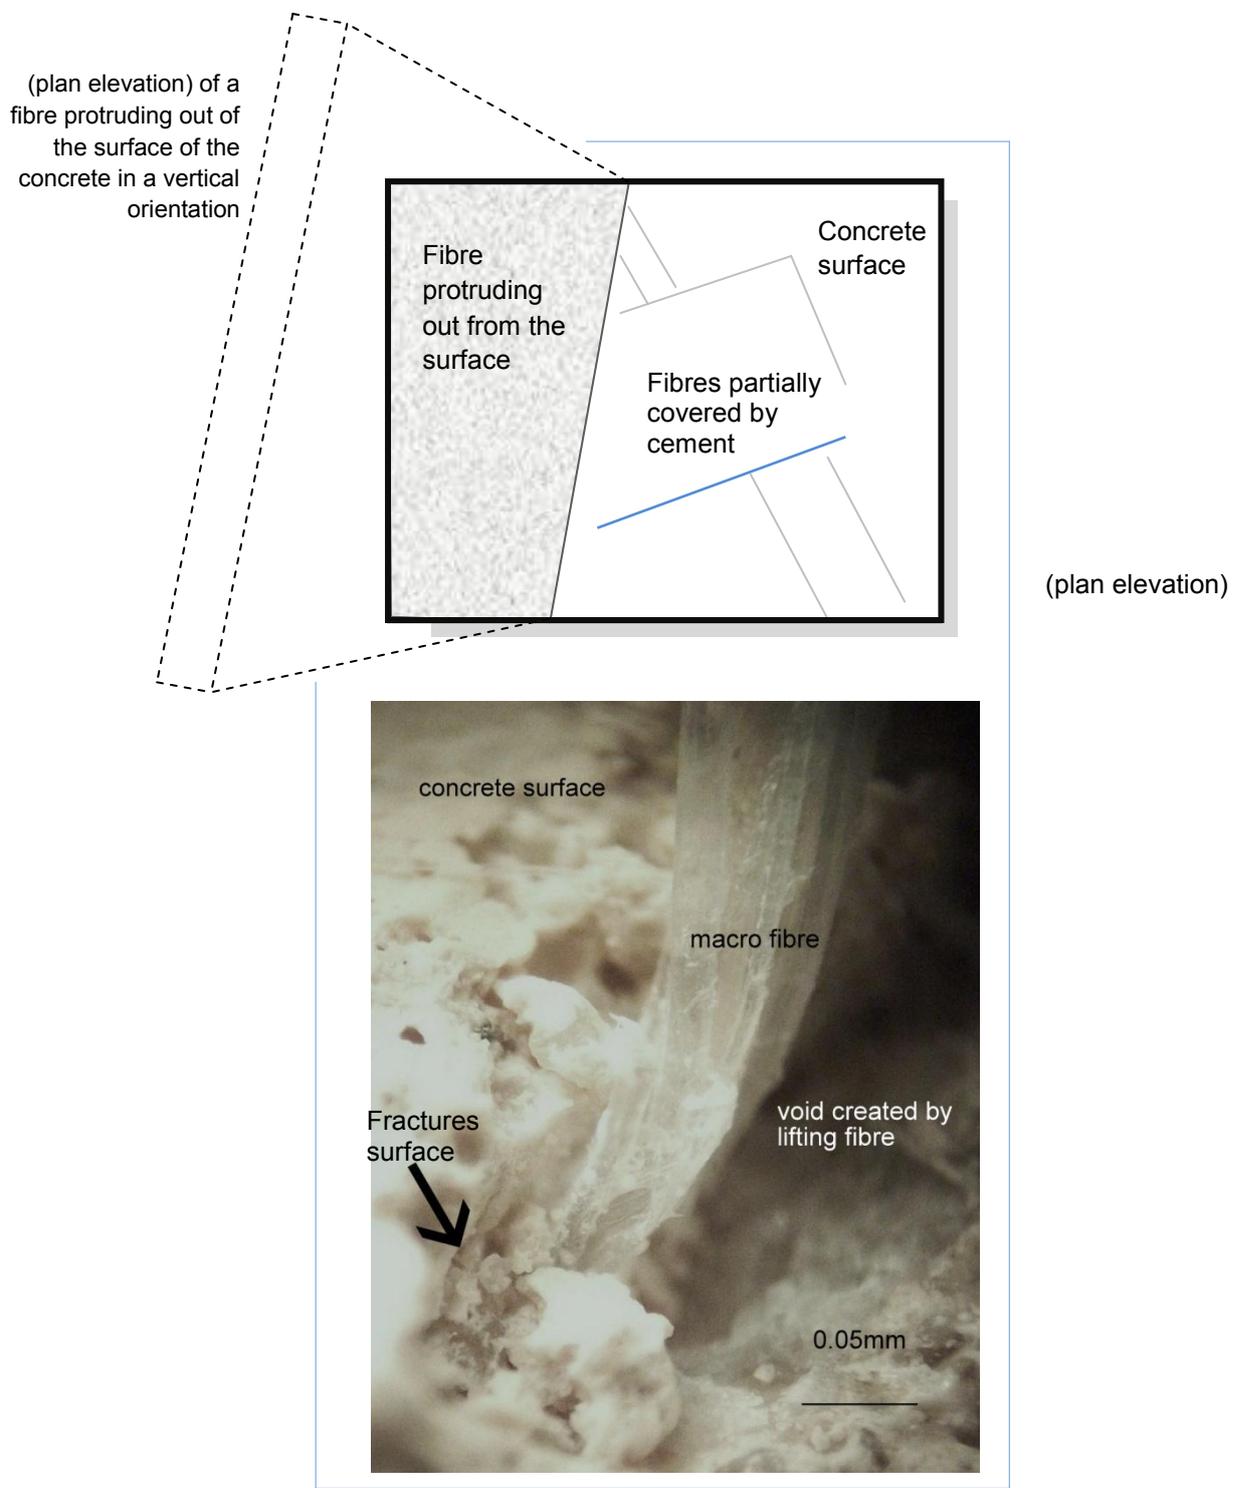
**Figure 8.2** Second element of the holistic model; schematic and digital image showing fibres protruding from the surface of the revetment armour concrete.

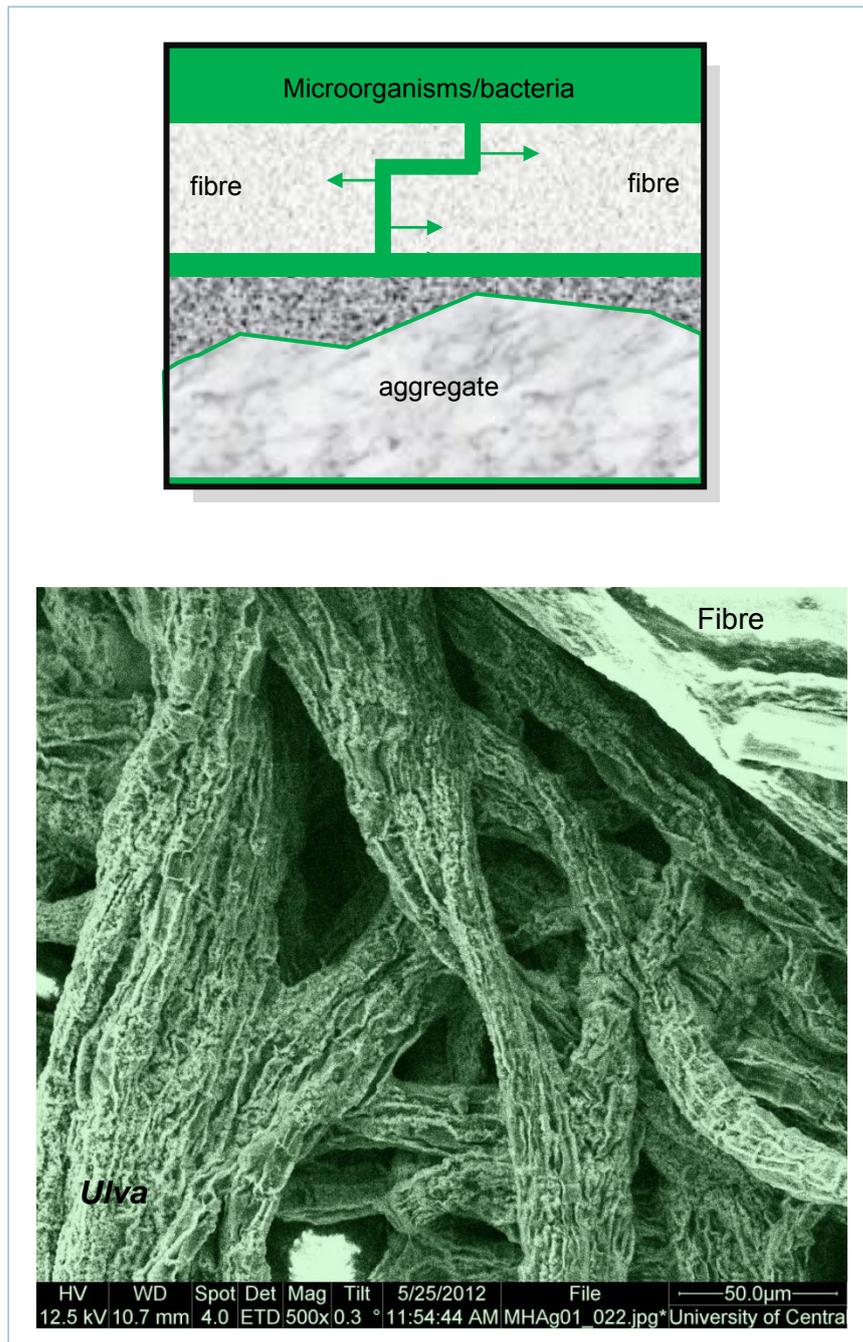
**Figure 8.5** Fifth element of the holistic model; schematic and digital image showing showing algal colonisation under synthetic fibres.

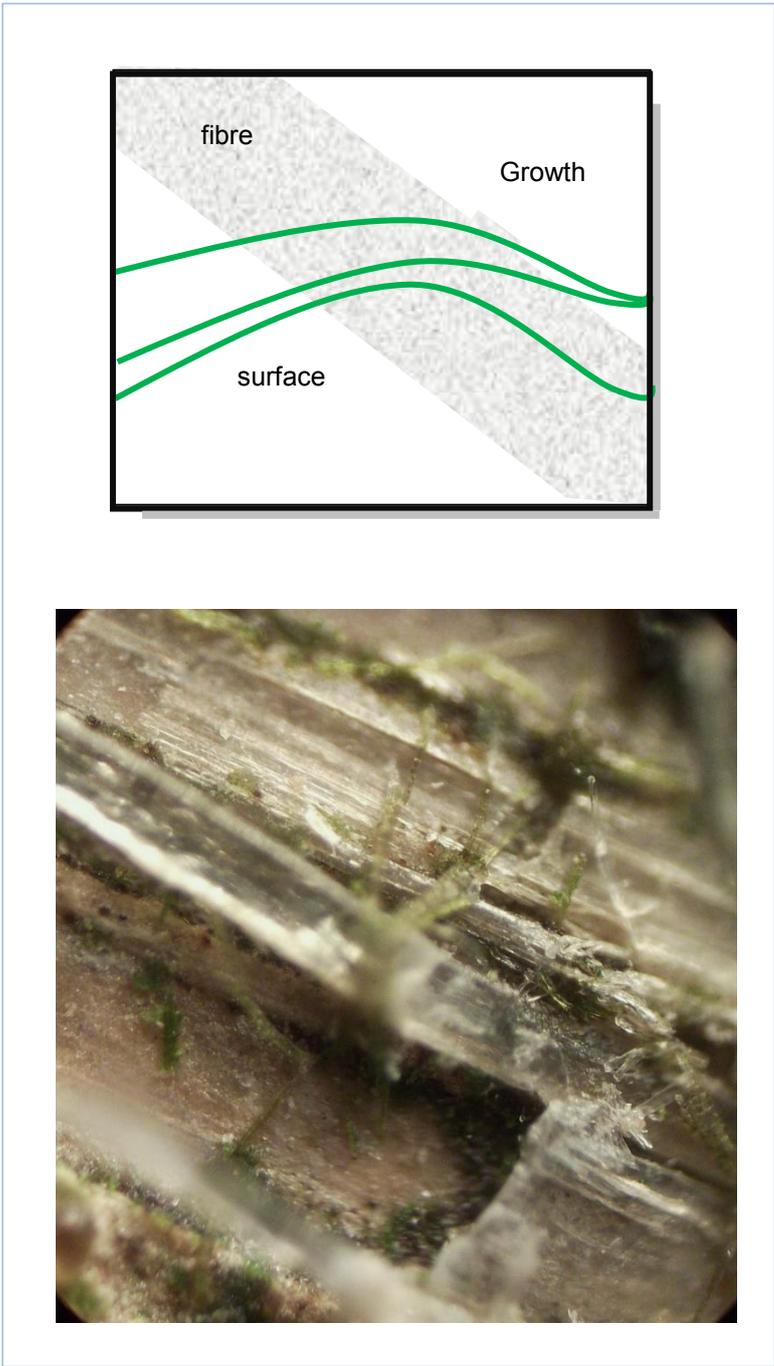
**Figure 8.6** Sixth element of the holistic model; schematic and digital image showing how filaments can grow within the surface zone of the revetment armour concrete.

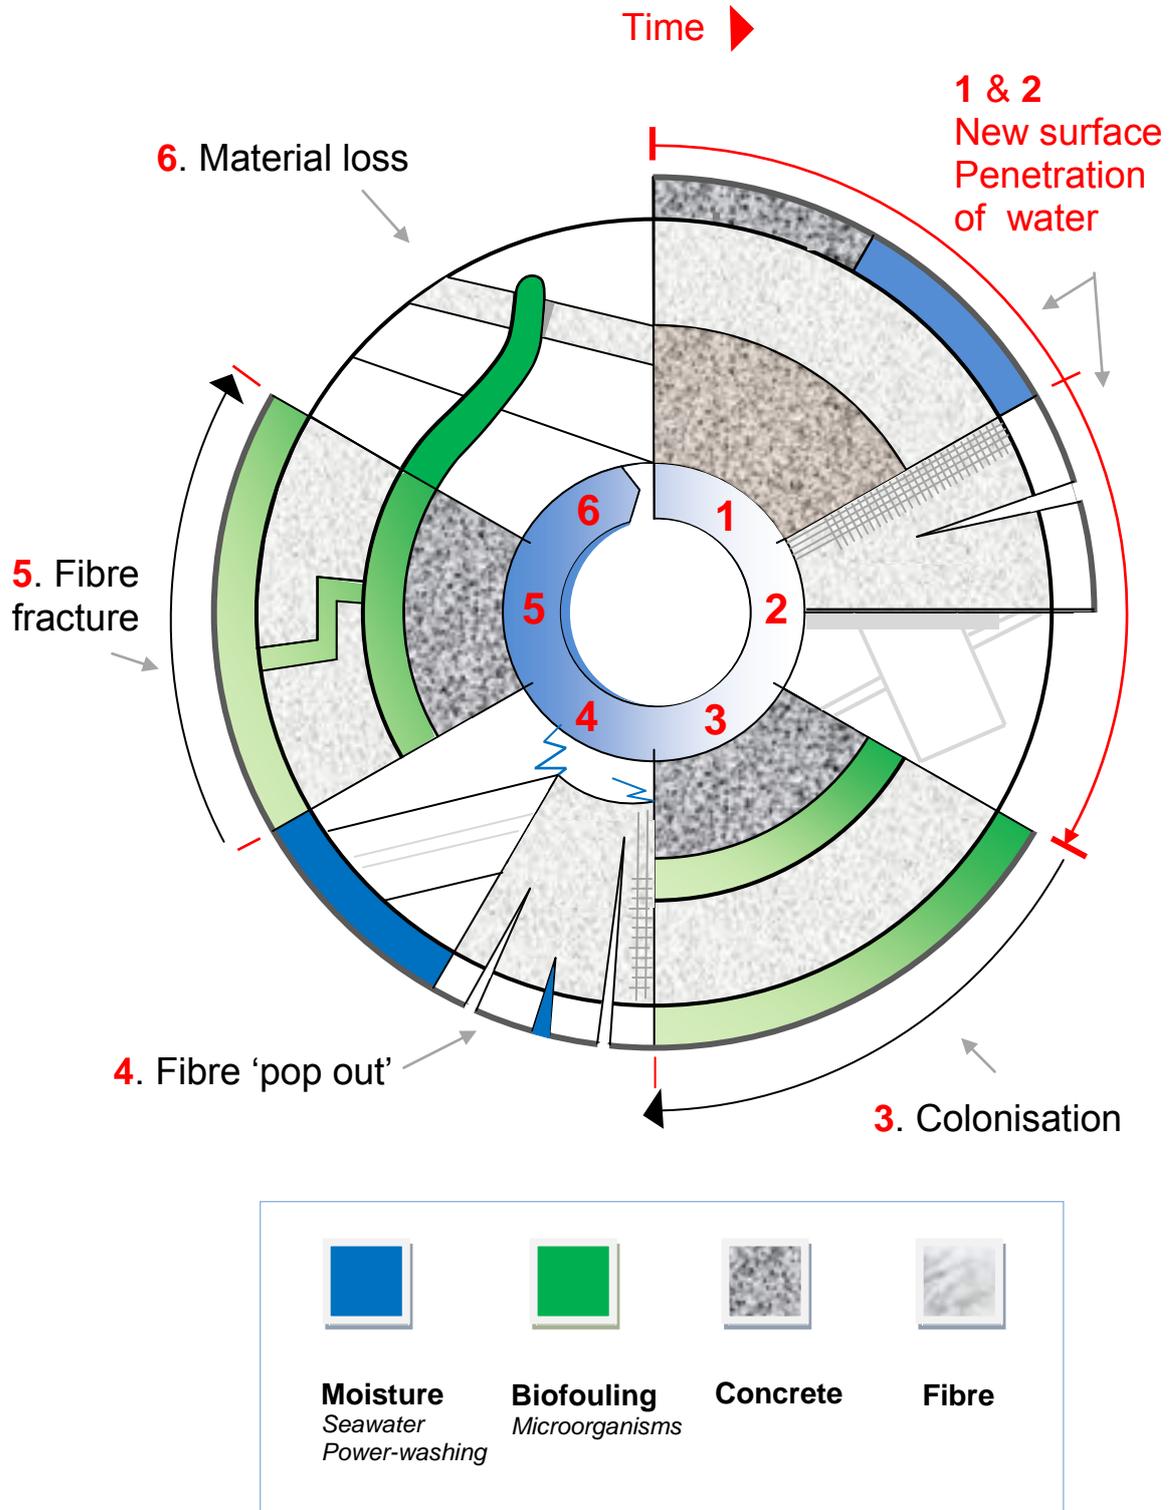
**Figure 8.8** A Holistic Model of fibre degradation, combining elements (of Figure 8.7).

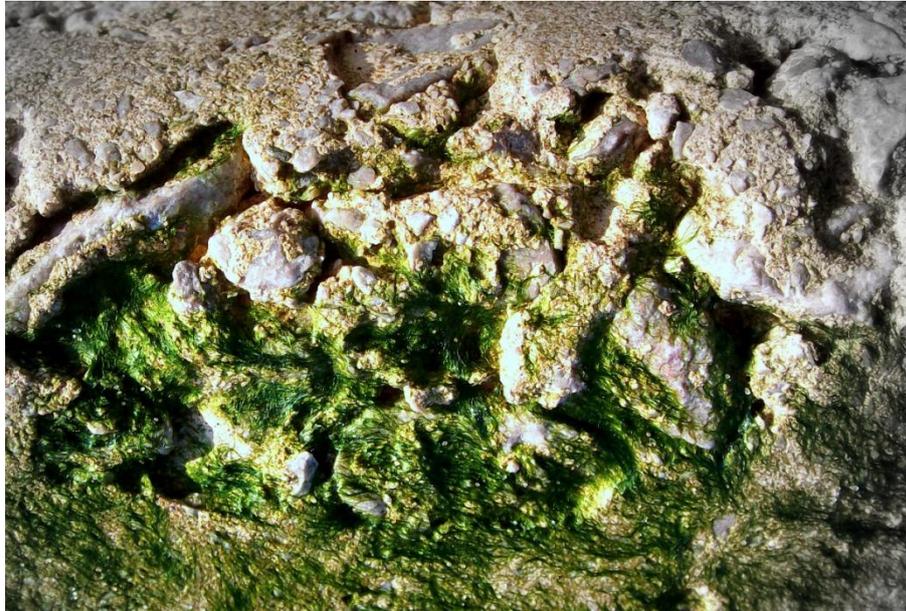
**Figure 8.9** Algal colonisation around large aggregate

**A.** A surface with epilithic microorganisms is initially shown (Figure 8.9 & 8.11). The new surface of the revetment armour contains many protruding synthetic fibres. Immediately these exposed fibres are subject to tidal action, as well as biofouling control, where the surface is power washed and treated with a chlorine-based disinfectant. The entry point of fibre into the matrix, not present in a horizontal fibre, becomes damaged as the exposed part of the fibre reacts to environmental conditions such as submersion in seawater, rich in microorganisms.

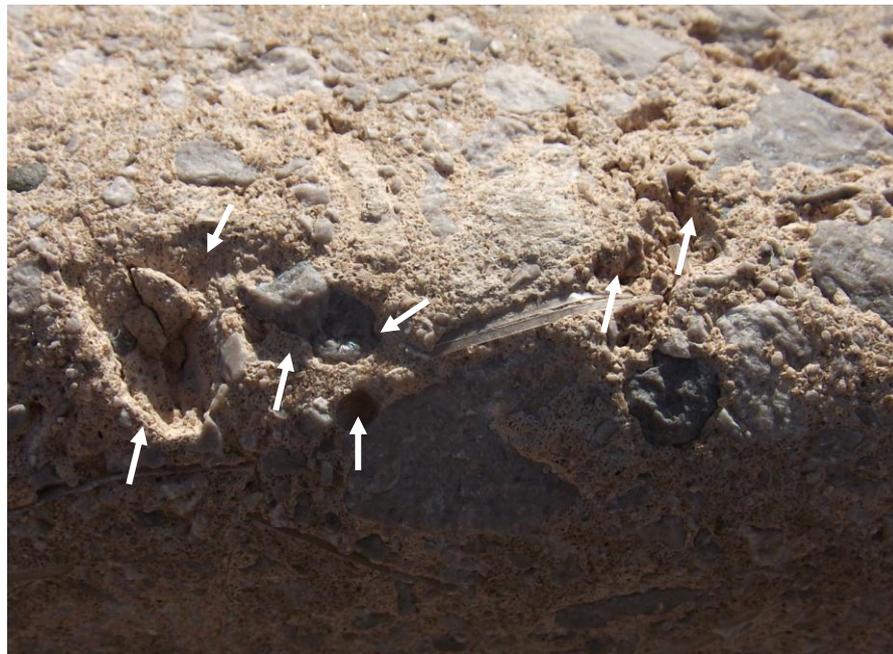
**Figure 8.10** Recently cleaned surface of armour with aggregate liberation (arrowed)

**C.** Material loss is accelerated due to the filamentous growth weakening and displacing the material (Figure 8.10 & 8.13). As degradation progresses, more aggregate is lost, resulting in a more permeable cement matrix. This process continues and phase one of the model now repeats in sequence. Due to variations environmental conditions and aggregate positions a precise determination of the length of each stage is not possible.

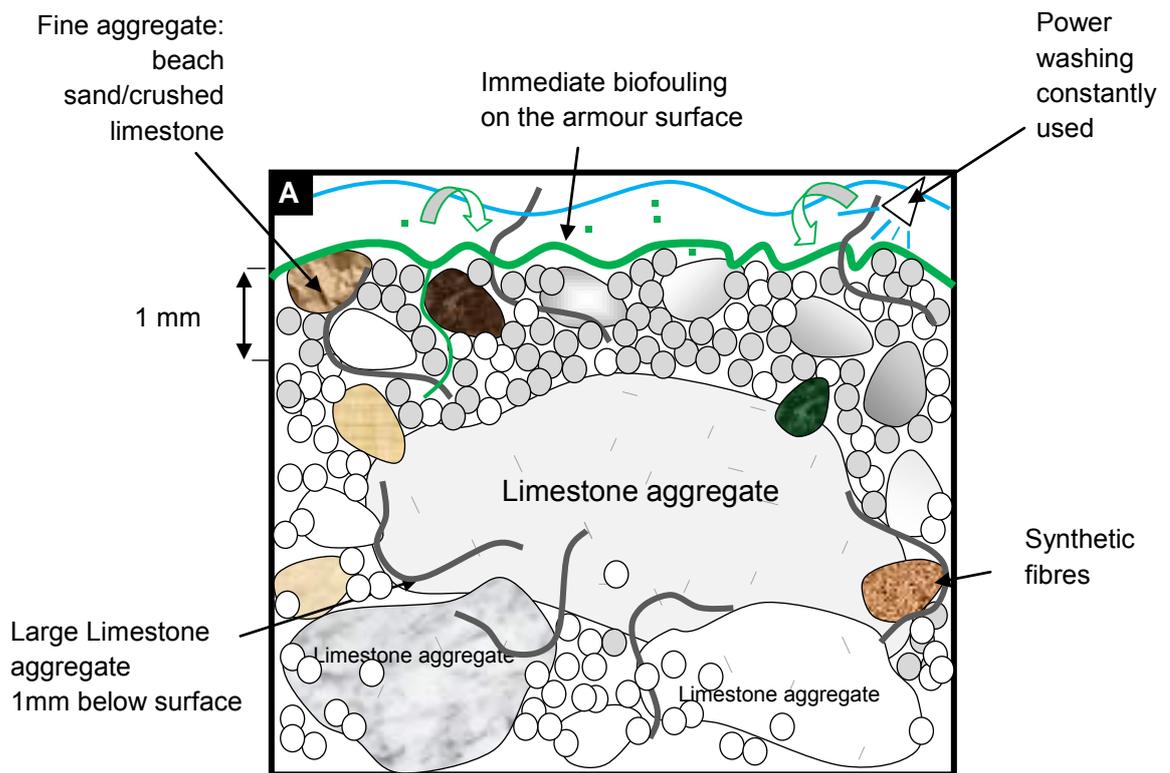
**Figure 8.11** A new surface with epilithic microorganisms. Large aggregate packed together at the nose of the armour unit as discussed in Chapter 4.

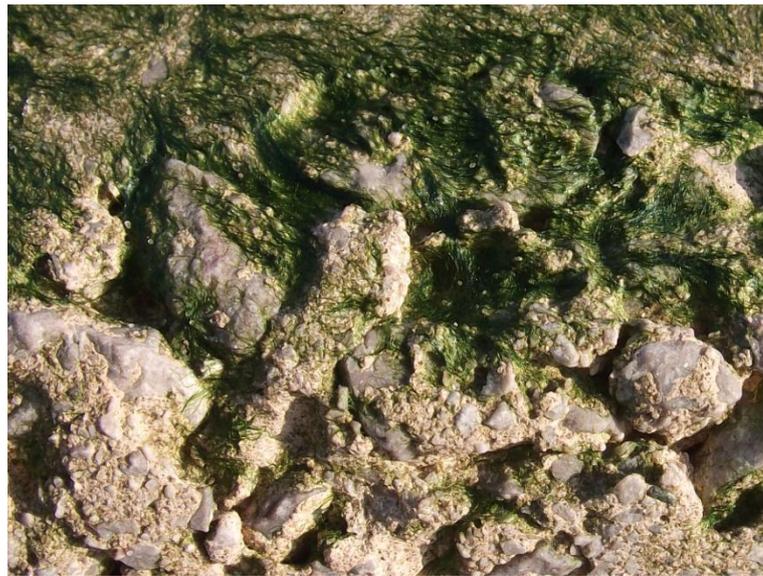
**Figure 8.12** The initial surface has now eroded. Aggregate appearing at the surface of the concrete unit.

**B.** Aggregate appearing at the surface of the concrete unit is shown in the next stage of the model (Figure 8.12). The ingress of moisture around exposed aggregate, allows microorganisms to penetrate the surface under the aggregate and to attach, this leading to colonisation, therefore allowing more microorganisms to enter leading to more attachment to take place.

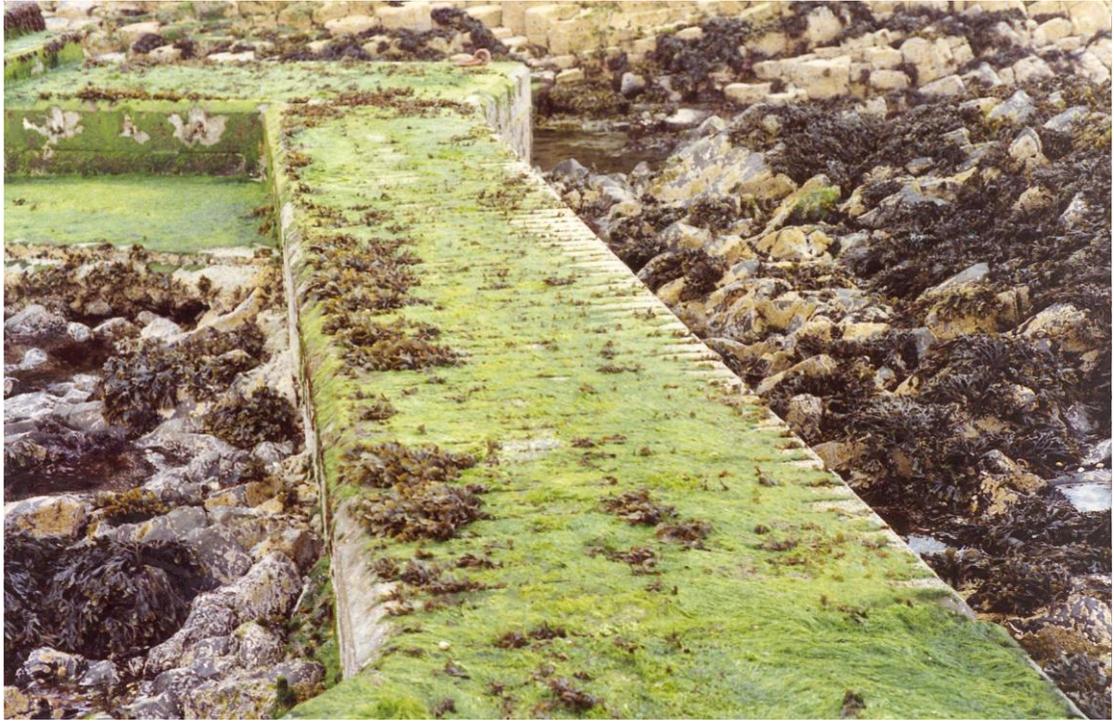
**Figure A2.1** Staffa jetty June 1992, colonised path.

The self cleaning concrete jetty at Staffa is a unique example of coastal engineering sustainability in practice (Figure A2.1). The remarkable and innovative research (Clokic, 2008) using nature for self cleaning concrete, still working today (Figure A2.2) will be briefly summarised. When the landing jetty at Staffa (West Scotland, U.K.) was replaced the opportunity was taken to seek to mimic on it the mature overgrazed, in part sessile animal dominated, facies in the locality. In such facies, algal settlement and production is equalled or exceeded by consumption by herbivores, mainly limpets. Surfaces which are largely free of algae tend to be less slippery and dangerous. Since construction 20 years ago, circa 1 million visitors have used the jetty and it is functioning as was intended. Design features were added at emplacement and post emplacement phases within the whole tide range, e.g. roosting areas for limpets (small trenches), the structure being of unreinforced concrete cast within permanent steel facing. The aim was to obtain the best compromise between maintaining the integrity of the concrete and having the sought after effect on algal communities. Different levels of the shore presented different problems within the complicated micro-structured series of ecotones and gradients within the tide range. In the early years some biological interventions and transplanting of herbivores was performed. On the smallest scale, littorinid activity in older communities seems relatively more important than the literature suggests in augmenting patellid activity. Maintaining overgrazed facies relied on the boatmen users not using biocides when algal production was temporarily ahead of removal. They also took a great deal of care with the surface. This approach may have wider application wherever intertidal slipperyness is a problem whether of structures or armouring. Each situation will necessitate design for its own habitat.

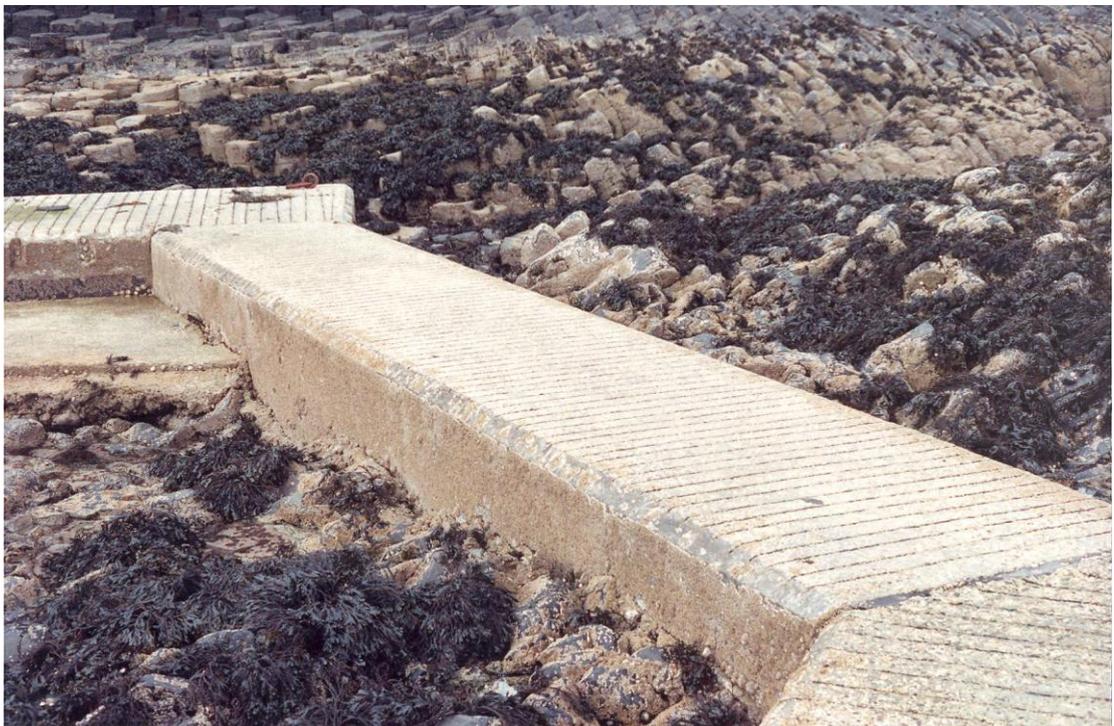
**Figure A2.2** Staffa October 1993, hazard free walkway.

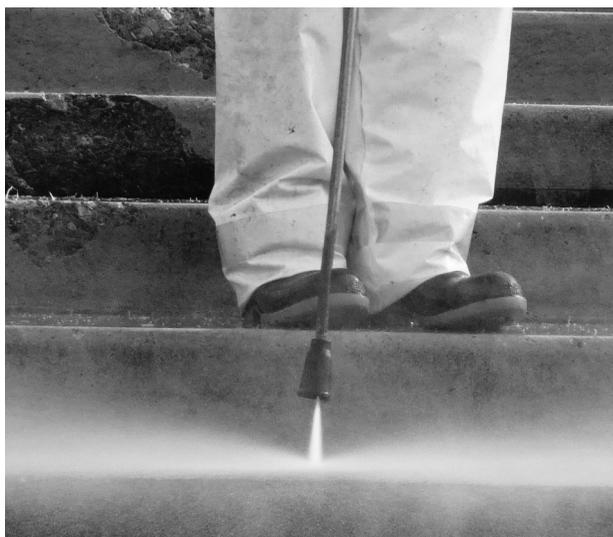
Figure 1. Revetment armour surface after 2 years exposure (Fujifilm Finepix JX). As the surface zone is eroded, fibres at the surface 'pop out', dry, crack, and are washed away exposing new voids for micro-organisms

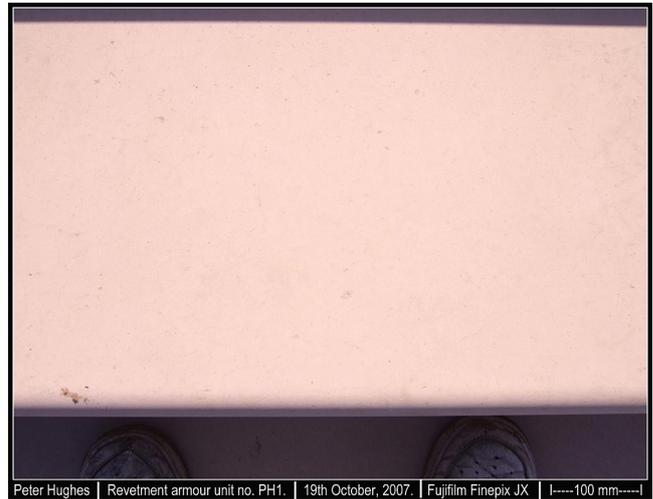
Figure 4. Digital photograph of the step of the newly-placed (in 2007) revetment armour unit tested in this research

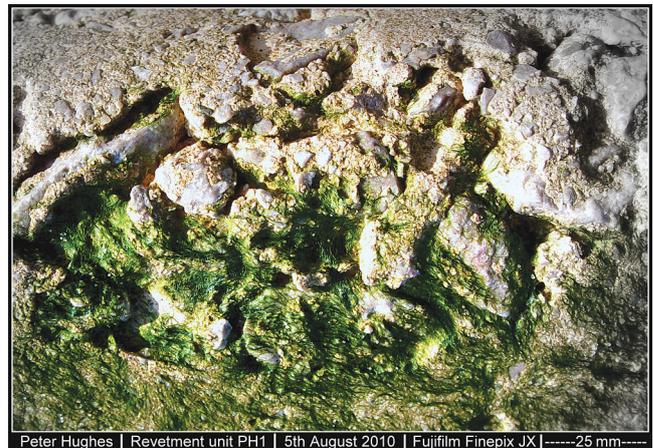
Figure 5. Digital photograph showing the nose of the step of the unit, tested in this research after 2.5 years' exposure (2010)

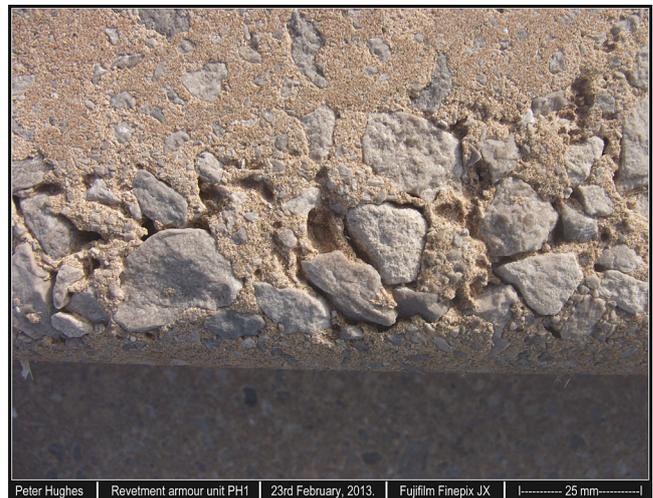
Figure 6. Digital photograph showing the nose of the step of the unit, tested in this research after 5 years' exposure (2013)

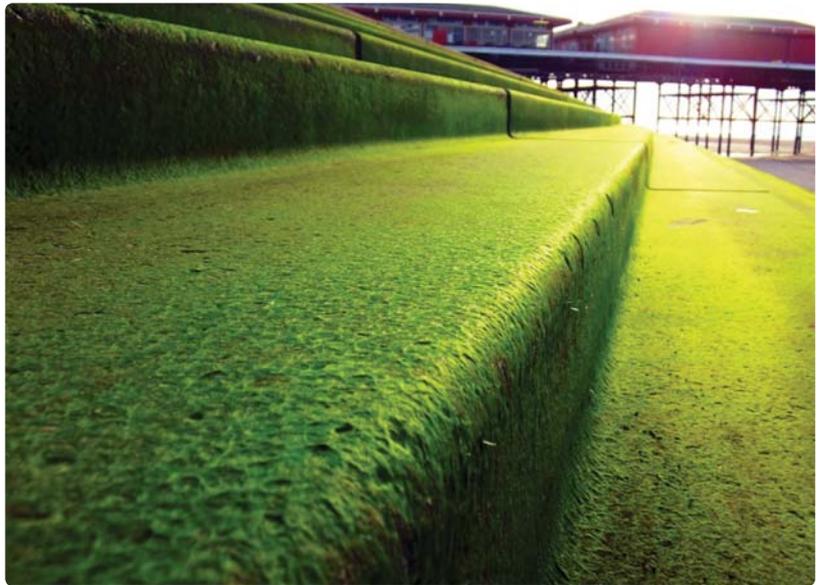
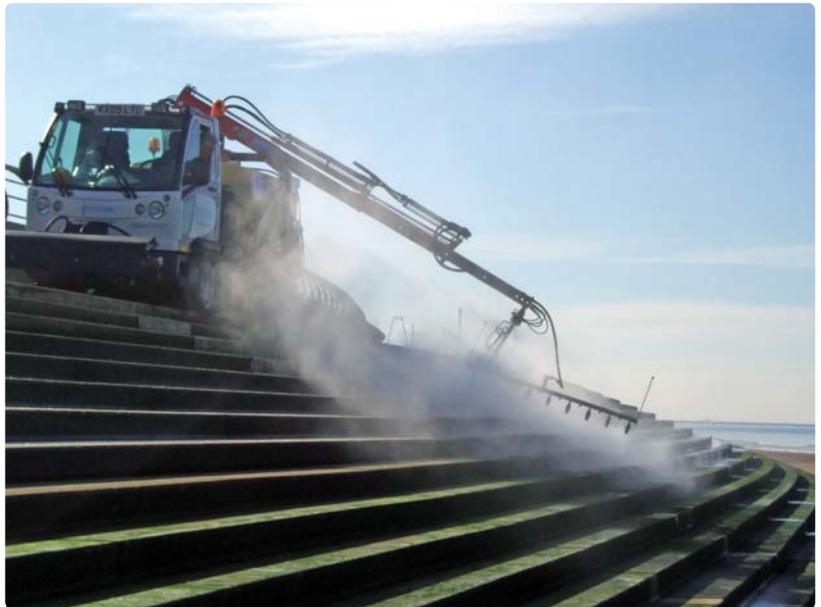
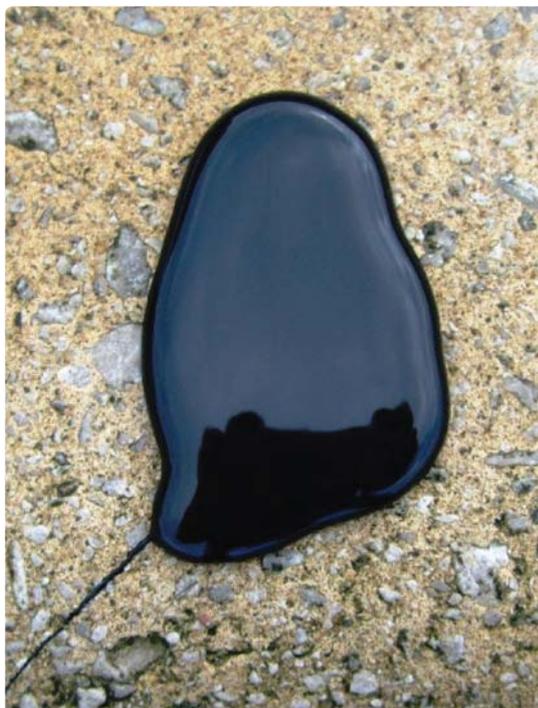
**Top:** Revetment armour steps at Blackpool colonised with *Ulva intestinalis*.

**Centre:** Power washing by Blackpool Council to avoid slip hazard.

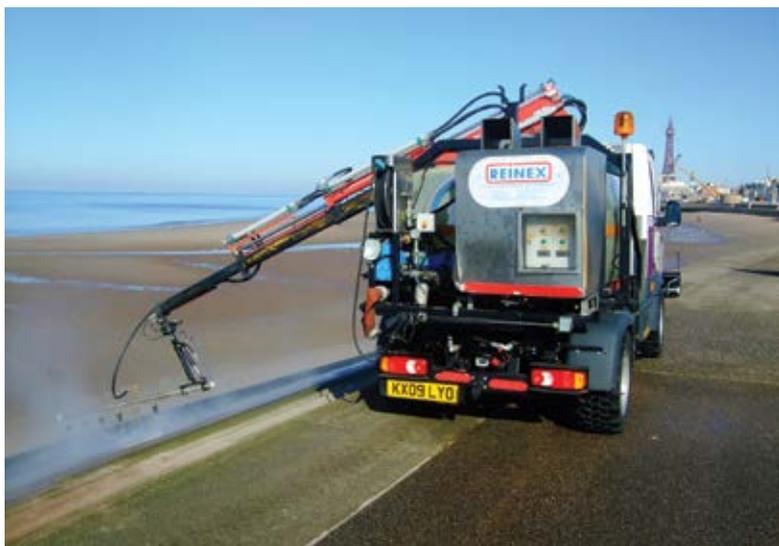
Fig. 1: Equipment used to manage biofouling at the study site

term durability of many material surfaces.<sup>1</sup> This article reports early findings from an ongoing study into the effects of power washing concrete. The study was conducted at a site on the northwest coast of England (Fig. 1), where concrete revetment armor with a design life of 100 years has been monitored for surface changes over a period of 3 years (Fig. 2).

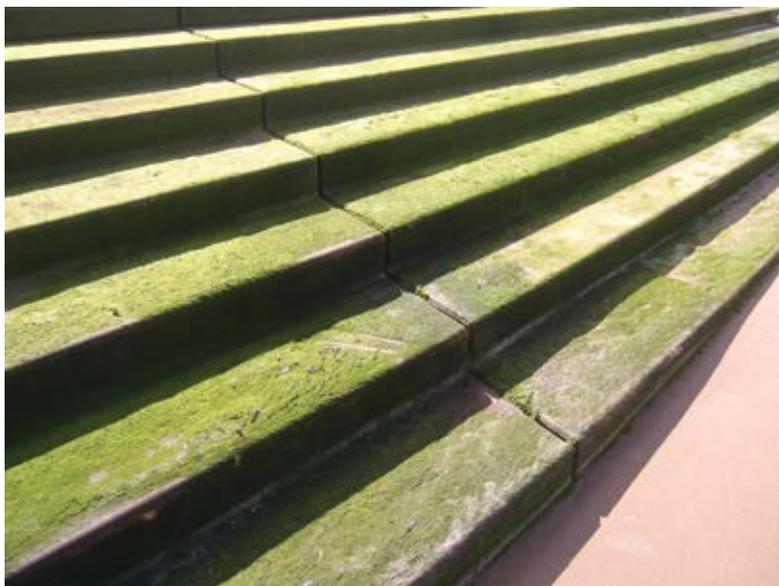
Fig. 2: Revetment armor steps colonized with algae

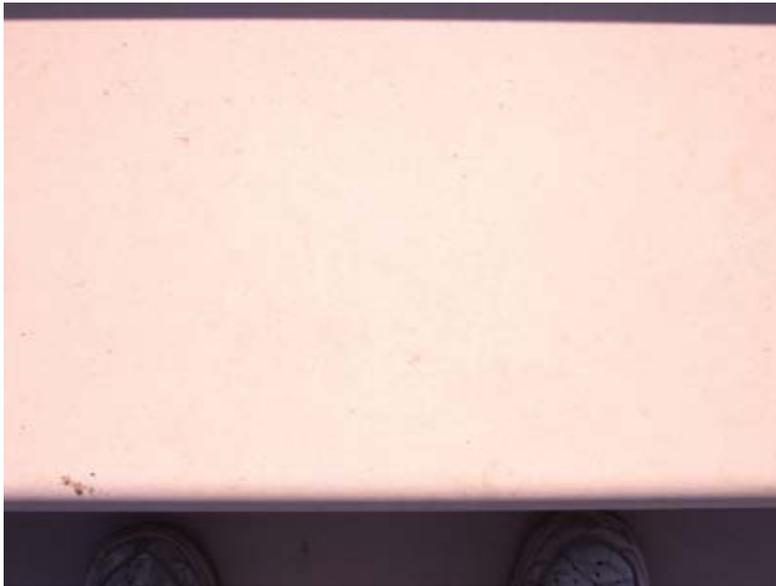
Fig. 6: Newly placed concrete tested in this research

Weekly site surveys yielded a comprehensive photographic archive so visual evidence could also be observed. Figure 6 shows a photo of the new unit at the test site and Fig. 7 shows the condition after 5 years of exposure.

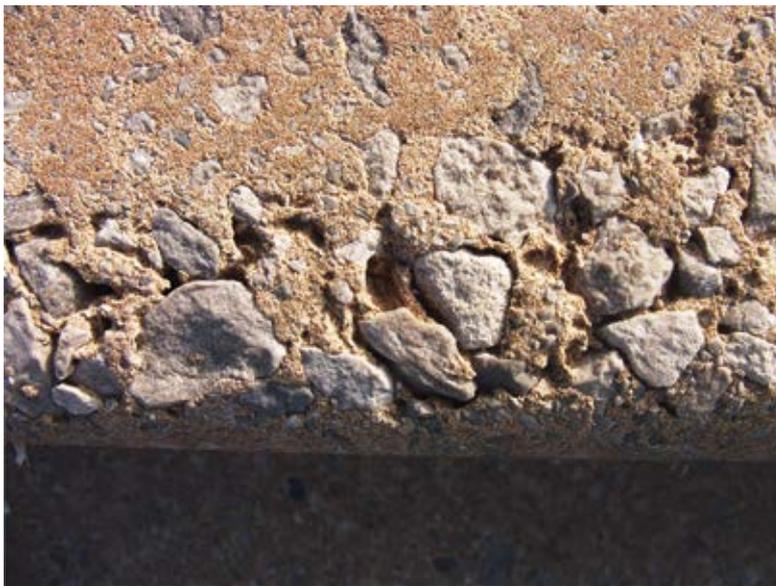
Fig. 7: Nose of the step of the unit shown in Fig. 6 after 5 years' exposure

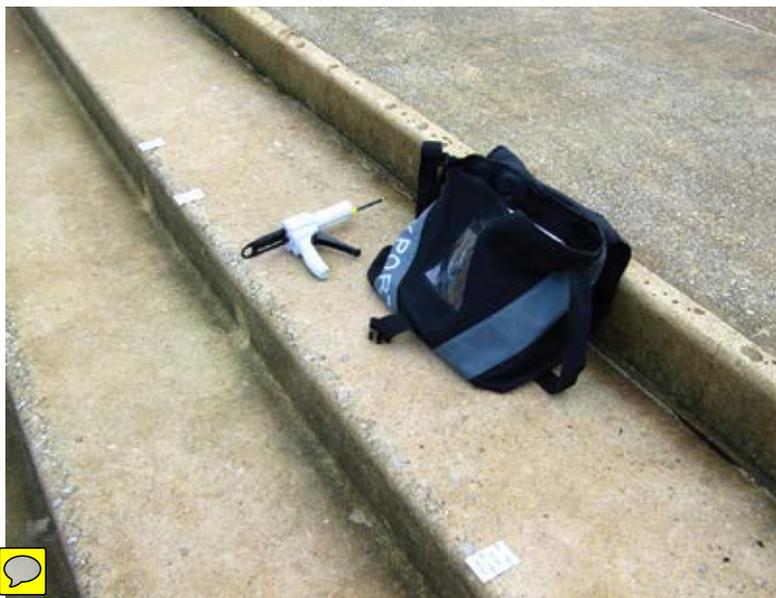
Fig. 8: Surface that was copied using silicone-based replicating polymers

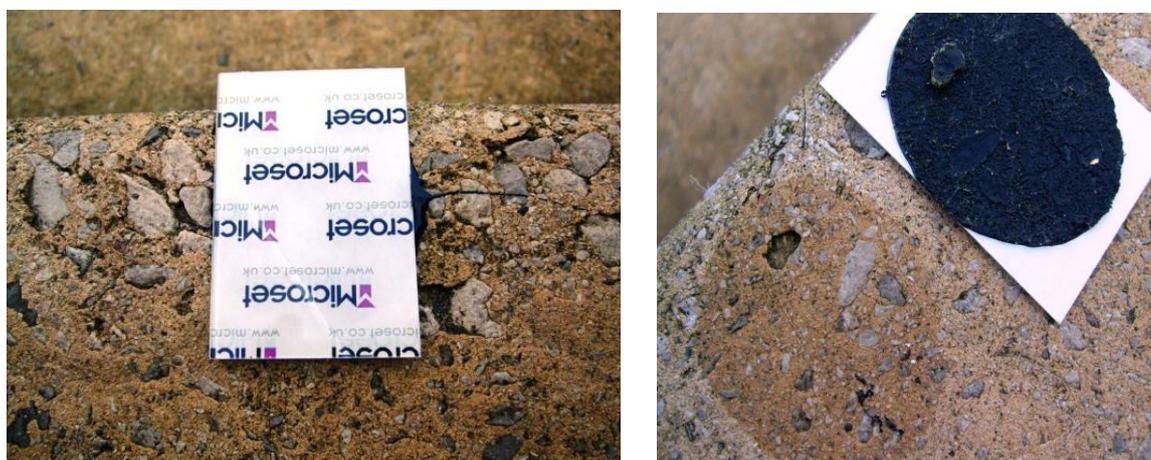
**Figure A3.3** Curing replication polymer at the study site.

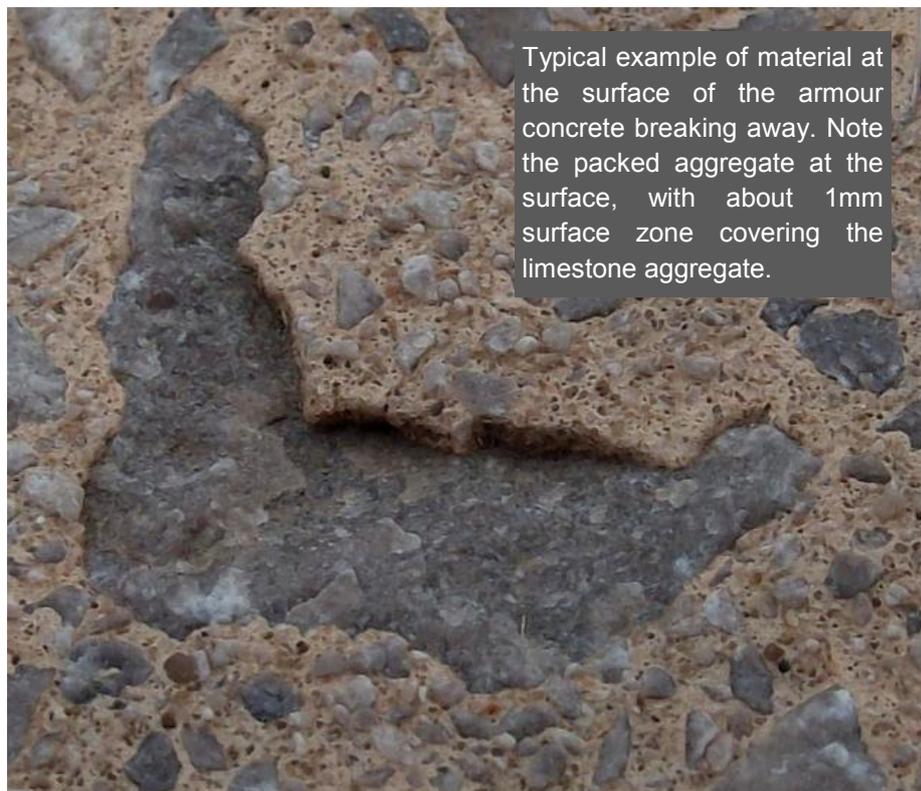
**Figure A3.8** Typical surface zone to revetment armour (after 1 yrs exposure).

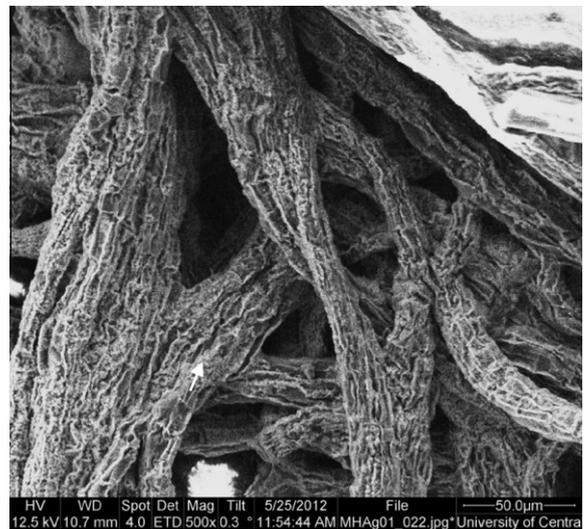
**Fig. 8.** SEM micrograph, side view of algal colonisation under a fibre specimen, after 4 years exposure.

Figs. 8–11 are from (winter) samples retrieved from site, showing abundant growth within the fibre cement interface. Fig. 8 shows a sample that was not sputter coated, to show the frond in its natural condition. Coatings gave the algae an artificial, smooth surface. Confirmation between algae or microfibre was obtained by EDX analysis.
