**An investigation into marine biofouling  
and its influence on the durability of  
concrete sea defences**

PETER HUGHES

A THESIS SUBMITTED TO THE UNIVERSITY OF  
CENTRAL LANCASHIRE IN PART FULFILLMENT FOR  
THE AWARD OF DOCTOR OF PHILOSOPHY

FEBRUARY 2014

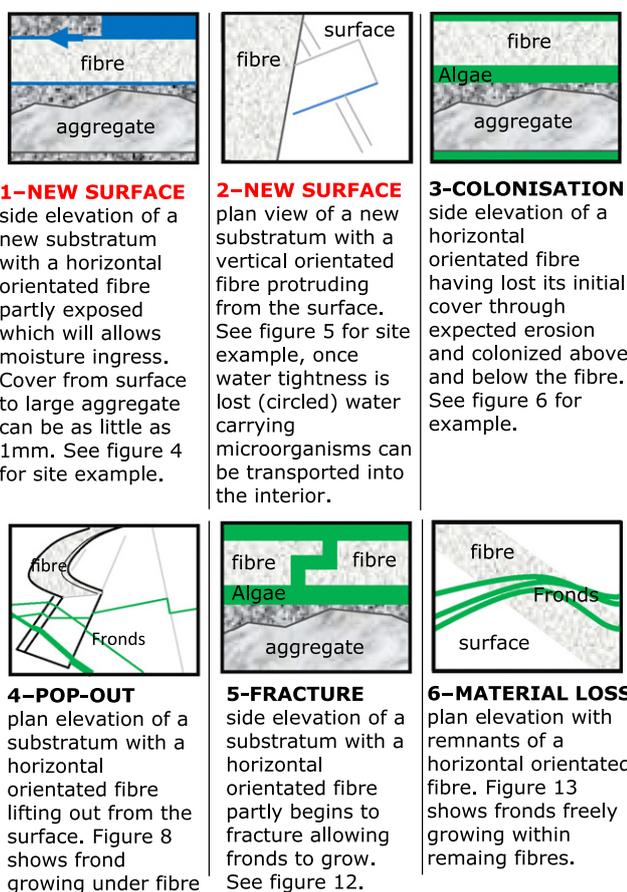
Fig. 13. Six, phases of the holistic degradation model.

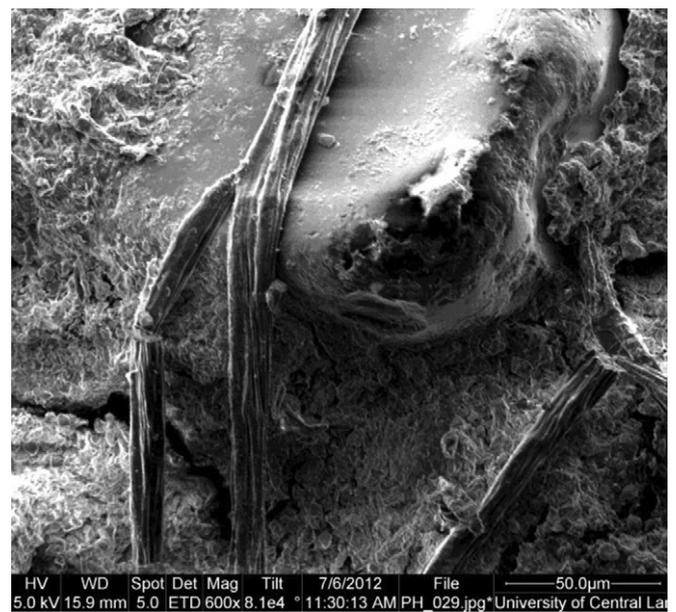
**Fig. 6.** SEM, secondary electron micrograph, surface view of revetment armour concrete surface, after 3 years exposure. This sample was not sputter coated, showing the filament in its natural condition. A branched mature filament can be seen growing over the exposed fine aggregate.

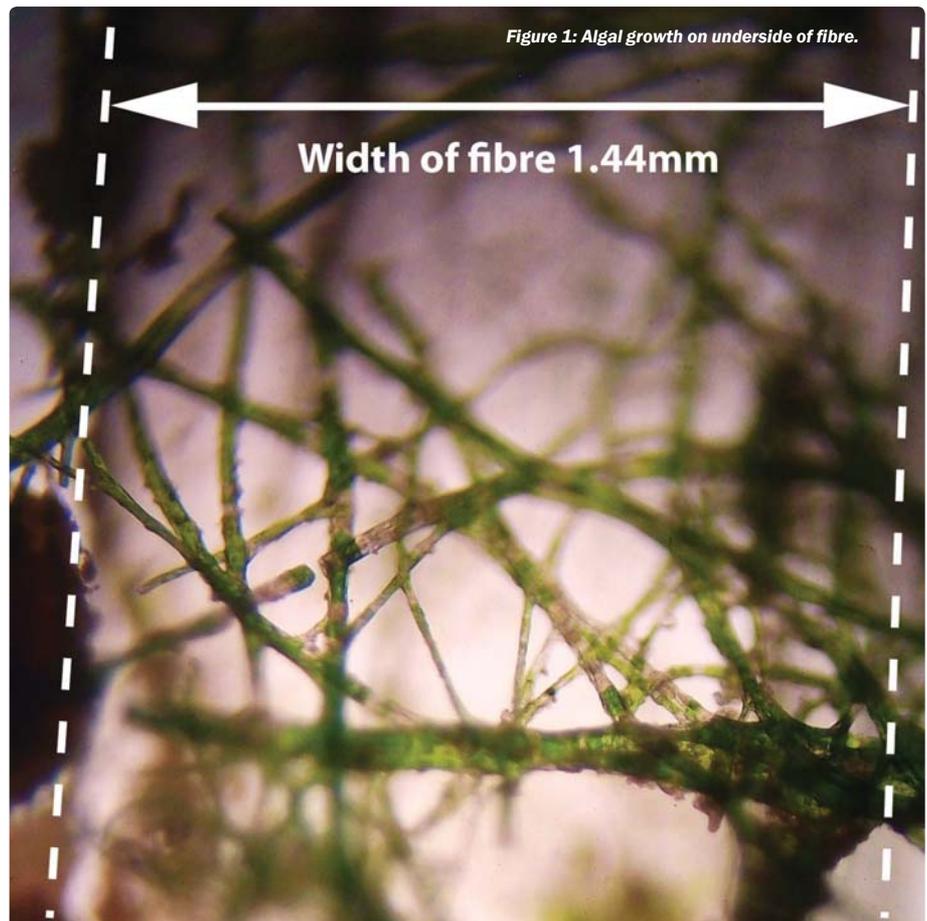
Figure 1: Algal growth on underside of fibre.

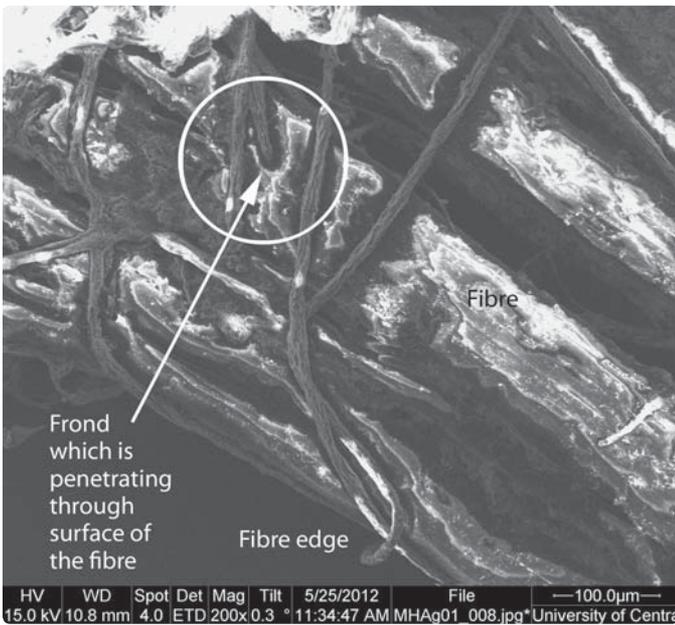
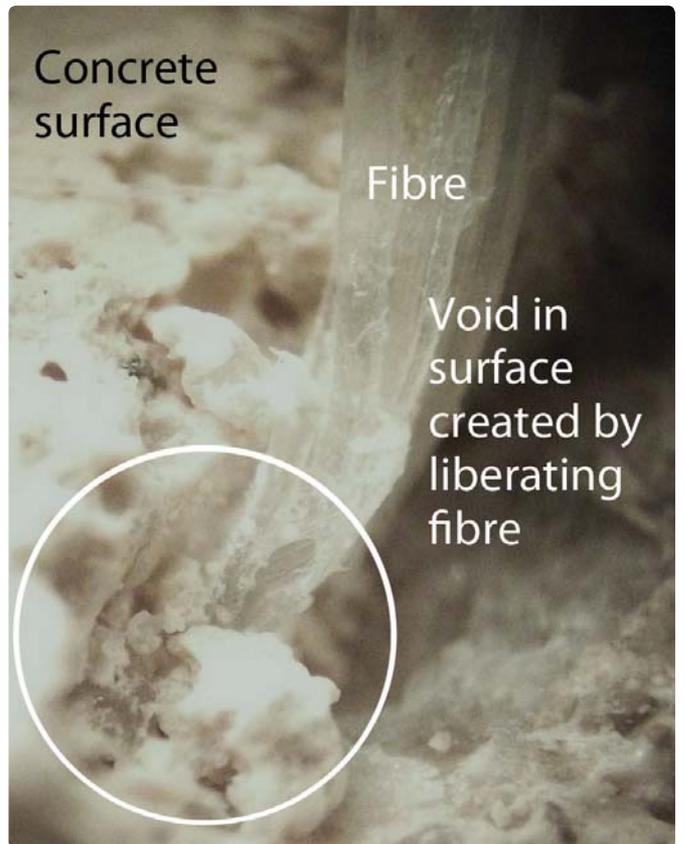
Figure 3 (top left): Extensive microbial surface fouling – algae growth can be seen on concrete surface, fibre cement interface and underside of fibre.

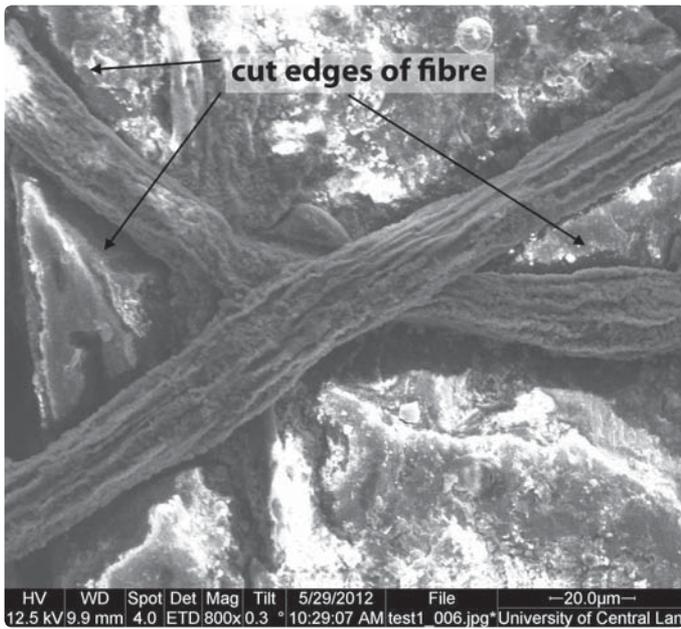
Figure 7: Algae growth on fibre cutting through fibre.

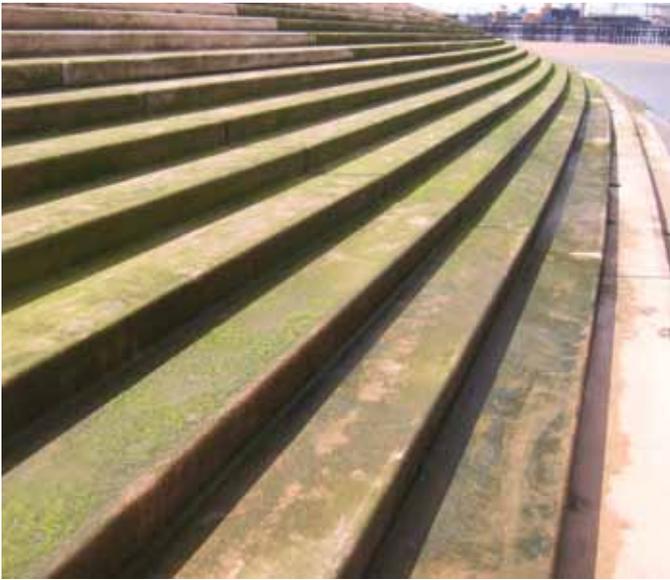
Fig. 1: Precast steps at the Fylde coast of England. The steps have been colonized by algae

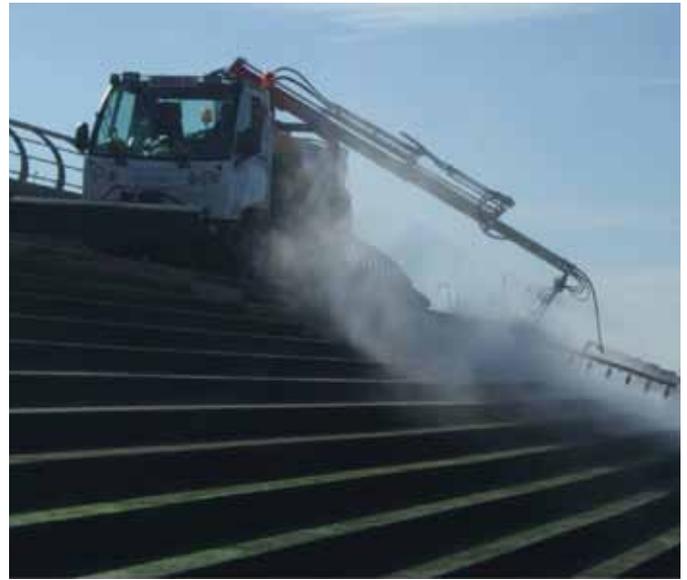
Fig. 2: Power-washing of the precast steps to remove biological growth and minimize slipping hazards

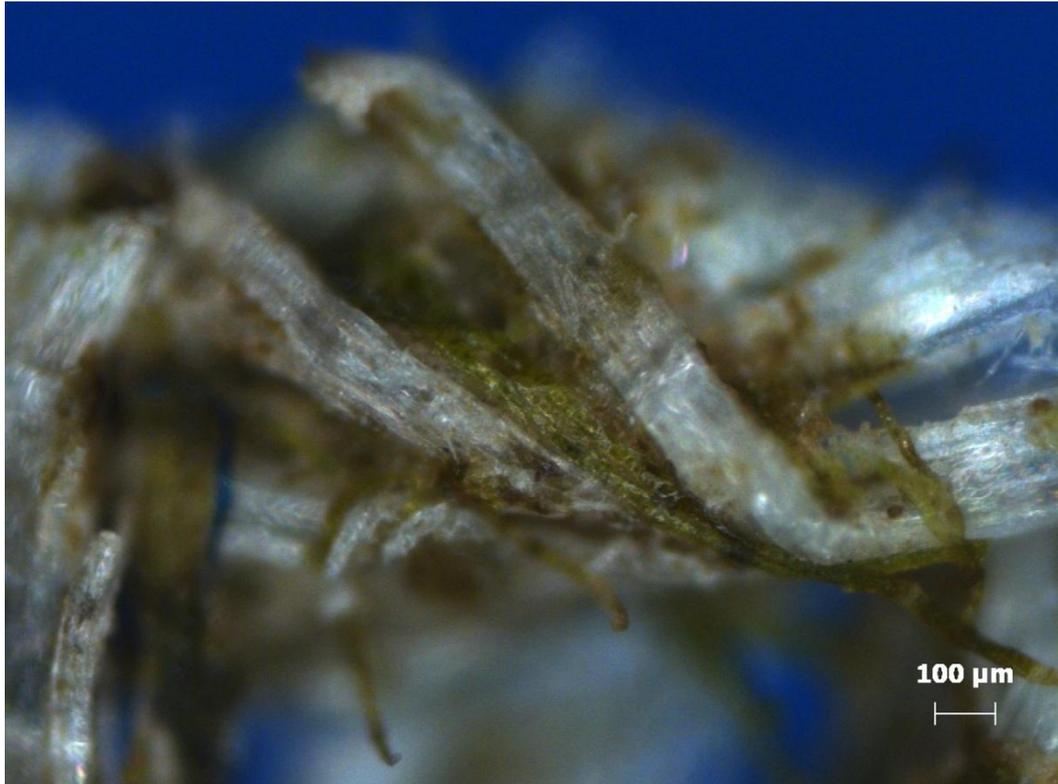
**Figure A4.1** Biotranacious algal growth around and within fibres.

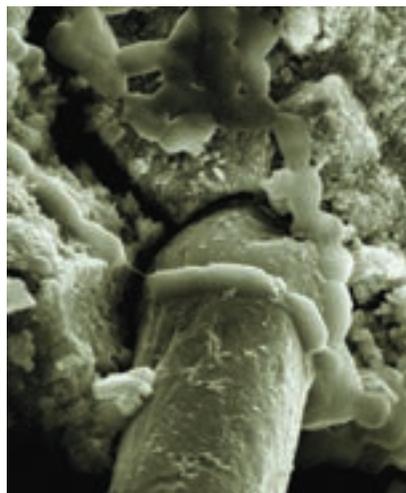
Figure 1: a micro-fibre (22µm-diameter) with bacterial bio-tenacious growth (350nm-diameter) around the cement interface

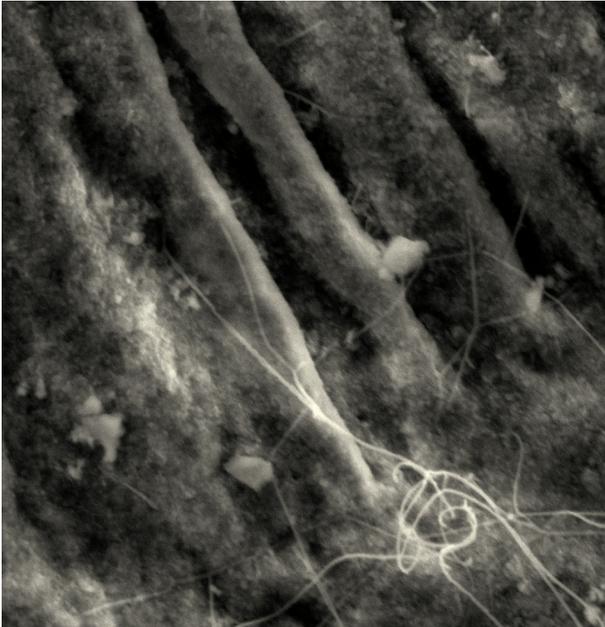
**Left - Figure 4:** SEM of a water void within the matrix. The chamber had 'rippled' effect walls, similar to tide marks on a beach. This cavity probably held water utilised by the micro-organism.

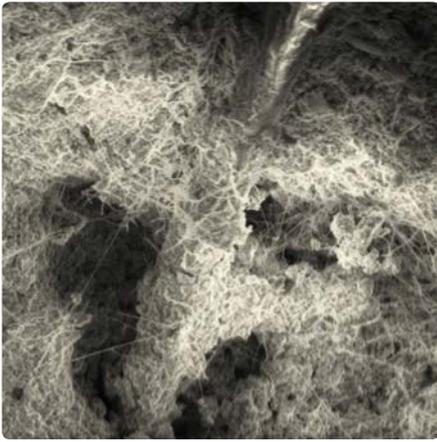
Figure 2 above: A micro-fibre protruding from the surface of concrete. Note the bacterial colonisation within the void beneath the surface.

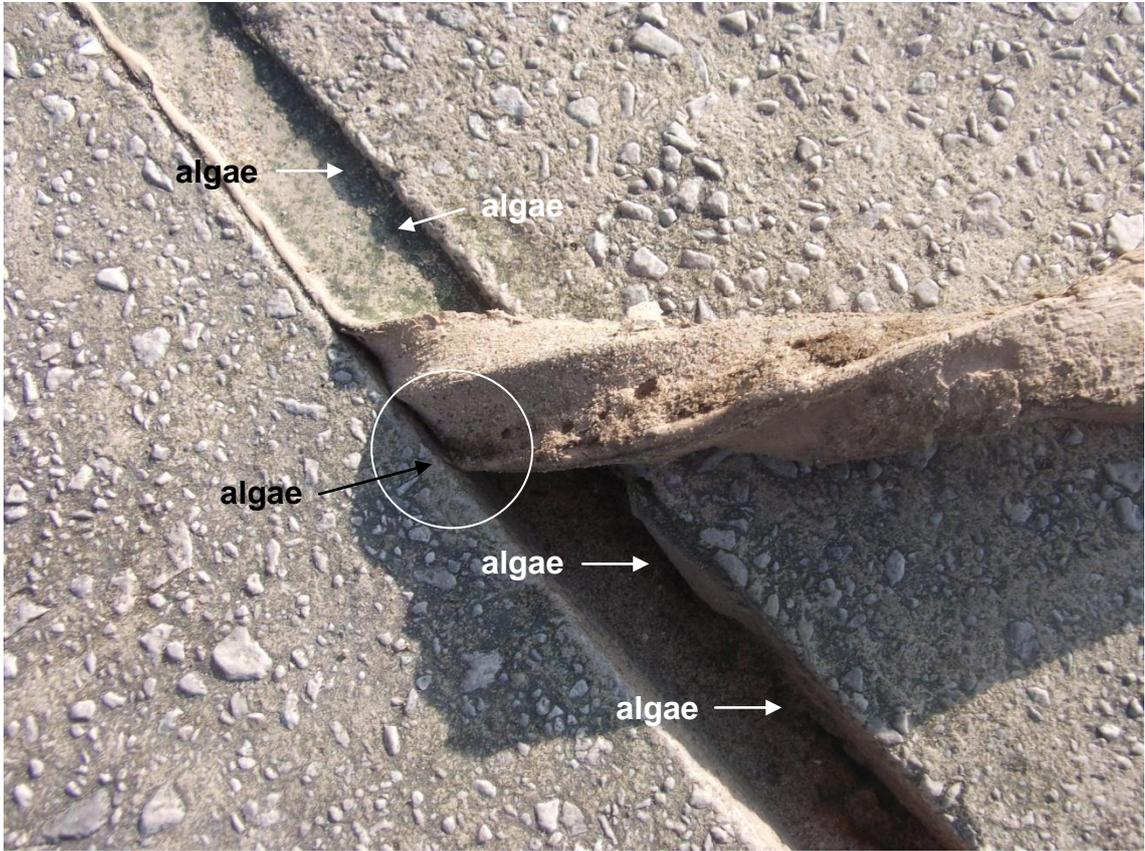
**Figure A5-1** Sealant at the study site. Algae growing under the sealant (arrowed), eventually causing the material to de-bond. Other degradation mechanisms such as cleaning and tidal impact will also play a role.

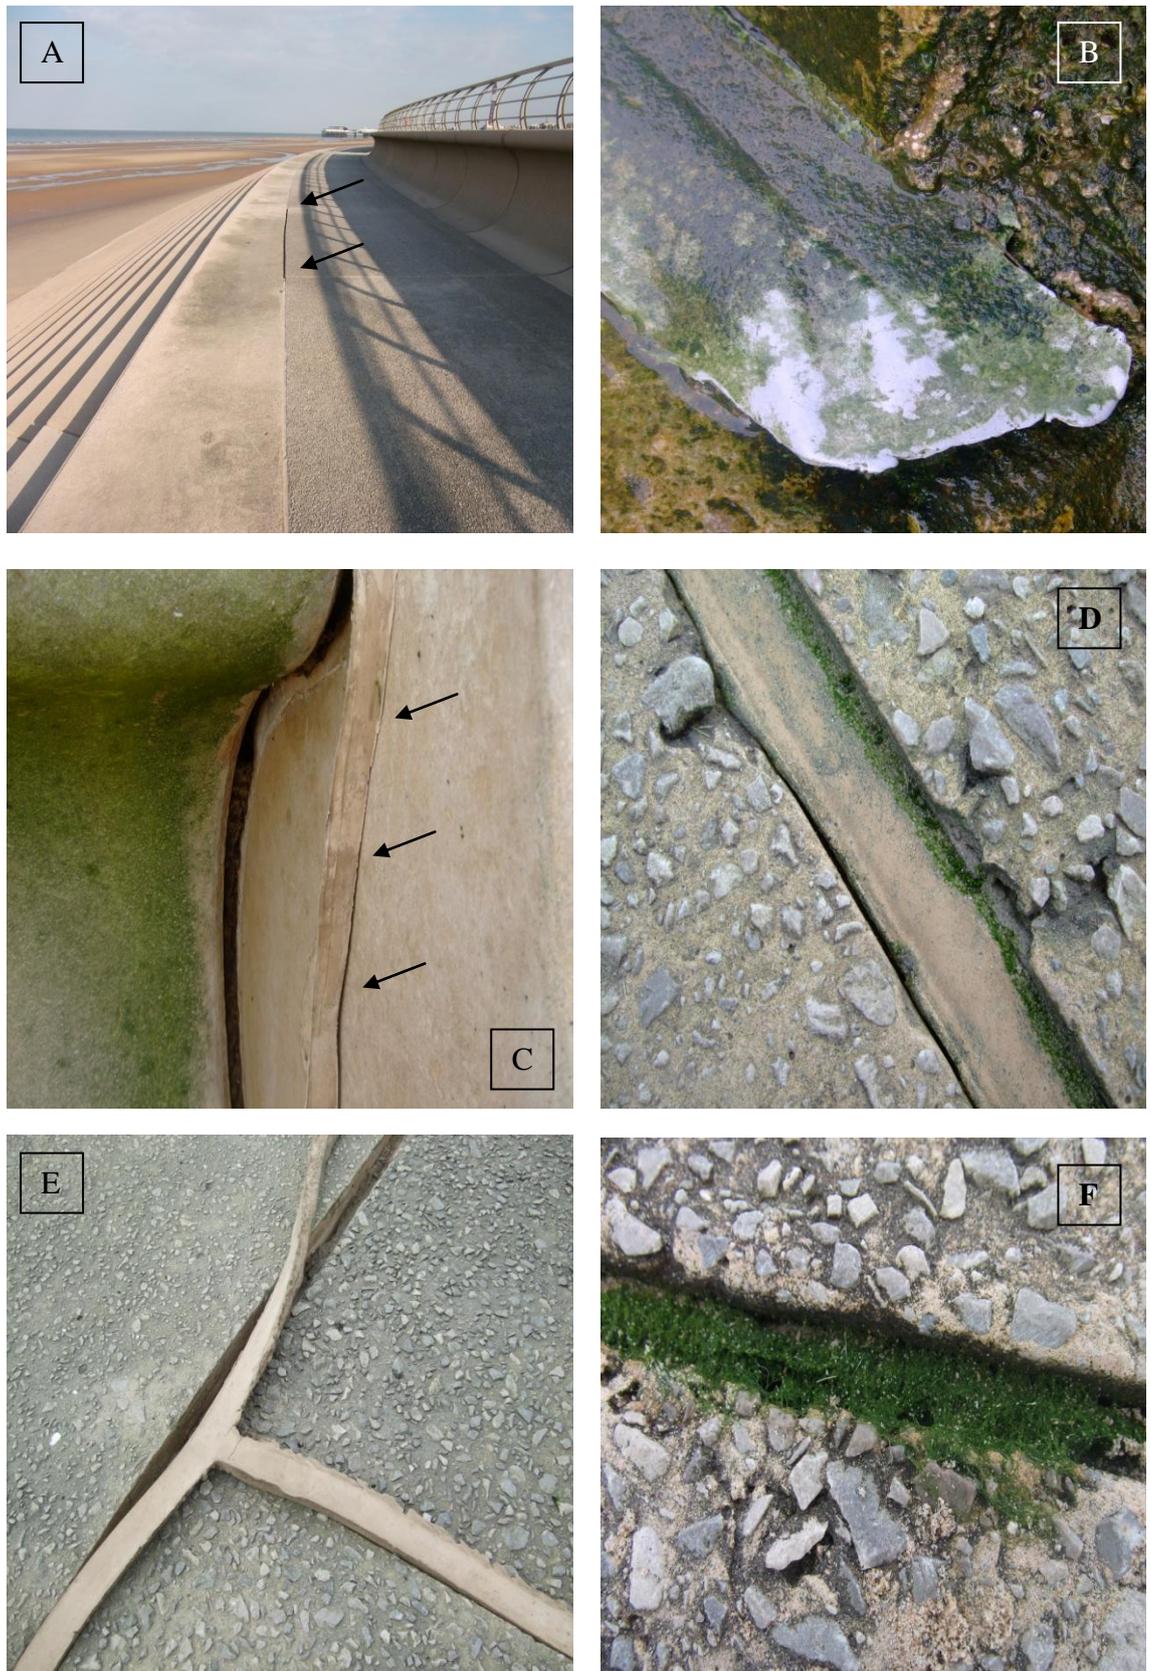
**Figure A5.2** Sealants used at the study site. **A.** Section of sealant missing. **B.** *Ulva* growing on and underneath. **C.** A section of wave wall with sealant fallen away. **D.** *Ulva* at the surface of sealant. **E.** Illustrates a serious trip hazard to the public. **F.** *Ulva* growing under sealant before being removed.

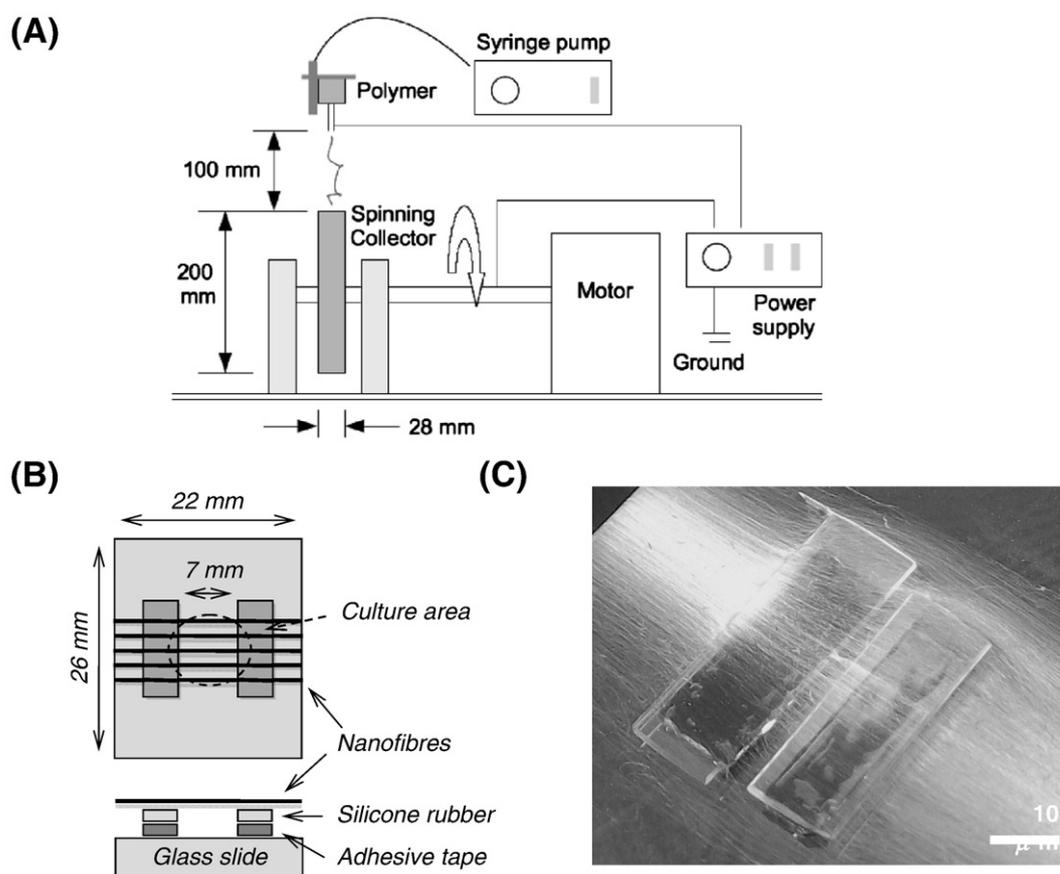
**Scheme 1.** Schematic illustration of (A) electrospinning set-up and (B) the 'bridging' system, designed to lift and separate individual nanofibres from the glass. Cells are inoculated and cultured onto the bridged fibres between lifts. (C) Digital photograph of the 'bridging' system. Good alignment of PU nanofibres has bridged the 7-mm gap between the two pieces of silicone rubber. Bar = 10 µm.

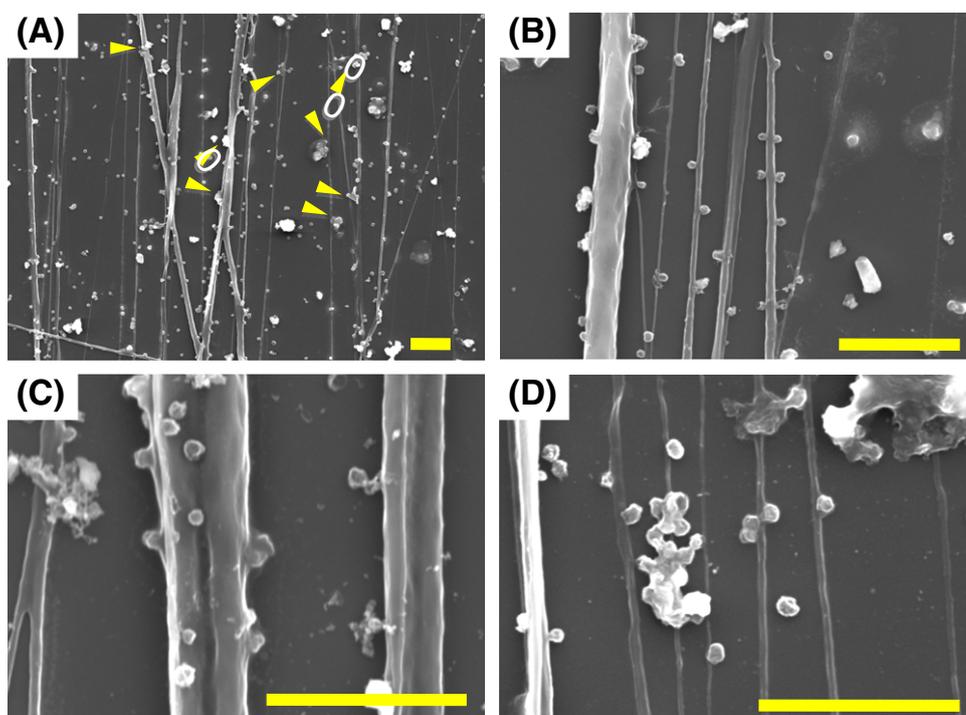
**Fig. 3.** SEM observation of *S. solfataricus* cultured on PU nanofibers for 1 week. (A) Low magnification image. Arrowheads indicate colonies. (B, C) High magnification images of a single cell attached on a thin (B) or thick (C) fibre. (D) High magnification image of a clump of proliferated cells. Bar = 10 μm.
