Modelling, identification and structural damage investigation of the Neoria monument in Chania

The structural behavior of Neoria masonry monument is studied here. The determination of structural and material properties of a partially collapsed monument and the evaluation of existing damages and their importance for further restoration studies are not trivial tasks. The investigation has been based on detailed geometric data, collected from sources and in-situ measurements. For the mechanical analysis, finite element models have been created with different level of detail, including simplified description of documented damages. Modal analysis is assisted by micro-tremor measurements. Comparison of the predictions with the experimentally measured quantities, allows the determination of material parameters with higher accuracy. A least square technique assisted by the modal assurance criterion has been used, by driving the model from a Python script. A comparison of collapse predictions based on modified pushover analysis, with classical modal analysis has been performed. An explanation of existing damages is attempted, based on the numerical models.

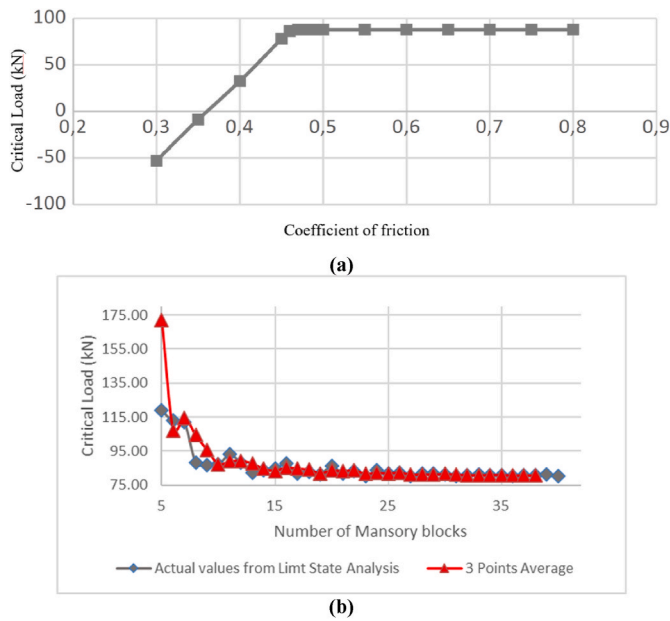
Fig. 15. Parametric analysis showing (a) the critical load vs the coefficient of friction between the masonry blocks and (b) the critical load vs the number of masonry blocks.

For the parametric analysis models, a 1 kN load was applied across the span of the arch at 150 mm intervals to identify the critical failure load of the arch and the position it is obtained. The results from the parametric analysis are shown in Figs. 15–16.

From the parametric analysis, it can be observed that failure load increases, until coefficient of friction reaches the value 0.47. The critical load observed is 87.9 kN when the number of segments is set to 10. From previous studies, it has been shown that the assumed coefficient of

In the next step, the number of masonry blocks that make up the ring were investigated to determine the point at which the number of blocks has no significant effect on the failure load. It can be noted from Fig. 15, that the critical load decreases with the increase in the number of blocks until 10 blocks, whereby the critical load shows a lot of noise. However, when the average of the corresponding critical load from 3 consecutive blocks is plotted, the noise in the critical load becomes insignificant after 20 blocks are used to make up the arch. Therefore, for the rest of the models, each arch is made up of 20 masonry blocks.

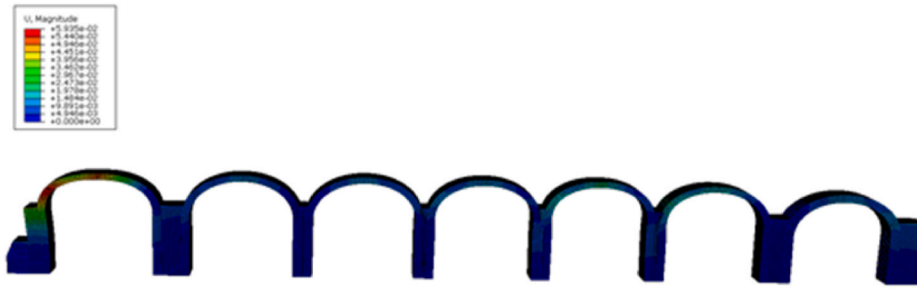
Fig. 19. The displacement contour of the whole structure under gravity loads.

closure and sticking-slipping along the masonry stone interfaces. The models were developed with a fixed support and the self-weight was incorporated in the loading condition. Two steps were used to create the models: the first step was a pure gravity load to simulate the state of inertia of the structure and to stabilize the model. The second step has an increased gravity load by 0.5g which was incrementally applied on the structure. This is used to provide a preliminary indication of the effect of the vertical component of an earthquake to the structural system. The results from these models are shown in Figs. 18–20.

The failure mechanism presented are shown in Figs. 18–20 correlate with the longitudinal cracks observed on the structure in-situ and the
