# Extensive Metallosis in a Primary Knee Arthroplasty as a Result of Polyethylene Wear: Is It Avoidable?

## Case Presentation

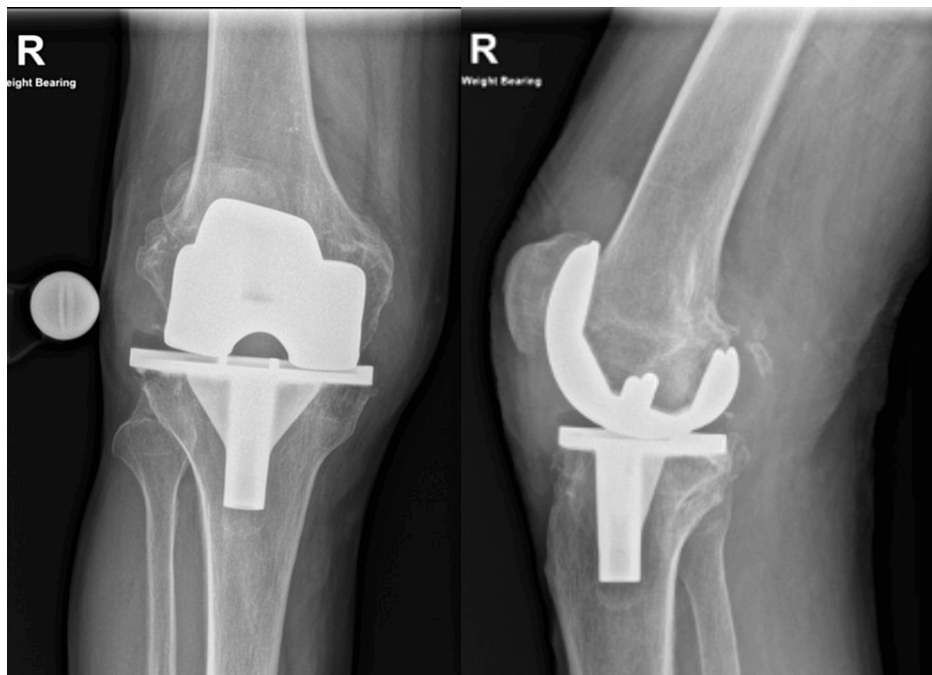
An 85-year-old man, without any comorbidities, who underwent a TKA in 1996, presented to his General Practitioner in 2021 with knee pain and swelling. An X-ray showed PE wear and narrowing of the artificial joint space (Figure 1).

**FIGURE 1: Anteroposterior and lateral X-rays of the right knee showing narrowing of the joint space.**

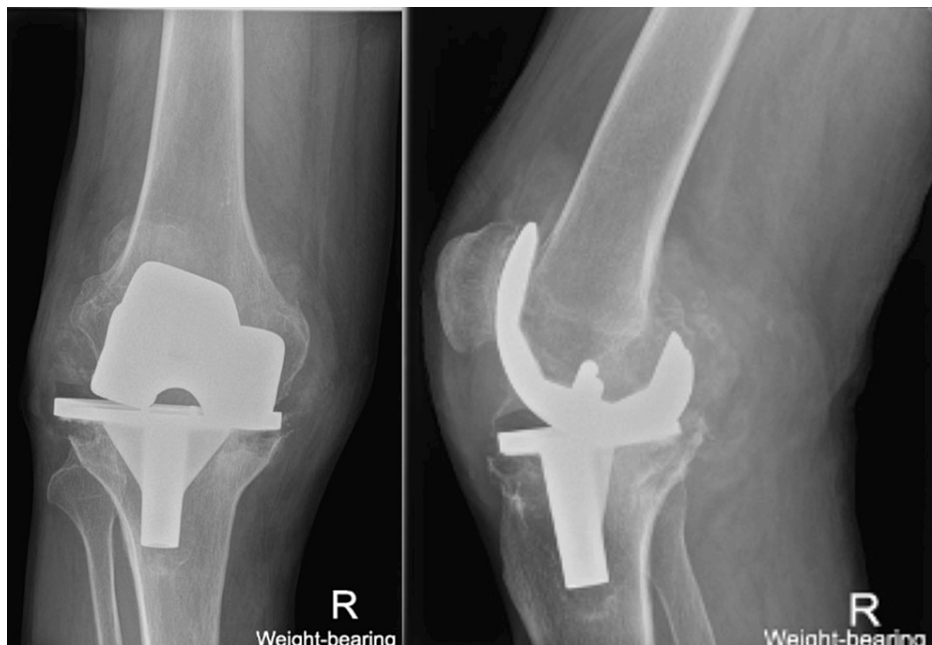
However, due to the COVID-19 pandemic, follow-up and treatment were delayed. Two years later, the patient presented to us with increased knee pain, stiffness, swelling, decreased range of motion (ROM), crepitations, and having to rely on a stick for ambulation. Further imaging showed progressing PE wear, increased loss of joint space, and metal-on-metal articulation of the femoral and tibial components along with osteolysis (Figure 2).

**FIGURE 2: Anteroposterior and lateral X-rays of the right knee showing further wear of the polyethylene liner along with osteolysis.**

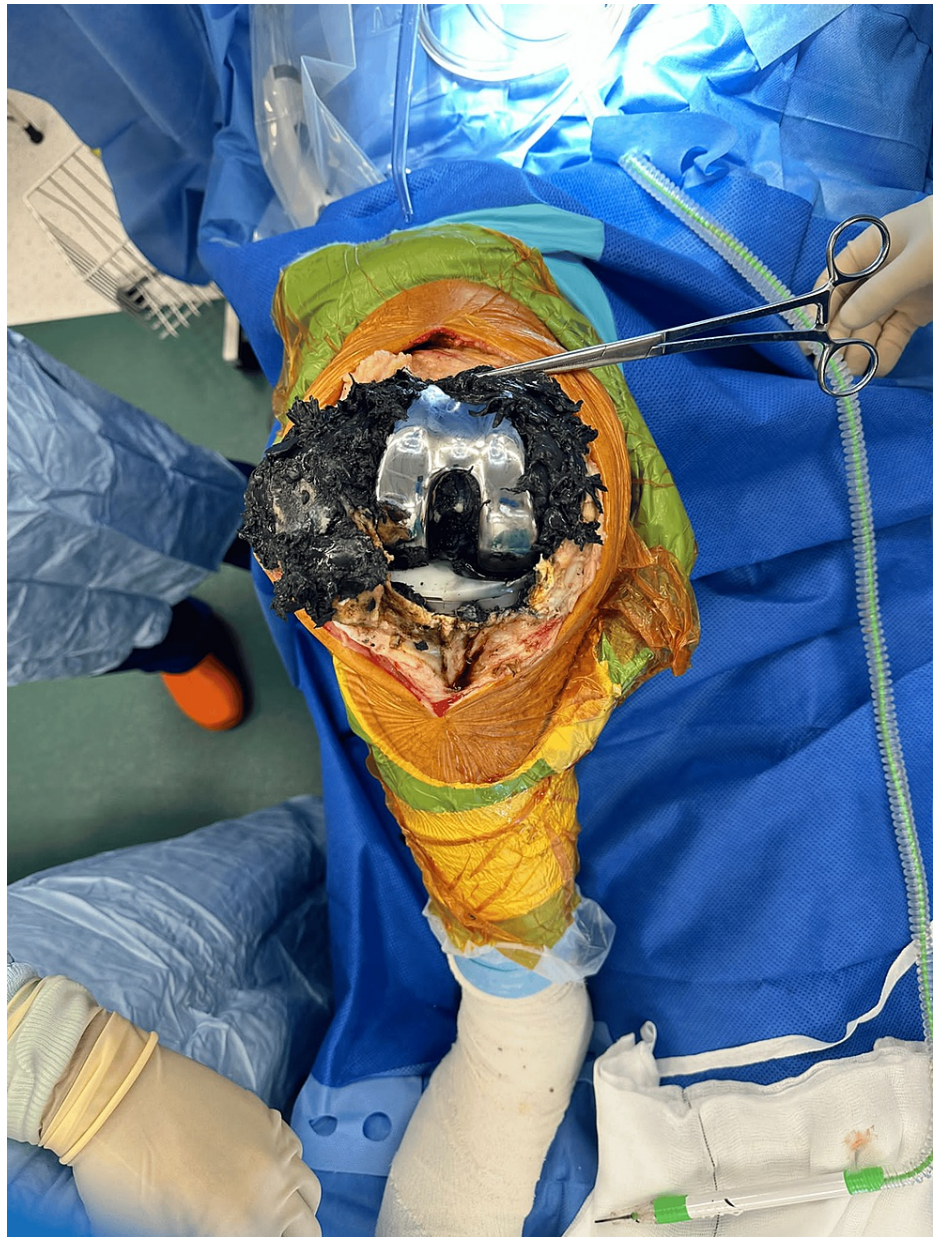
synovectomy of all inflammatory tissue with metallic debris deposits if present, and, finally, implanting a prosthesis with a level of constraint depending on the knee's ligamentous integrity. During the surgery, extensive metallosis with dark black-stained synovial tissue was seen due to the deposition of metal debris in the surrounding tissue (Figure 3).

**FIGURE 3: Metallosis within the surrounding tissue.**

In our case, extensive metallosis presented as a rare late complication of TKA. This complication occurred due to wear of the PE liner, resulting in metal-on-metal articulation and deposition of metal and PE debris within the surrounding tissue. Metallic debris infiltration in bone and soft tissue leads to osteolysis, tissue necrosis, and a pseudotumor. This eventually leads to pain, joint swelling, implant loosening, and instability. A comprehensive review revealed that PE wear/failure ranked as the most common cause of inducing metallosis due to its propensity for enabling abrasion between metal surfaces [6].

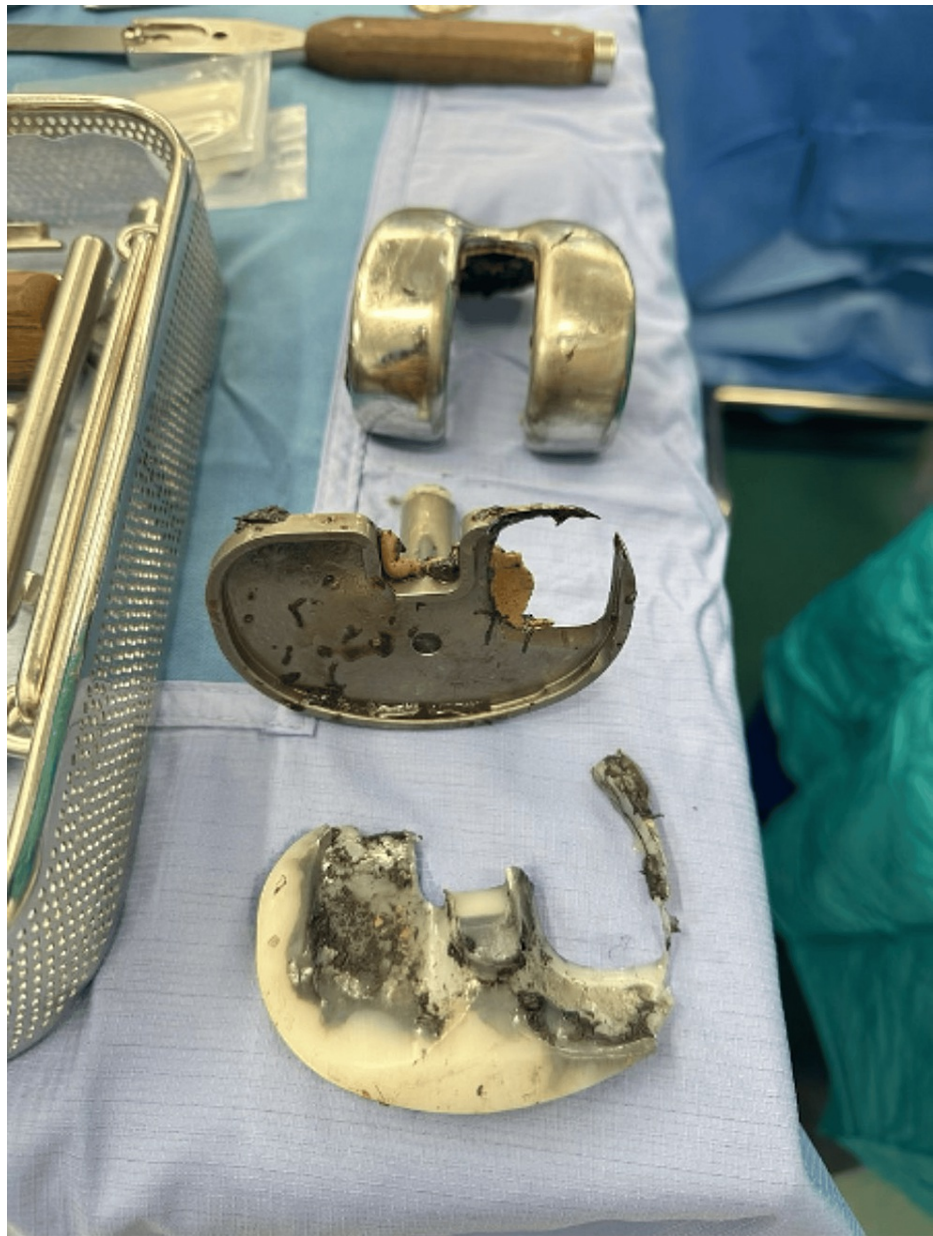
**FIGURE 4: Knee prostheses of the right knee showing polyethylene wear with tibial tray defect.**

After extensive debridement of stained tissue, the prosthetic components were removed (Figure 4), the knee was washed out, and a new semi-constrained modular revision knee prosthesis (Attune revision system, Depuy) was implanted (Figure 5) using sleeves and cones to achieve good fixation. The extracted prosthesis was a PFC (Press Fit Condylar, Depuy) Sigma fixed bearing, in which the femoral component was made of cobalt-chromium and the tibial tray was made of titanium with a matte articulating surface. The extracted insert was deficient posteromedially and resulted in a large defect in the corresponding area of the tibial tray (Figure 6). Because of bone loss and poor metaphysis, the sleeves and long stems were used on both the femoral and tibial sides. The patient had an uneventful postoperative recovery and was allowed to fully weight-bear. At his six-week follow-up, the scar had healed well and he was walking without any support with an ROM of 0 to 100 degrees.

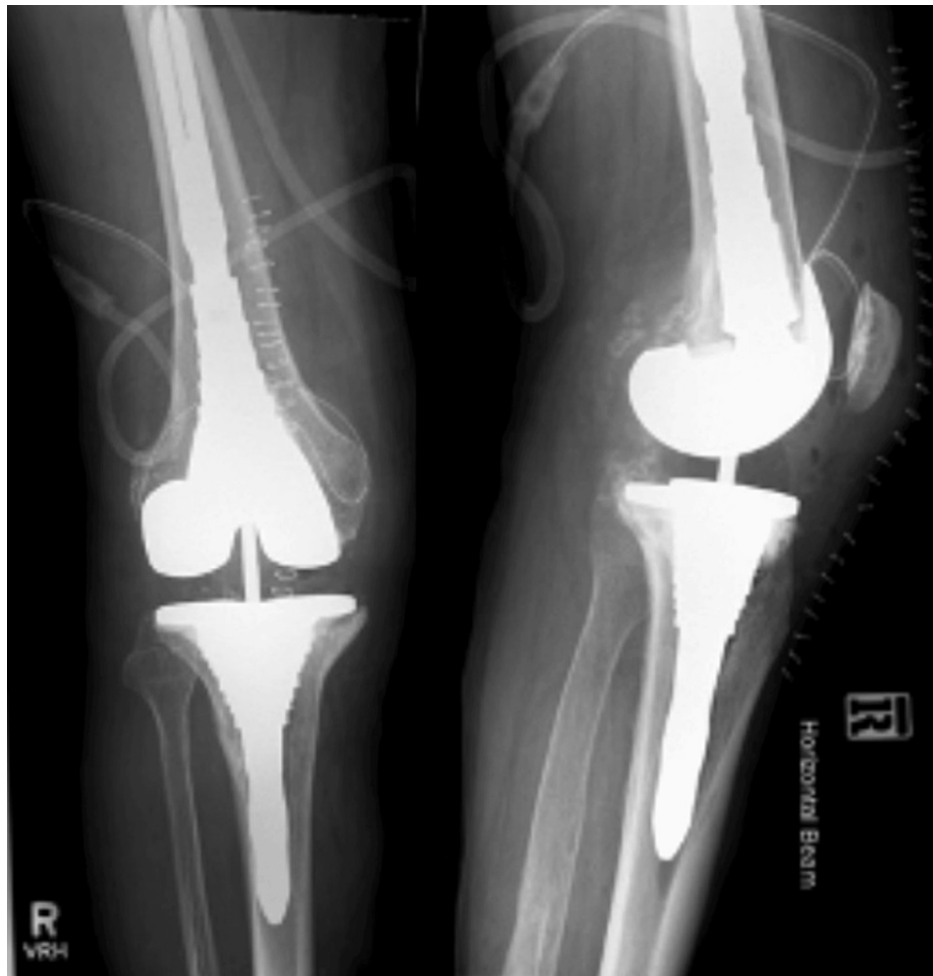
**FIGURE 5: Postoperative anteroposterior and lateral X-rays.**

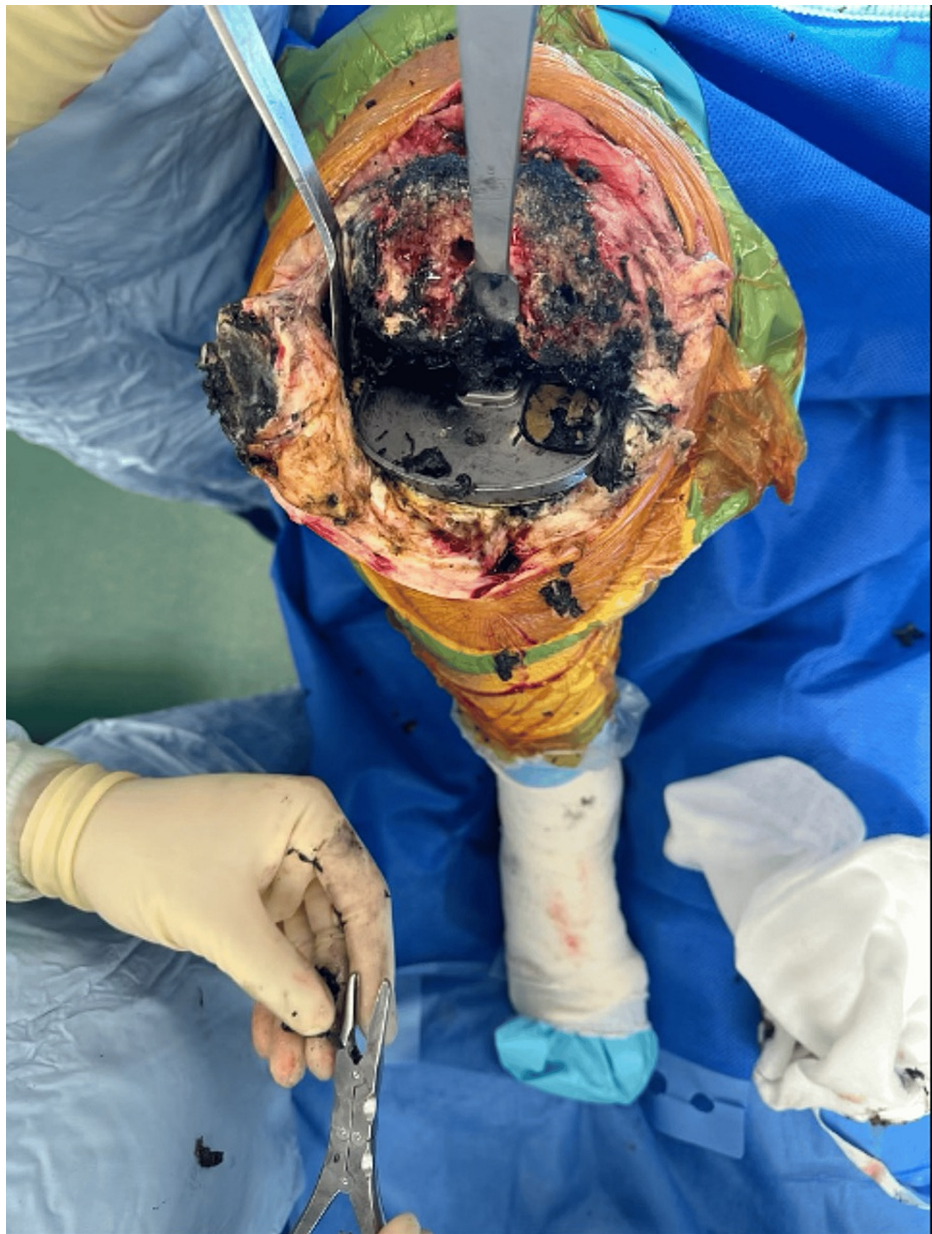
**FIGURE 6: Tibial tray defect posteromedially.**
