Development of a Fire Safety Assessment Test for External Cladding Systems

A thesis submitted in partial fulfilment for the requirements for the degree of MSc (by Research) at the University of Central Lancashire

Version 2.0 17/09/2024

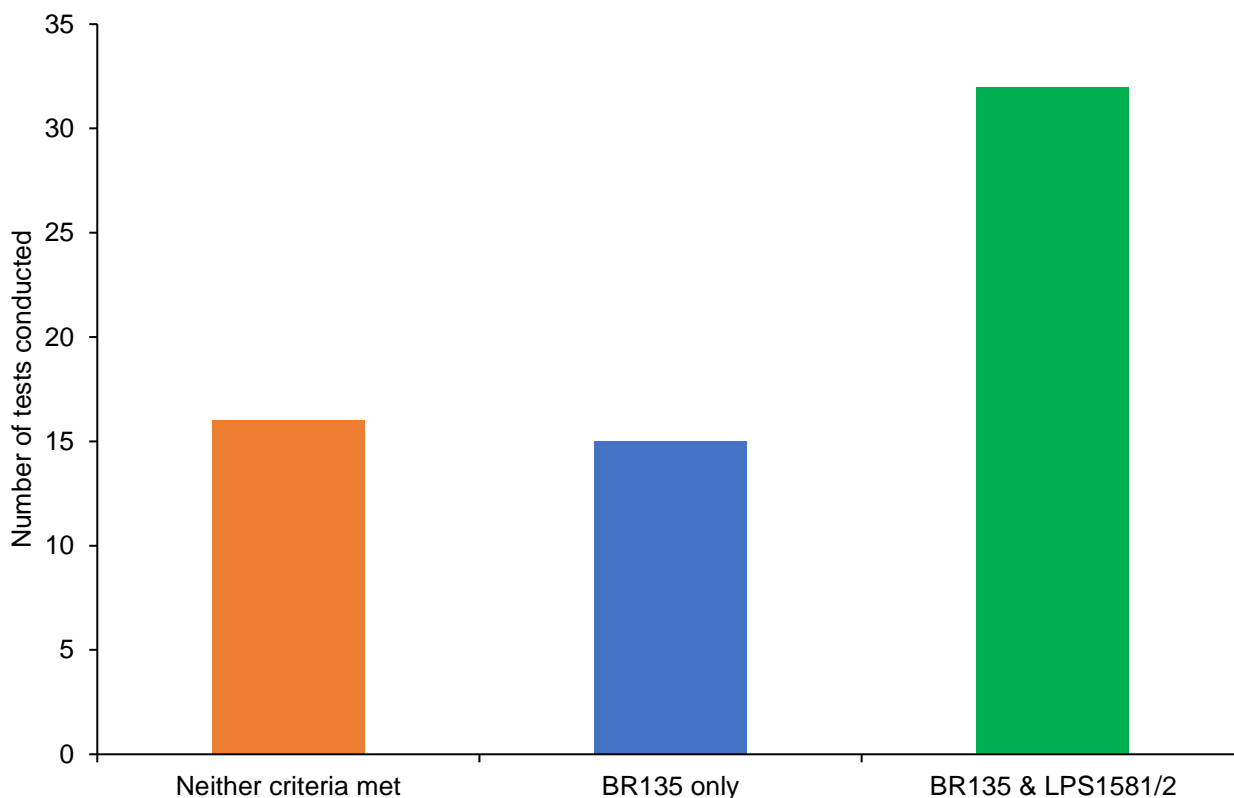
Figure 4 – General system performance (n = 61)

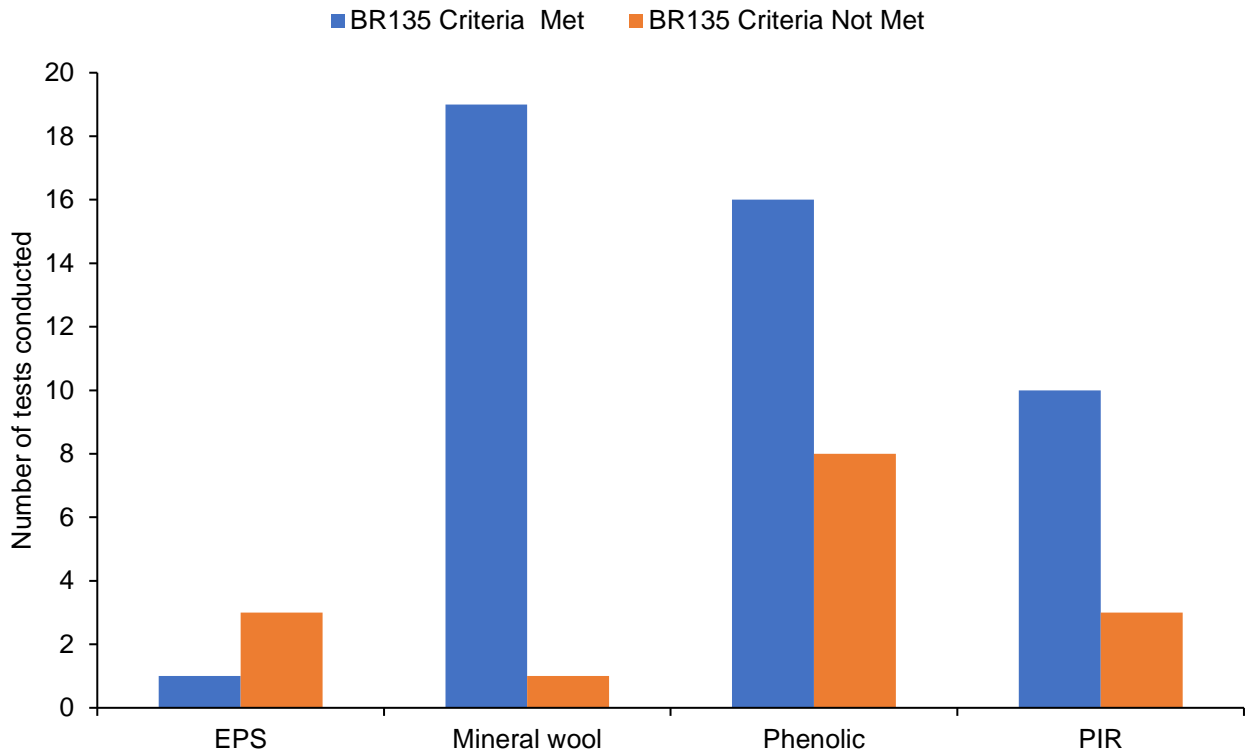
Figure 5 – Frequency of meeting BR 135 criteria as a function of insulation material (n = 61)

Mineral wool insulation was found to meet the requirements of BR 135 in 95% of tests conducted. It was unable to meet the requirements during one test, when combined with a polyethylene filled ACM façade panel.

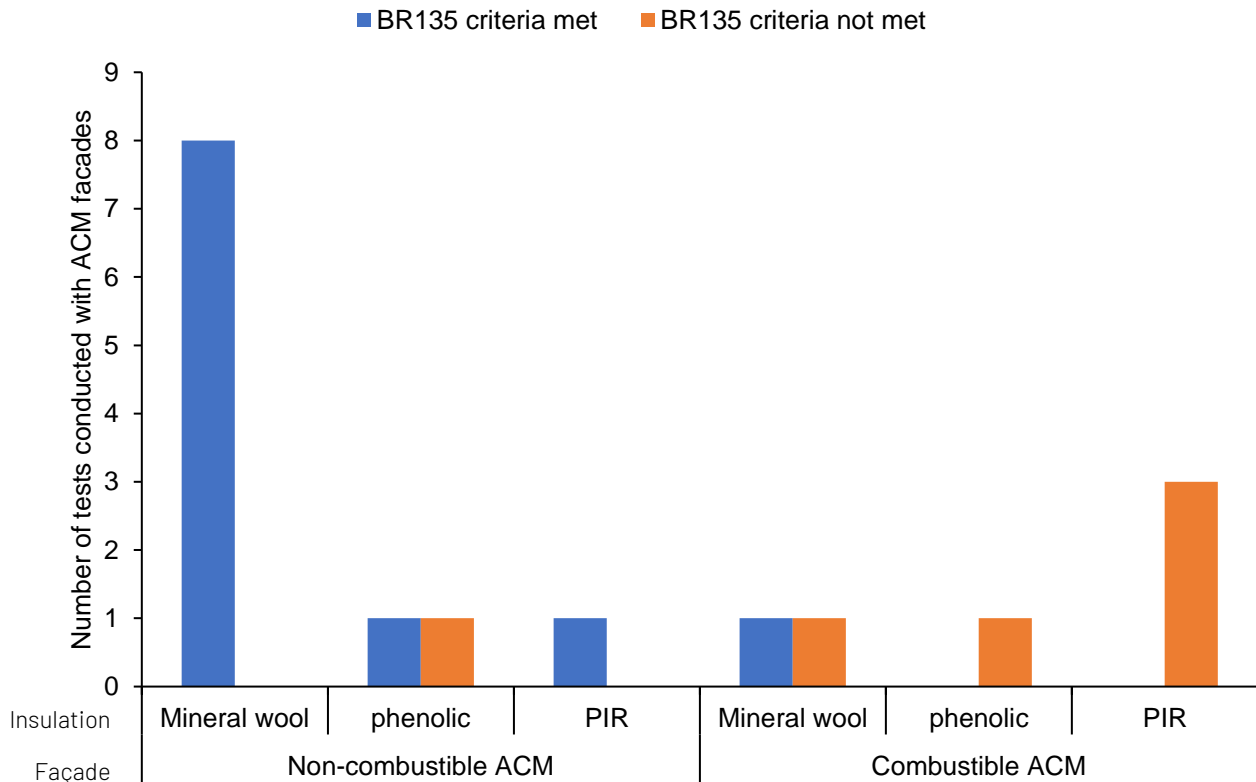
Figure 7 – Frequency of meeting BR 135 criteria as a function of façade and insulation material combinations for ACM facades only (n = 17)

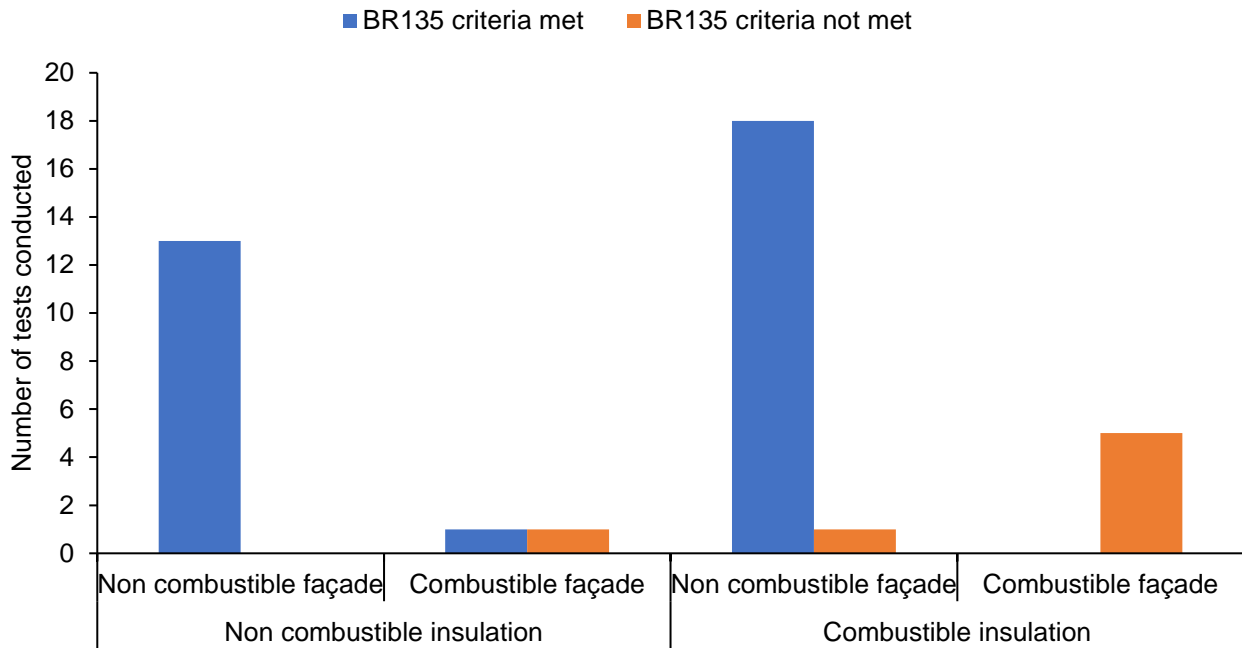
Figure 8 – Frequency of meeting the BR 135 criteria as a function of insulation and façade combustibility (n = 39)

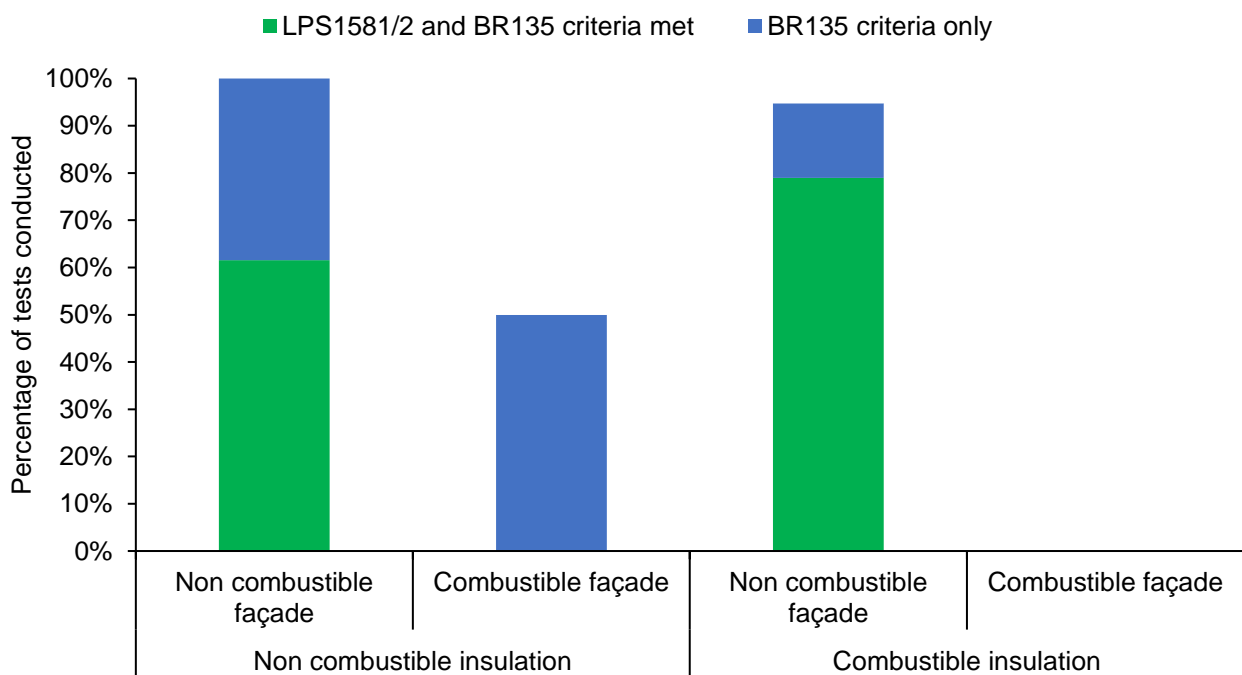
Figure 9 – Bar graph showing the percentage of tests meeting BR 135 and LPS 1581/2 criteria as a function of insulation and façade combustibility (n = 39)

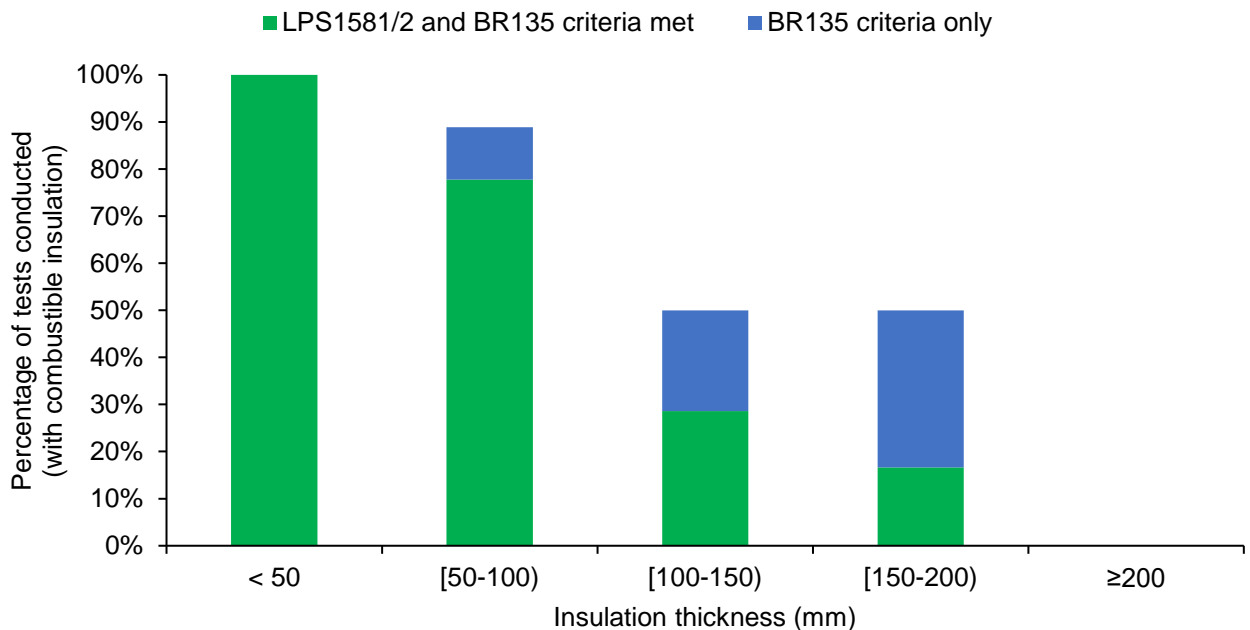
Figure 11 – Stacked bar graph showing the frequency of meeting the BR 135 criteria as a function of insulation thickness for combustible insulations only (n = 41)

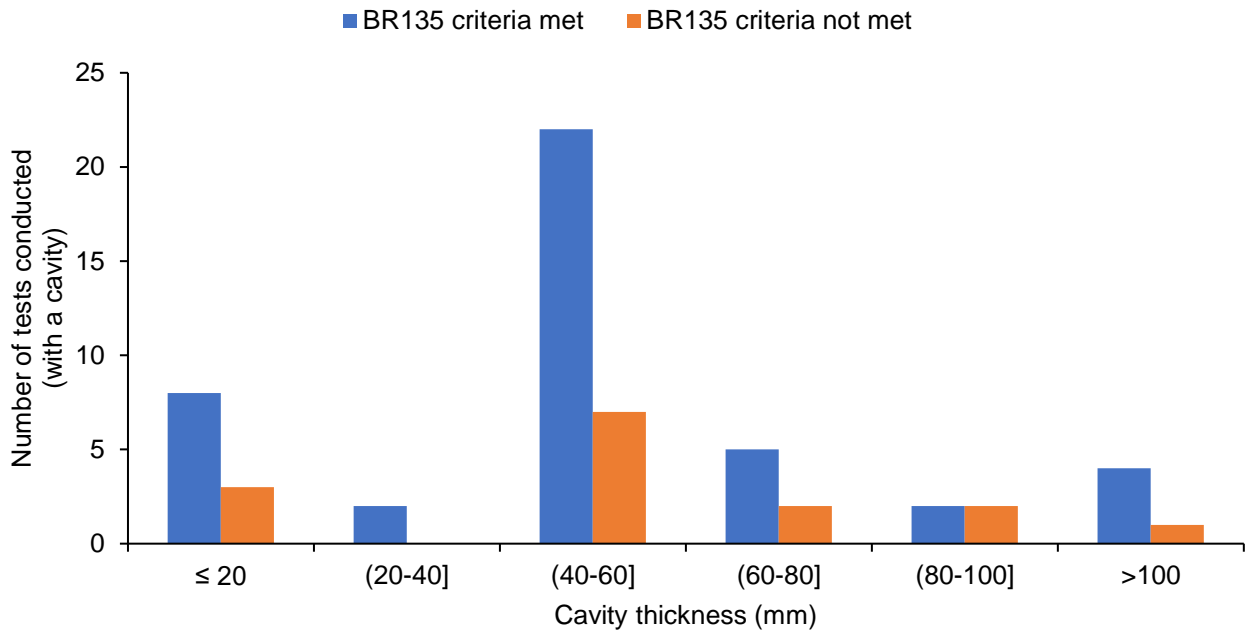
Figure 15 – Frequency of meeting the BR 135 criteria as a function of cavity thickness (n = 58)

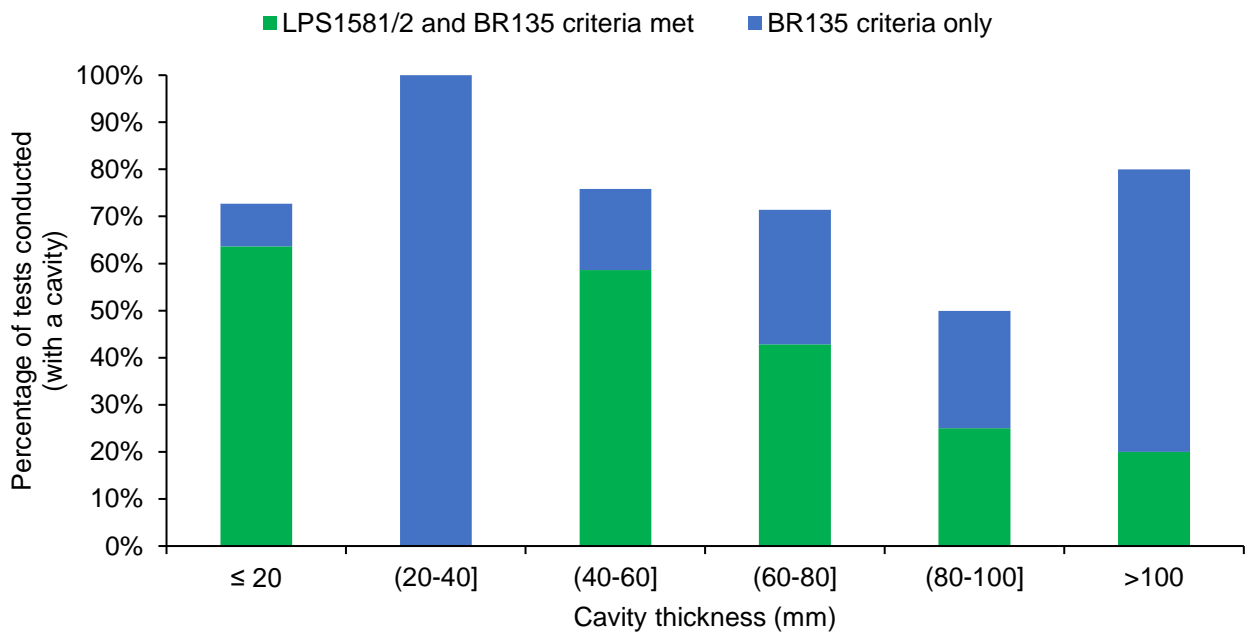
Figure 16 – Stacked bar graph showing the frequency of meeting the BR 135 criteria as a function of cavity thickness (n = 58)

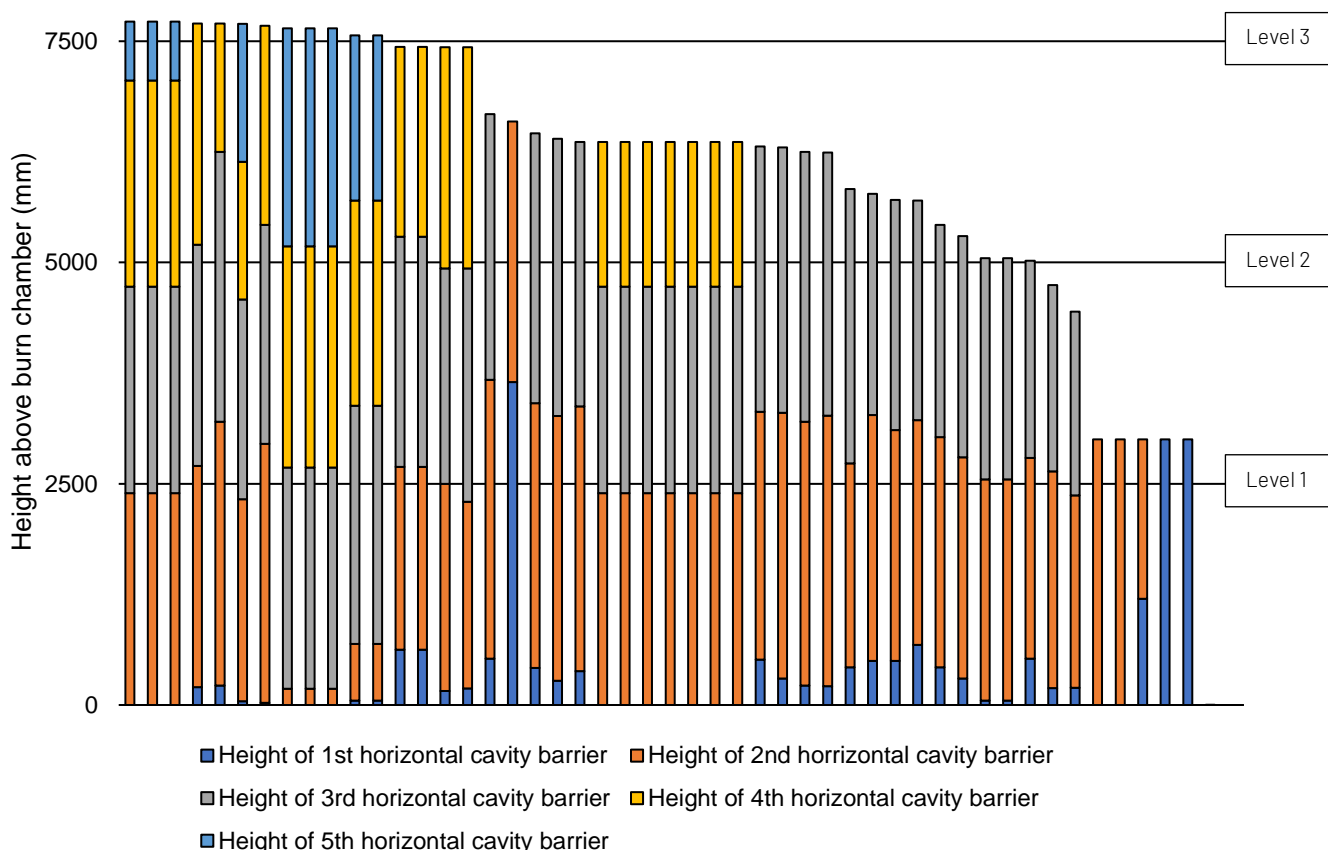
Figure 19 – Graph of horizontal cavity barrier locations with each bar representing a single cladding system (n = 45)

It should be noted that BR 135 uses the level 2 thermocouples, 5000 mm above the burn chamber, for its temperature criteria. The relative position of the thermocouples and cavity barrier has a significant impact on the test outcome.

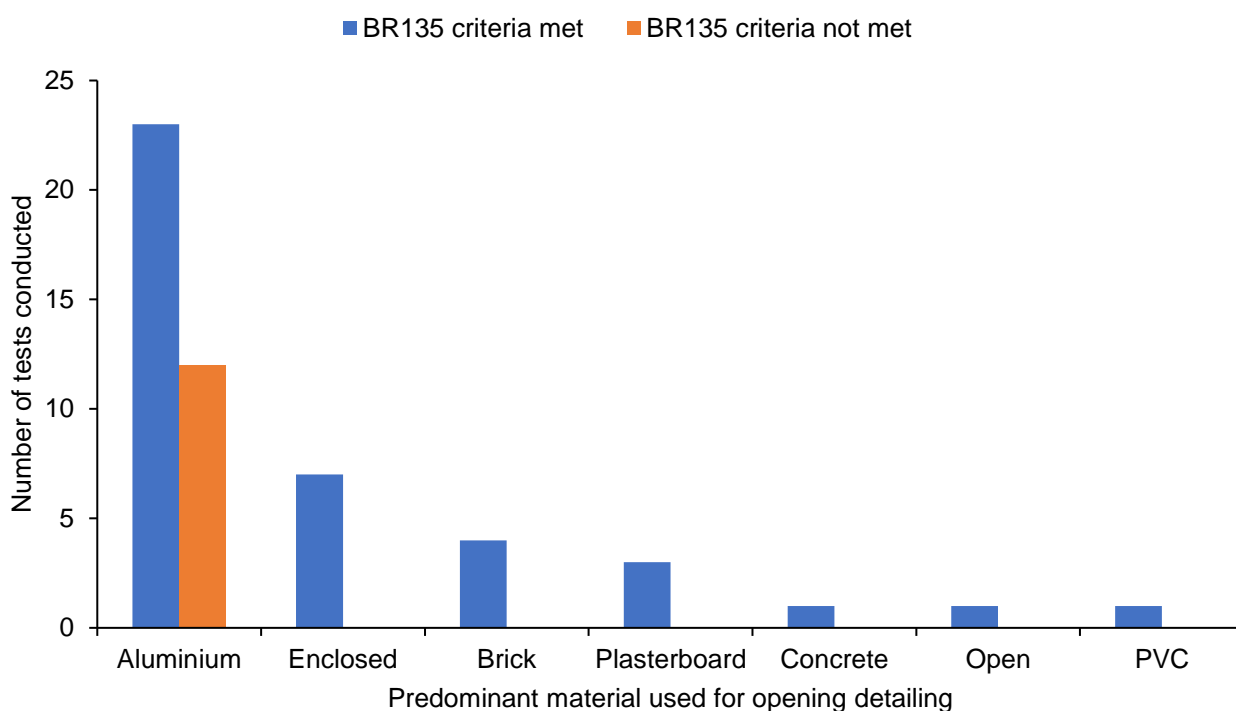
Figure 21 – Frequency of meeting the BR 135 criteria as a function of opening detailing material (n = 52)

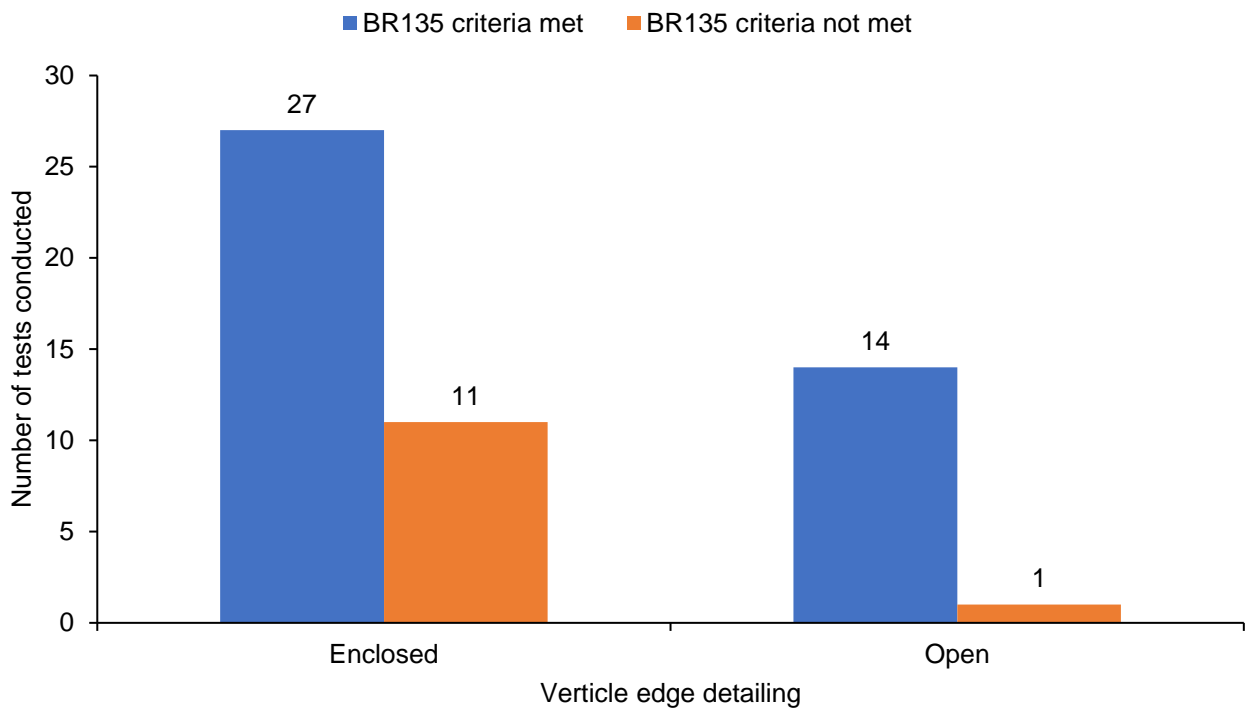
Figure 22 - Frequency of meeting the BR 135 criteria as a function of vertical edge detailing material (n = 53)

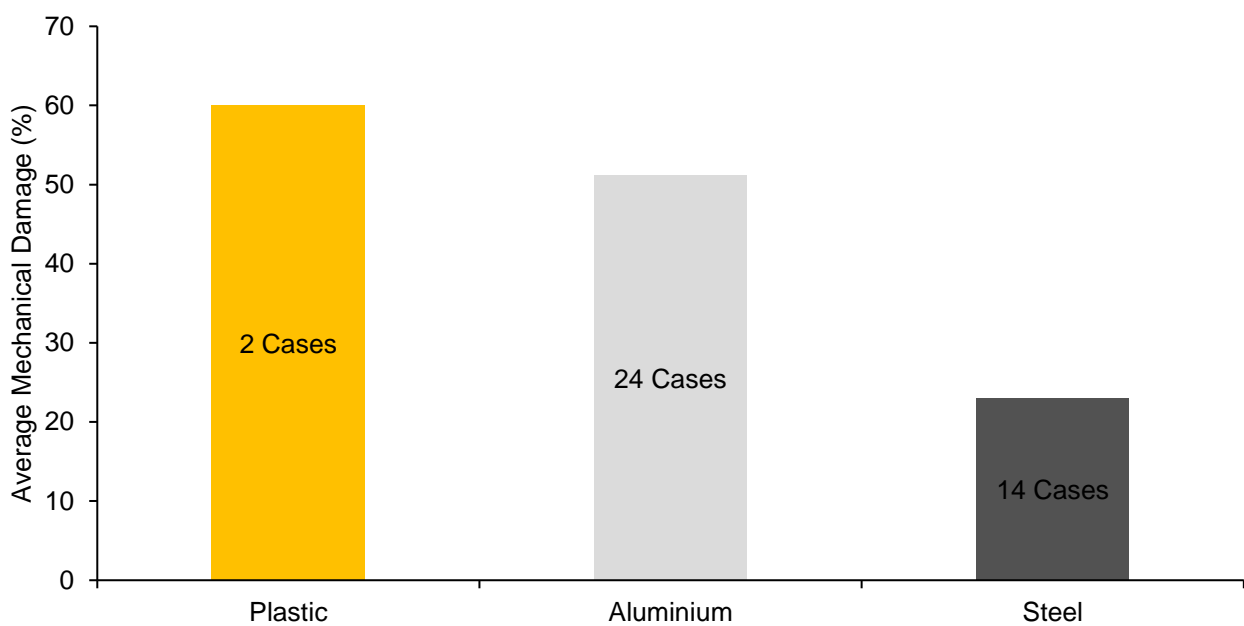
Figure 23 - Mechanical damage as a function of bracketry material (n = 40)

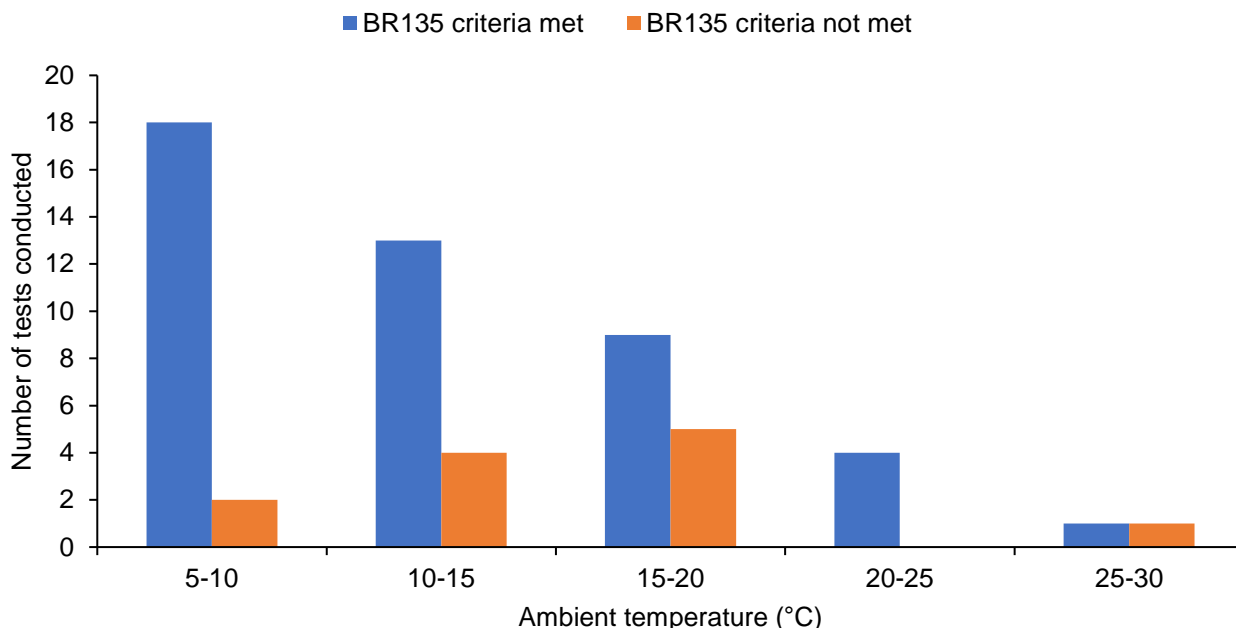
Figure 24 – Frequency of meeting the BR 135 criteria as a function of ambient temperature (n = 57)

Figure 24 suggests that as the ambient temperature increases, the likelihood of a system failing to meet the BR 135 criteria significantly increases. This suggests that the warmer the cladding system is, the less energy is required for drying and heating each component to its activation energy for ignition.

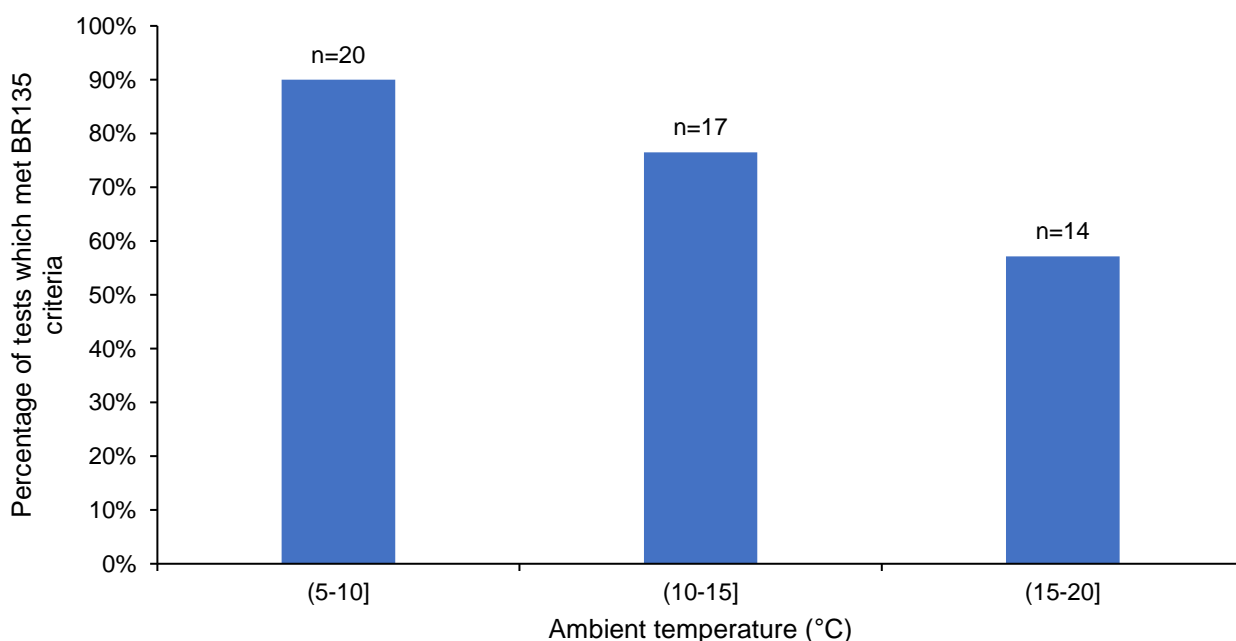
Figure 25 – Bar graph showing the percentage of tests meeting BR 135 criteria as a function of ambient temperature (n = 51)

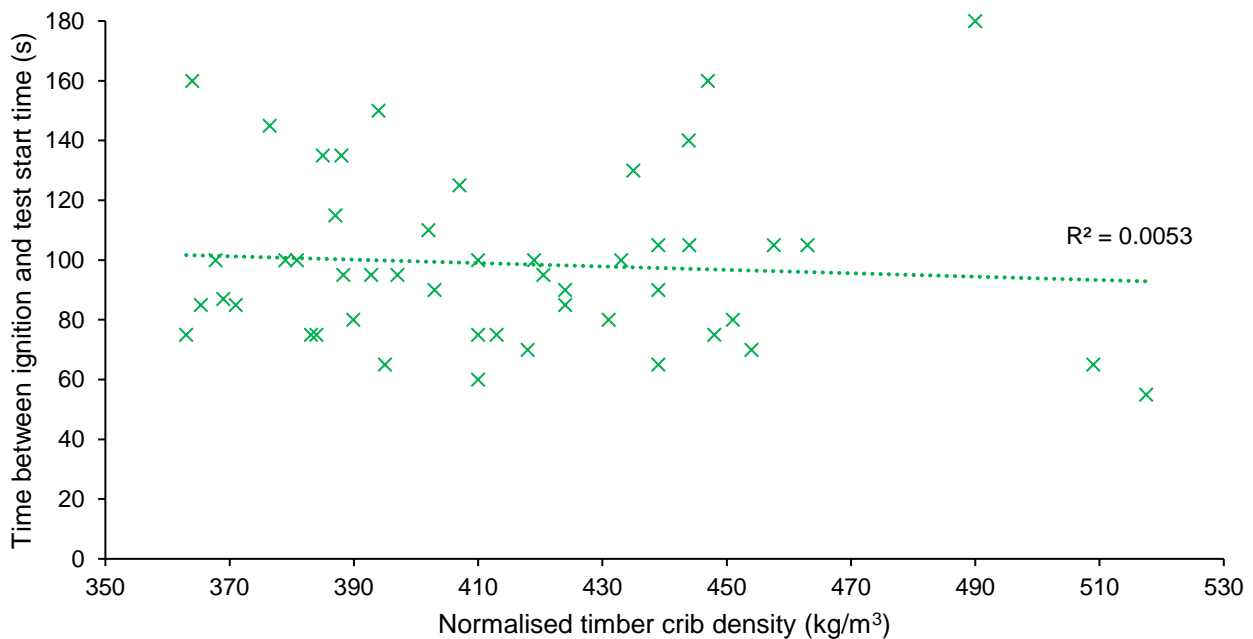
Figure 27 – Scatter graph showing no correlation between normalised fuel load density and test start time (n = 61)

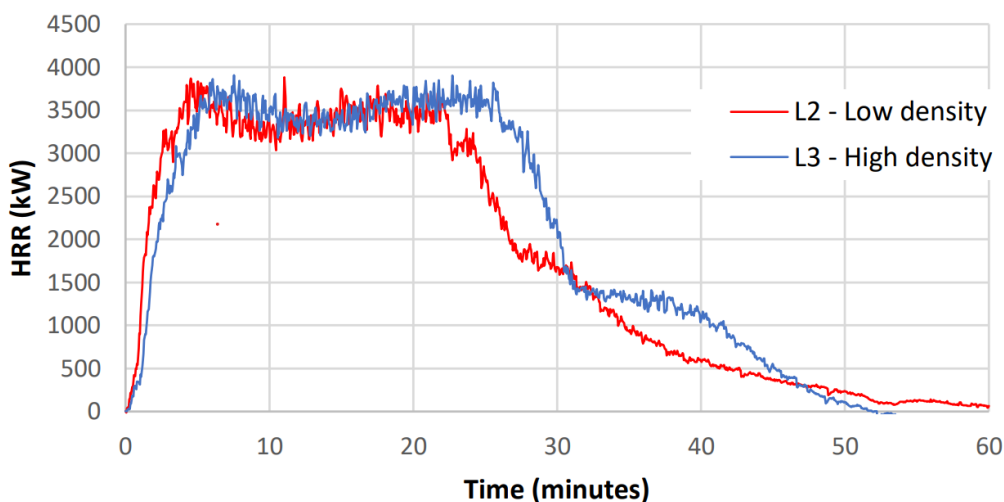
Figure 28 – Effect of wood density on a BS 8414 crib's heat release rate [27]

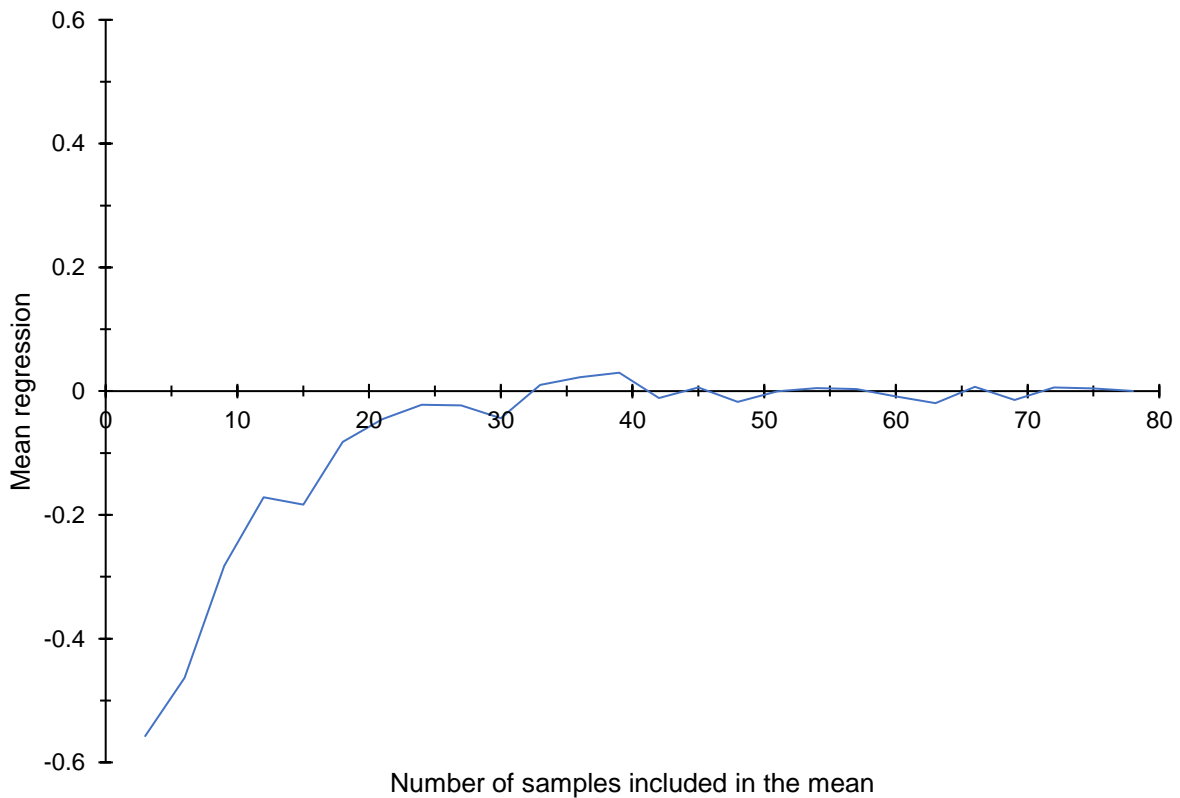
Figure 44 - Mean regression as the number of samples included in the mean increases, with a standard deviation of 0.65

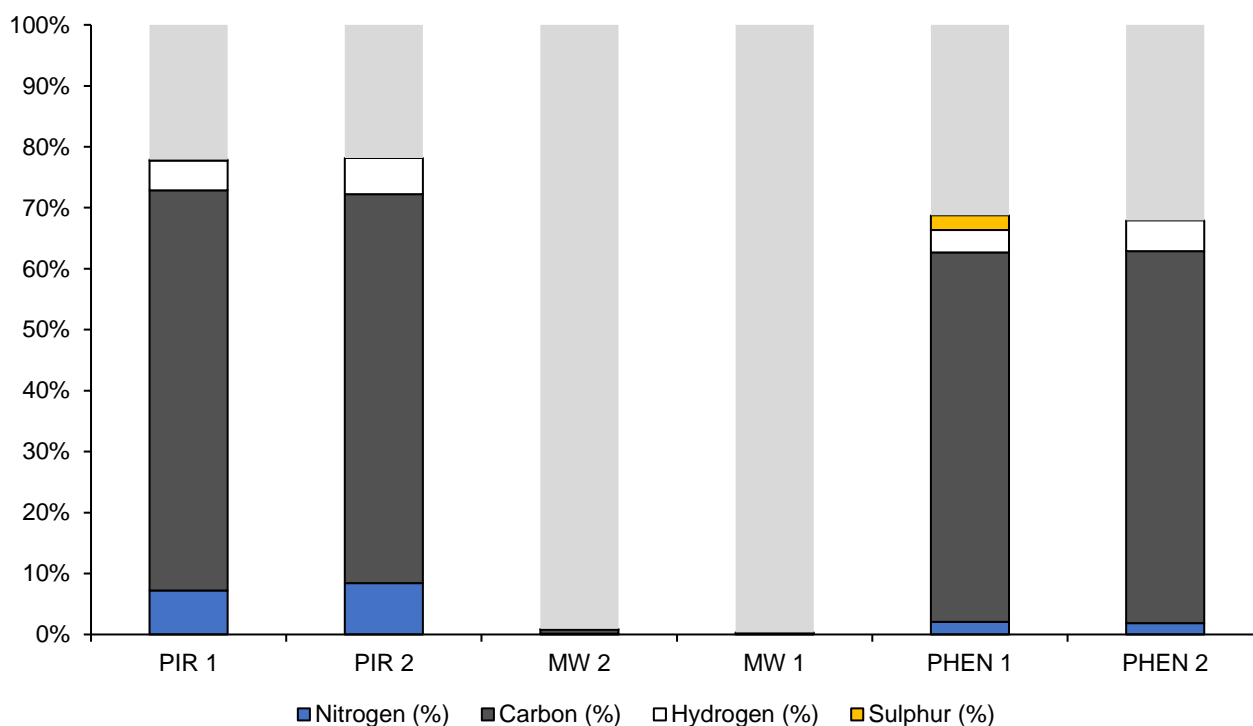
Figure 46 - CHNS results for common insulation products

Mineral wool fibres do not typically contain the components the CHNS analyser measures and is typically composed of calcium, magnesium and aluminium silicates [78]. There is usually a small amount of combustible product in mineral wools from the binding agent. This clearly wasn't significant enough in mass to produce sufficient gas, for the gas chromatography to detect.

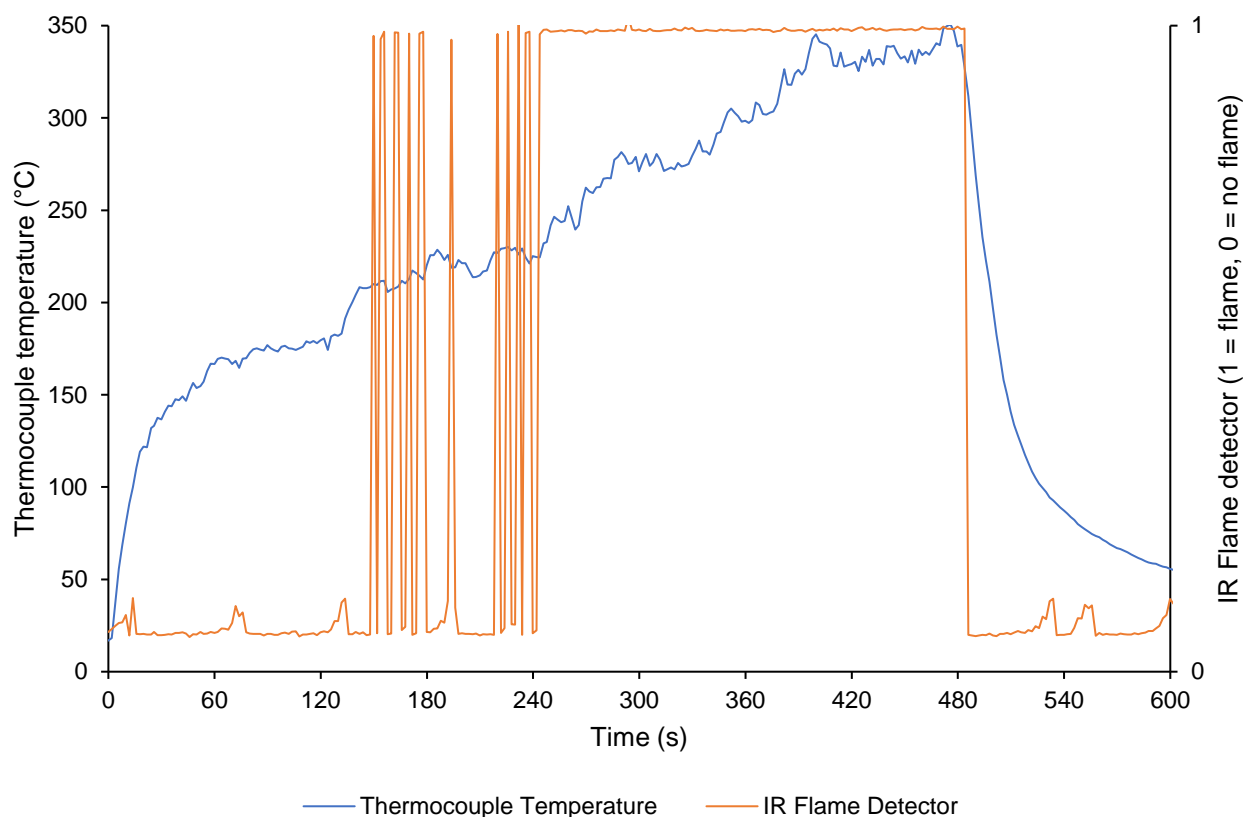
Figure 49 – The correlation between thermocouple temperatures and an Infrared Flame Detector in a 50 mm cavity as the flame height is gradually increased

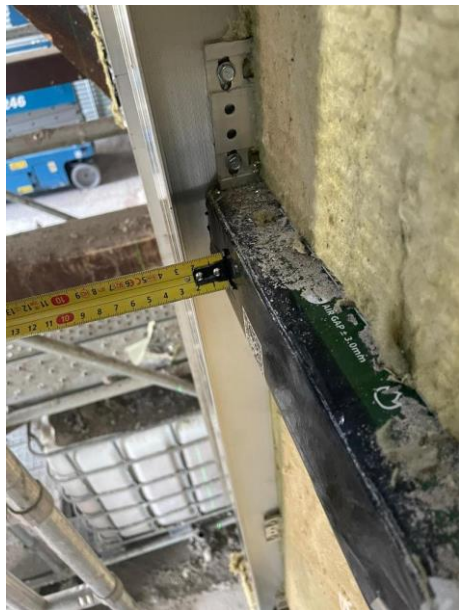
Figure 60 - Open state cavity barrier installed with 25 mm gap to façade panel

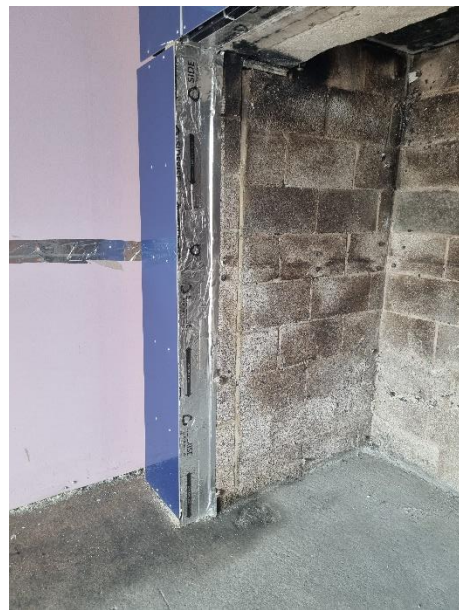
Figure 61 - Closed state cavity barrier installed on vertical edges of burn chamber

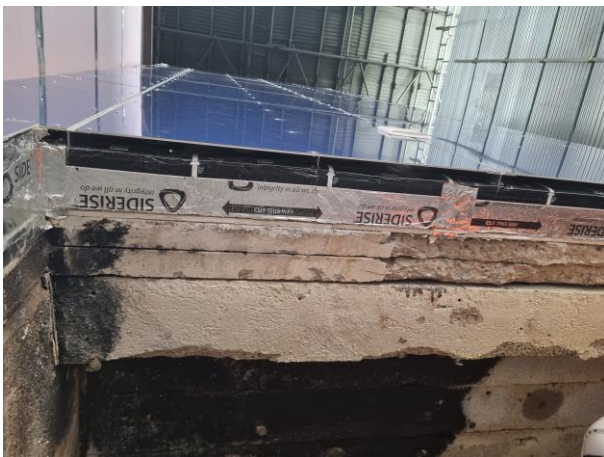
Figure 62 - Open state cavity barrier installed on horizontal edge of burn chamber

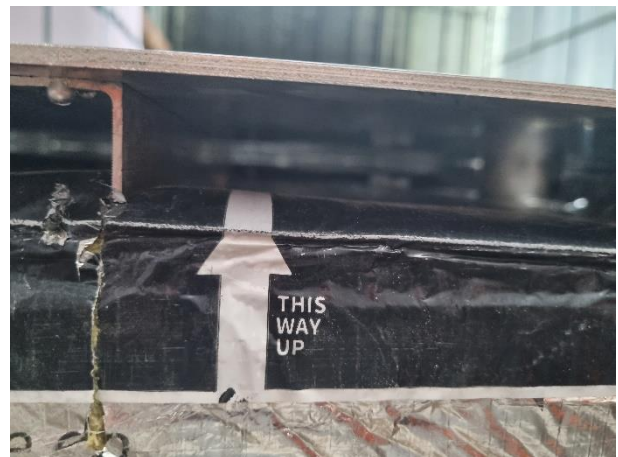
Figure 63 - Photograph of cavity extending from burn chamber opening to top of test rig

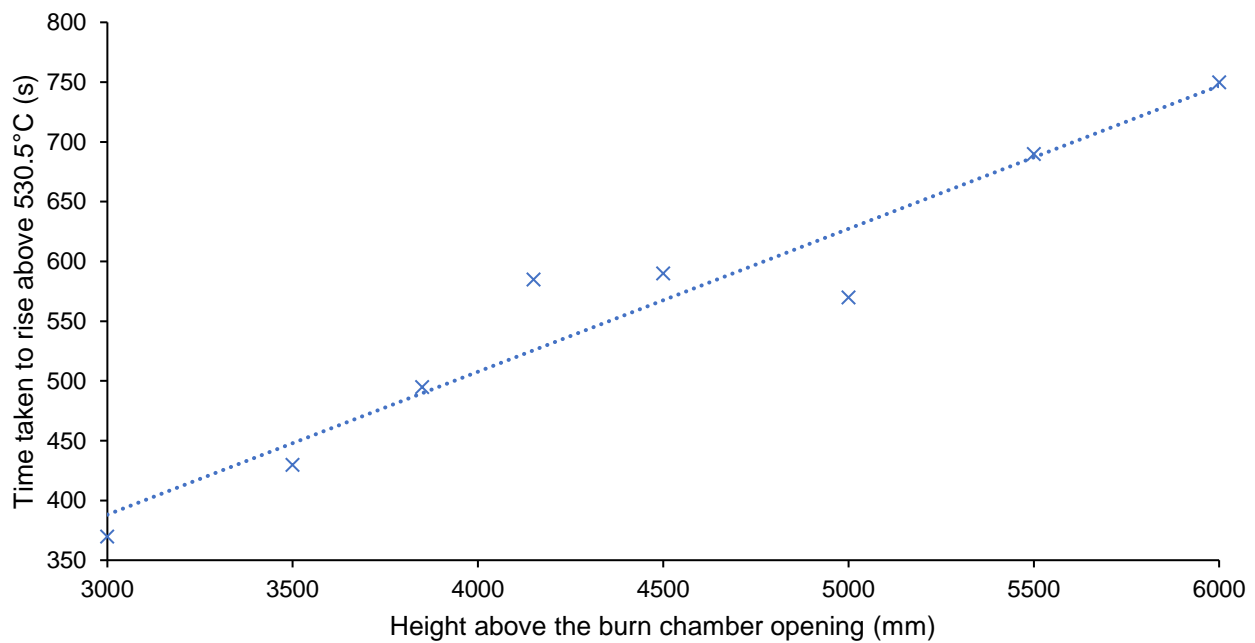
To investigate if the rate of fire spread during test 2 was accelerating or decelerating up the test rig the time taken for a thermocouple to rise above 530.5°C was plotted against the height above the burn chamber opening, shown in Figure 85. Decelerating fire spread would indicate that the fire may self-extinguish as it moves away from the timber crib heat source.
