| Title | Burning behaviour of rainscreen façades |

# Burning behaviour of rainscreen façades

## Abstract

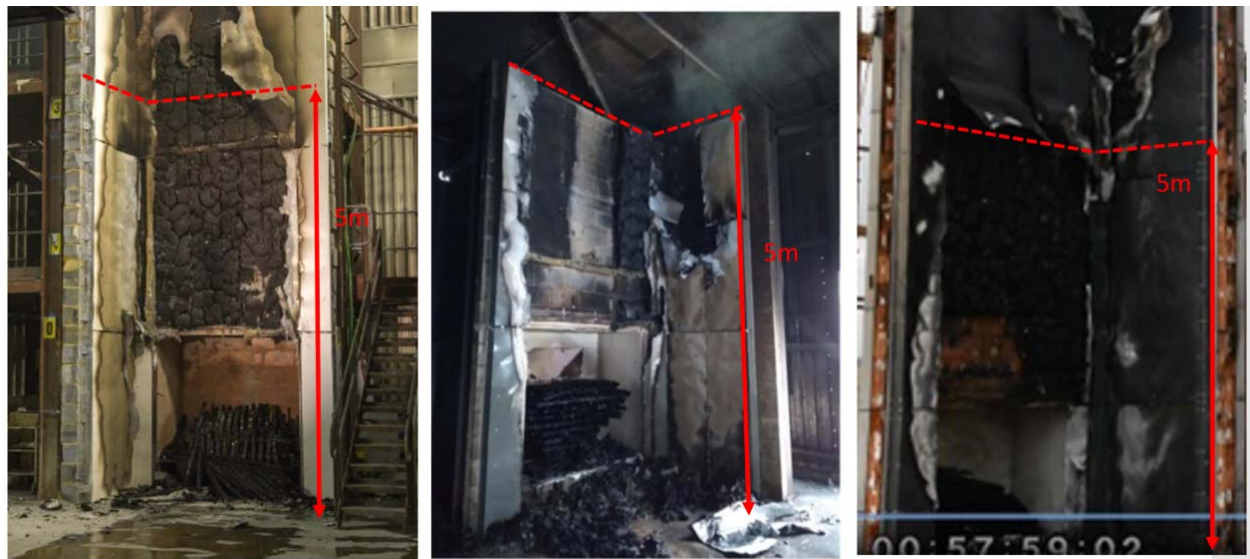
The photographs in Figure 13 show the burn areas for the FPA, DCLG and Čolić tests for PIR/A2. The burn areas show that the panels have burnt or fallen from the wall and failed to protect the underlying insulation from fire. The burn areas for all tests show that the damage is most severe in the area directly above the combustion chamber. In this area, the ACM panels are missing up to the 5 m point in all three tests. In the case of the DCLG test, charred PIR remains attached to the wall, suggesting more resilient mountings were used, whereas for our tests and the Čolić tests some PIR is missing and the masonry wall can be seen. Damage has occurred to the wings of all walls, most severe for our test where some of the ACM panels are damaged and partially missing, despite the lowest wing temperatures. The ACM on the wing of the DCLG and Čolić tests has been damaged on the surface, but has remained intact. The DCLG and Čolić test walls show that the damage to the wall, and missing ACM, above the combustion chamber extends beyond 5 m.

Figure 13 PIR/A2 comparison of burn area DCLG (left), FPA (centre) and Čolić (right) [17, 19]
