**Hazards presented by pyrolysis and combustion
products during laboratory experiments and real
incidents**

A thesis submitted in partial fulfilment for the requirements for the degree of
Doctor of Philosophy at the University of Central Lancashire in collaboration
with the Building Research Establishment

January 2015

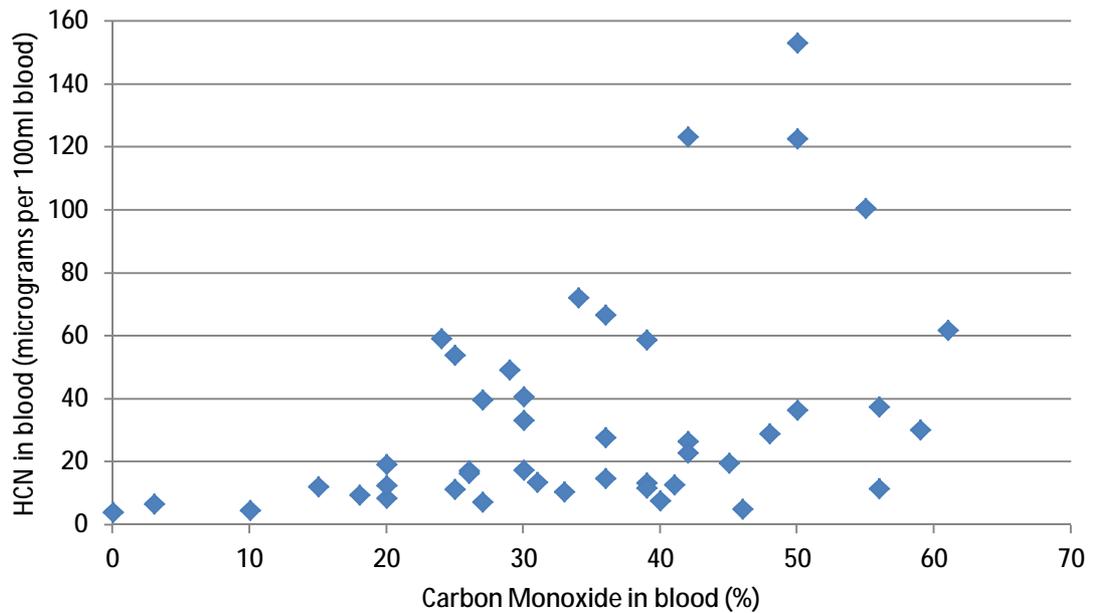
Figure 6 – Carbon monoxide and hydrogen cyanide data from Table 7, presented graphically

The tribunal of enquiry considered that carbon monoxide concentrations above 40% should be considered lethal and therefore relevant to cause of death, whilst a cyanide concentration over 100 micrograms per 100ml blood was also considered lethal. Concentrations of carbon monoxide between 20% and 40% were considered to indicate cause of death being a combination of the effects of heat and smoke inhalation, whilst lower concentrations were considered to indicate heat being the principle cause of death. When compared with modern figures for death due to asphyxiant gases (50% COHb and 3 µg CN/ml – or 300 µg CN per 100 ml), the data would tend to indicate that carbon monoxide was more significant than hydrogen cyanide in this incident. However, there is no information available concerning the interval between death and analysis of blood samples, so it is possible that actual hydrogen cyanide levels may have been higher at the time of death. None of the alcohol concentrations were considered to be sufficiently high to have contributed directly to any of deaths (i.e. via toxicity). However, intoxication is likely to have played a role in the ability of the victims to effect their own evacuation.

As mentioned in chapter 2.1, whilst the locations of the victims of this fire were recorded, it is not known which victim was which and therefore which postmortem blood analyses are relevant to each victim. However, it can be seen from Figure 6 in chapter 2.1 that relatively few victims died from smoke inhalation alone. This is supported by the FED plots for the annex (near the fire origin) and vent (away from the fire) points, which show that the hazard posed by toxic gases reduced significantly away from the fire during the evacuation period, whereas there was a high hazard presented by heat in either location. This indicates that hazard from heat was high regardless of victim location, whereas only those victims which remained close to the fire would have been significantly affected by smoke and toxicity.

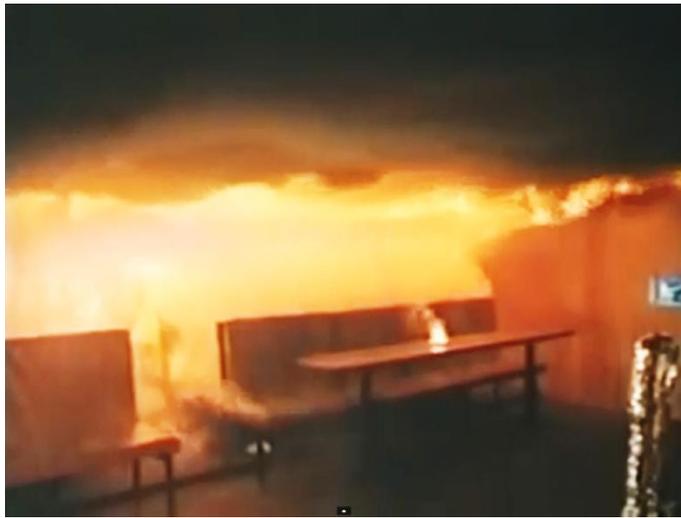
Figure 10 – Still from BRE/FRS video of Stardust reconstruction (see Appendix A), rapid fire development as materials ignite (flashover)

During this period of rapid growth culminating in flashover, temperatures in the hot gas layer below the insulating ceiling exceeded 1300°C. As more of the fuel became involved it was estimated that heat output approached 20 – 25 MW. By this stage the fire was ventilation controlled and so incomplete combustion was producing, among other things, large quantities of soot and black smoke. The data from the FRS report into the fire is shown in Figure 12. No electronic record of the data remains, so it has been necessary to recreate the data manually, so that this can be used for the FED analysis later. This has been achieved using free-to-use online software which can be used to generate coordinates for the lines on images of graphs.¹²⁹ The plot of the recovered data is shown in Figure 13.

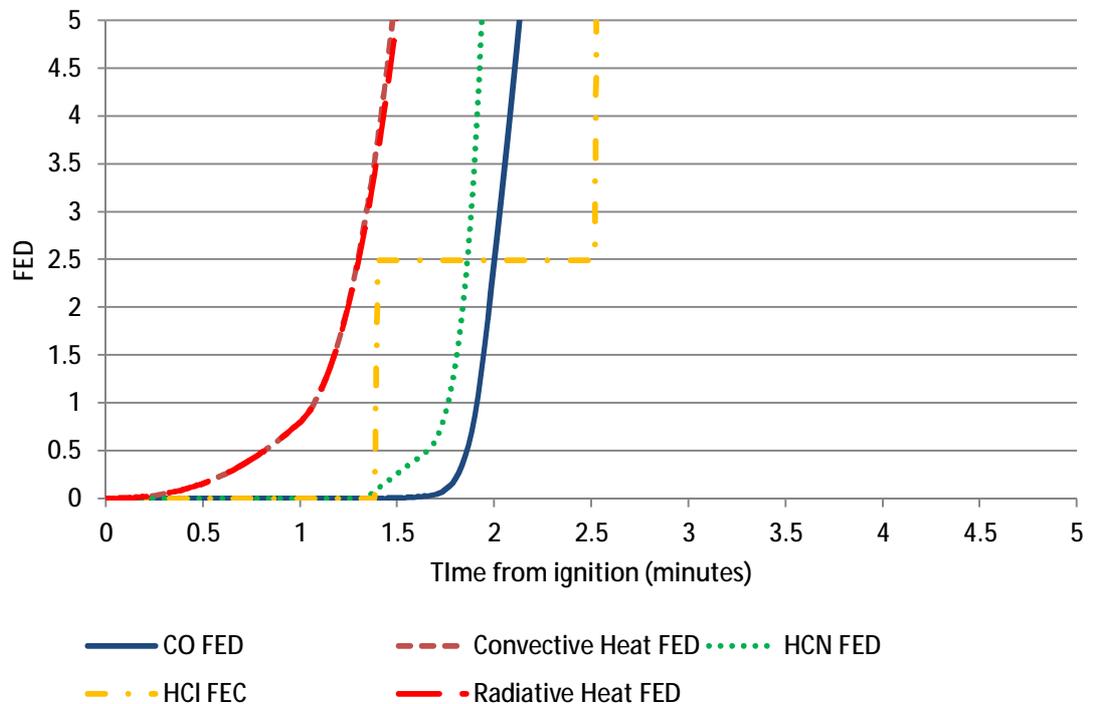
Figure 16 – FED values calculated using ISO 13571 method based upon Stardust reconstruction annex point measurements. As previously discussed, FED>1 is shown for indication and should not be considered an accurate representation of increasing hazard

The analysis in both cases indicates that heat is the dominant factor in the overall hazard. It is interesting to note that radiant and convective heat appear to be equally significant at the annex point (near the origin of the fire) whereas convective heat becomes the dominant factor further away at the vent point. Given the gas concentrations at the annex, the significance of radiant heat is likely to be attributable to the optical density of the smoke and its resultant emissivity of thermal radiation. Reports from the work carried out certainly indicate that extremely thick, black smoke was produced in very large quantities when the reconstruction was carried out.

It is interesting to note that hydrogen cyanide was the dominant toxicant at the annex point in Figure 16 (nearer the seat of the fire) whereas carbon monoxide was the dominant toxicant at the vent point in Figure 17 (away from the seat of the fire). This highlights the difference in proportion of carbon monoxide to hydrogen cyanide at these two locations (visible but less apparent in Figure 14 and Figure 15).

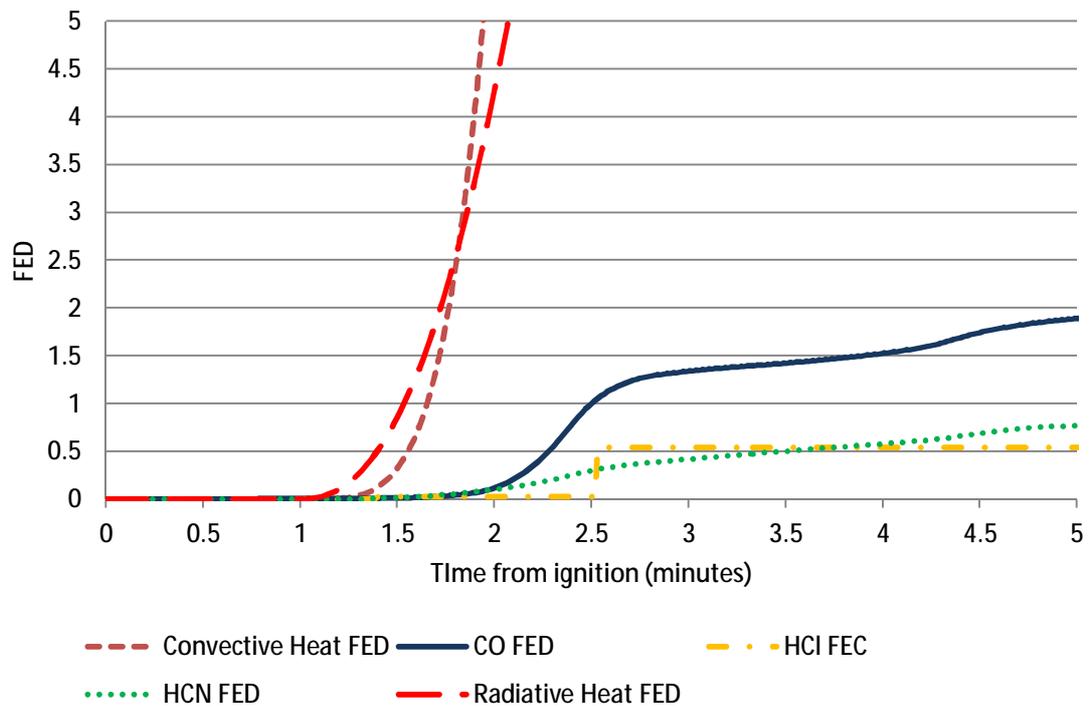
Figure 17 – FED values calculated using ISO 13571 method based upon Stardust reconstruction vent point measurements. As previously discussed, FED>1 is shown for indication and should not be considered an accurate representation of increasing hazard

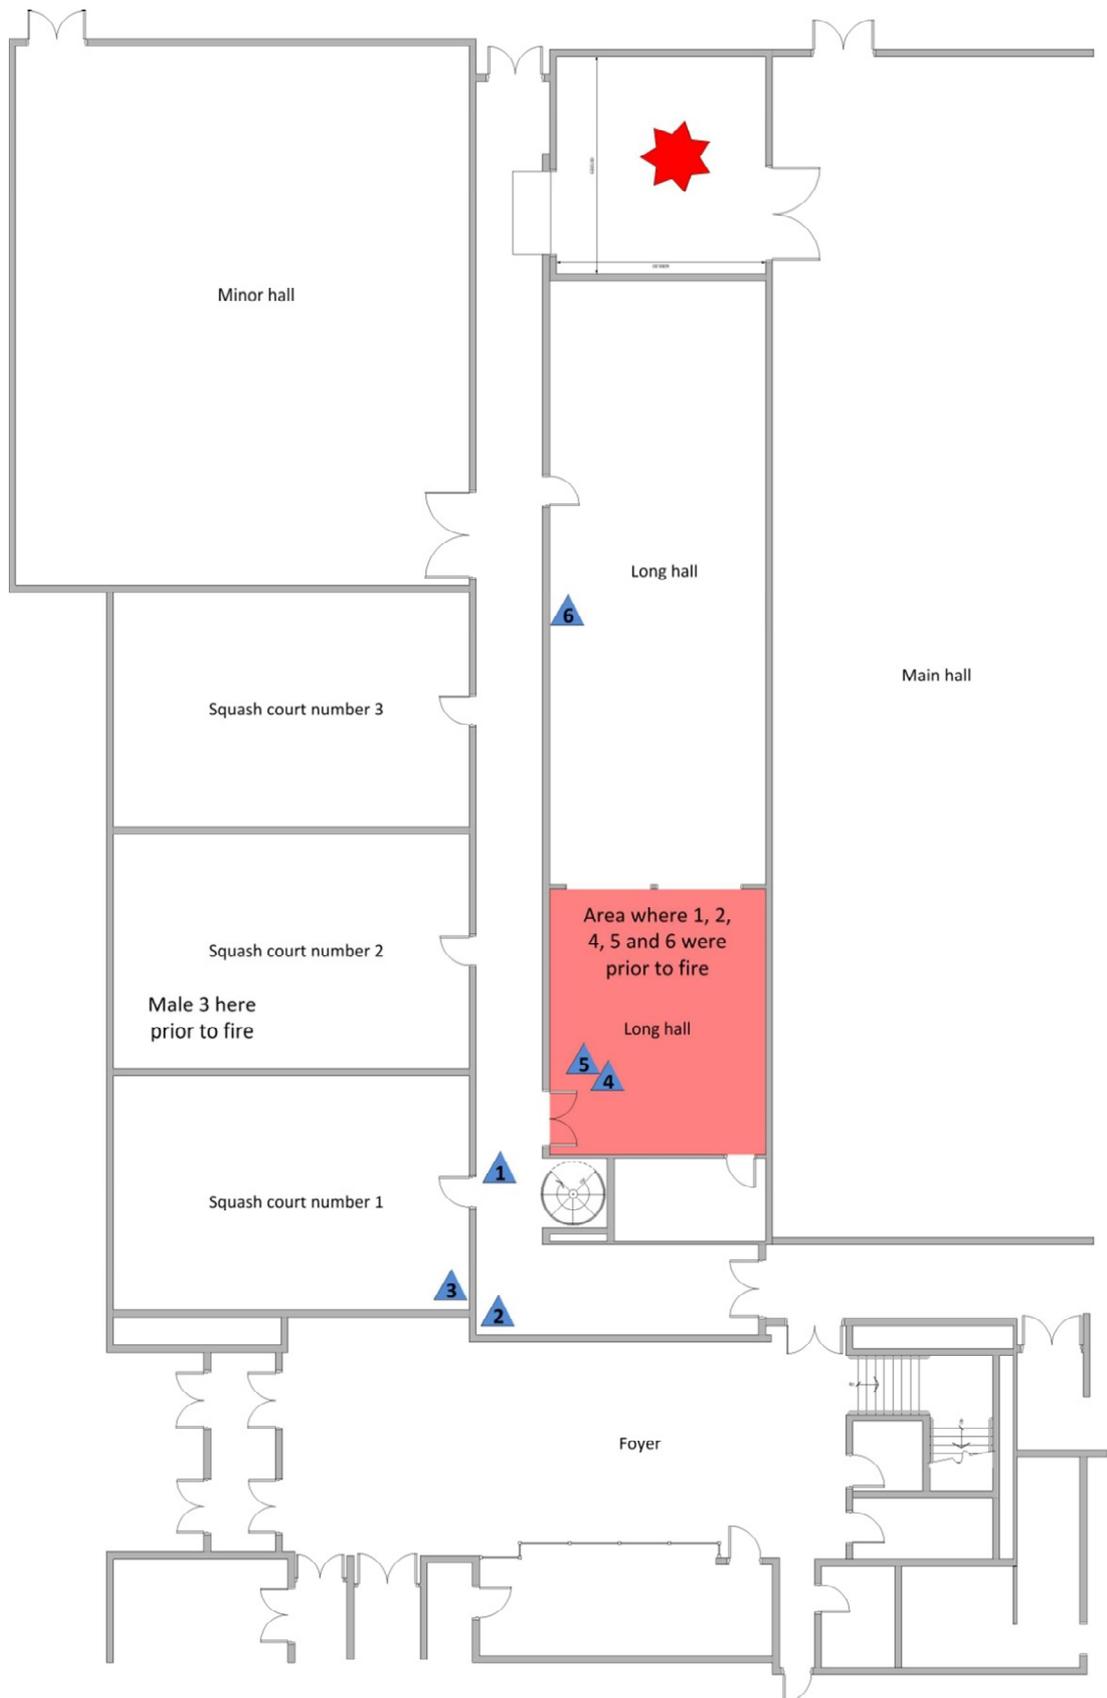
Figure 19 – Plan showing the relevant portion of Maysfield leisure centre and the locations of the bodies (see Table 9). The red star indicates the room where the fire occurred and the red shaded area indicates the area used as a darkened room

All of the victims were in locations are/or moved through spaces which brought them in contact with smoke in or spilling out of the main corridor (see Figure 19 in chapter 2.2). Given the dramatic change in severity of conditions once under-ventilated conditions were achieved and large concentrations of hydrogen cyanide (and carbon monoxide) started to be produced, it is perhaps unsurprising that victims were overcome by the smoke before they were able to leave the building. It is unfortunate that there was an extended postmortem interval prior to samples being taken for hydrogen cyanide. It seems likely that the impact of hydrogen cyanide may have been underplayed at the time due to the decreased measured levels and the lack of knowledge concerning the importance of postmortem interval on detection of hydrogen cyanide. The photographs from the reconstruction and witness evidence from the survivors of the fire also indicate that the thick, dark smoke produced by this fire would have significantly hampered movement through the building, although no quantitative data is available to assess this.

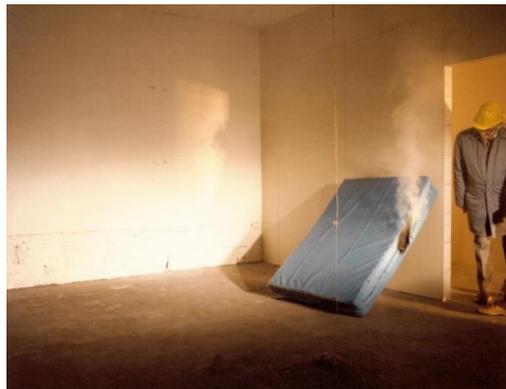
The first test was a smouldering test (ignited using a lit cigarette) on a single crash mat. The test was carried out to investigate the timescales that would have been needed for the smouldering fire to lead to a flaming fire and whether this was compatible with timescales and witness testimony from the incident. The test revealed that a strong and unpleasant smell would have been apparent to any people in the vicinity well before any life-threatening conditions presented themselves. This indicated that a smouldering fire would have allowed sufficient timescales between detection and onset of untenable conditions to have allowed building occupants to escape safely, Figure 21.

Figure 21 – Plate number 1 from the FRS report into the Maysfield fire¹³¹ (see Appendix A) showing the smouldering test on the crash mat 20 minutes after ignition

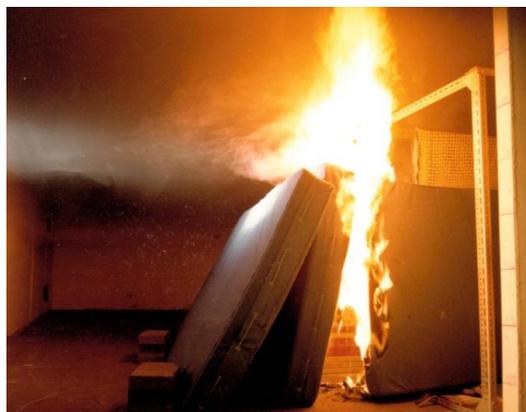
The second test was a full-scale flaming test using a set of contents for the rig which were designed to be representative of the contents involved in the actual fire. The fire is reported to have developed quickly; the timeline of fire development is shown in Table 10. The initial fire during this test is reported to have appeared to burn cleanly, with a little pale smoke. As the fire size increased and more fuel became involved, the quantity of smoke also increased.

Figure 22 – Plate number 7 from the FRS report into the Maysfield fire¹³¹ (see Appendix A) showing the full-scale flaming test 4 minutes 30 seconds after ignition

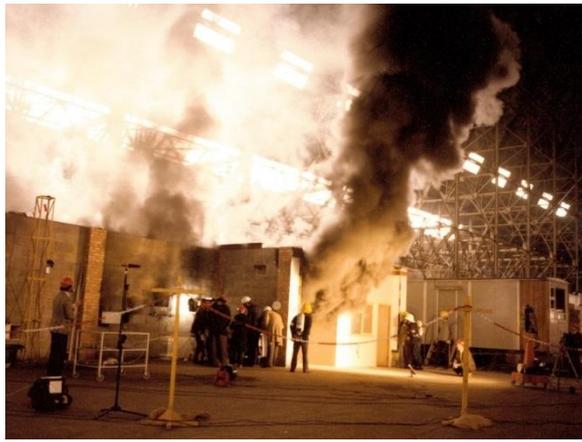
Figure 23 – Plate number 12 from the FRS report into the Maysfield fire¹³¹ (see Appendix A) showing the amount of smoke issuing from the full-scale flaming test 7 minutes after ignition

It was noted in the report that it was difficult to fully understand the mechanism by which increasing amounts of smoke were being produced by the fire. However, a note was made that the increase in smoke concentrations was possibly occurring when PVC covers on the judo mats became involved. It was also pointed out that PVC is normally difficult to ignite with a small flame, but happens when the severity of the fire is sufficient to force its involvement.

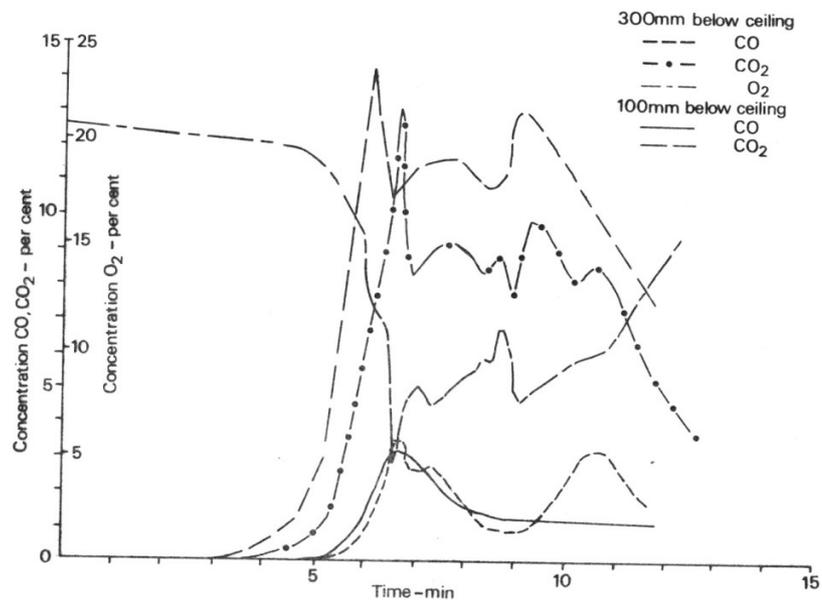
Figure 24 – Figure 8 from the FRS report into the Maysfield fire¹³¹ (see Appendix A), showing the gas analysis data collected from the sampling points in the reconstruction.

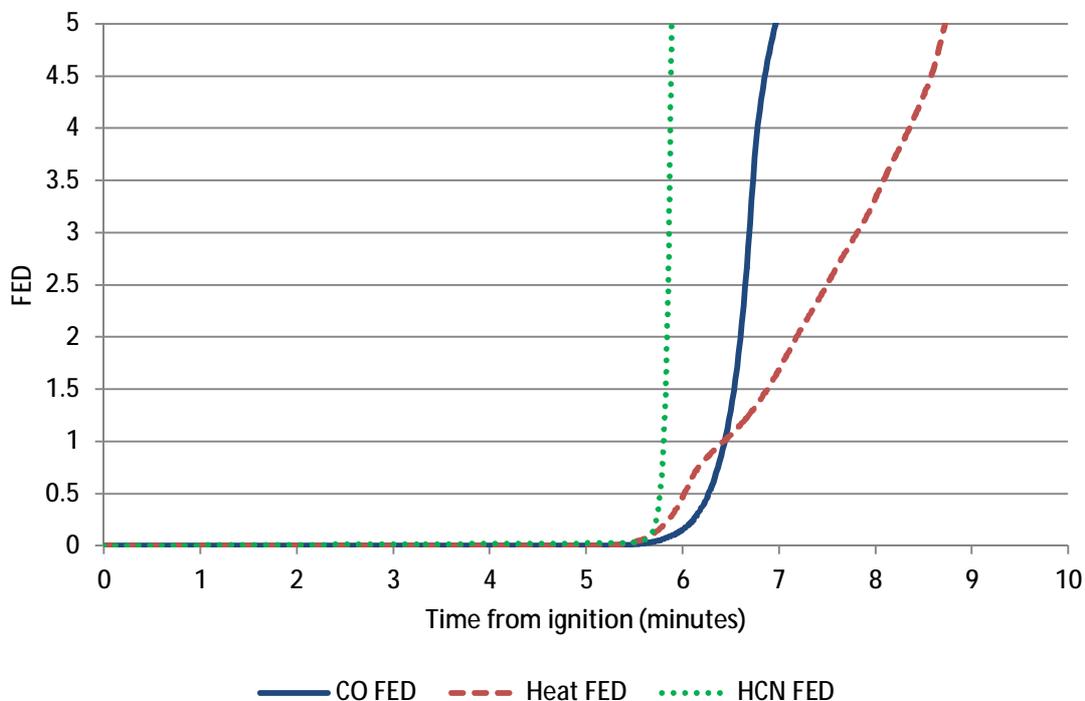
Figure 26 – FED values calculated using ISO 13571 method based upon Maysfield reconstruction data

The manner in which this fire developed means that there was a short time frame between FED values beginning to increase at any significant rate and those values exceeding 1 and 2; less than a minute. However, even within this timeframe it can be seen that the dominant contributor to the overall toxicity is HCN. This is perhaps unsurprising given that the primary fuel sources in this fire were polyurethane foam and rubber crumb. This finding correlates with the relatively high concentrations found in the blood samples from the victims of the fire, even more so when considered in conjunction with the delay in testing blood samples.

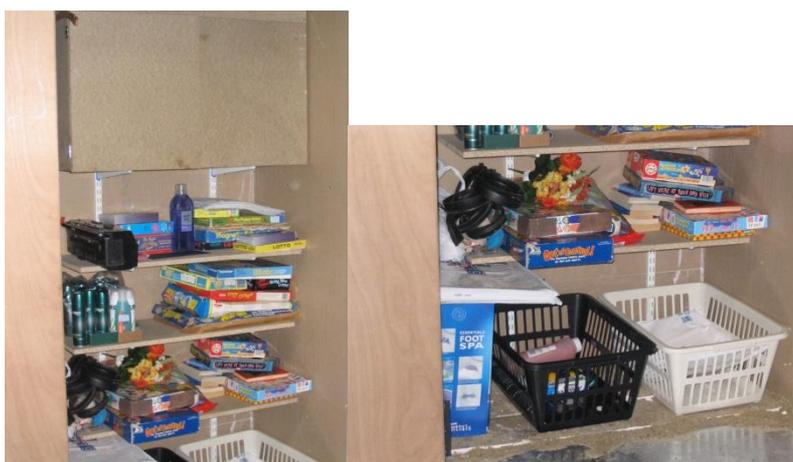
Figure 27 – Contents of cupboard used for Rosepark reconstruction fires, understood to represent actual contents of cupboard at time of fire. The distribution board (ignition source for the fire) is located in the brown box in the top of the left hand image

The most likely cause of the fire was determined by the Fatal Accident Inquiry as being an earth fault in the electrical distribution board in the cupboard. Specifically, mechanical action between the sharp edge of the earth knockout and the insulation around a live conductor allowed arcing to occur between the conductor and the knockout, heating and igniting first the insulation materials in the distribution board and then the contents of the cupboard.

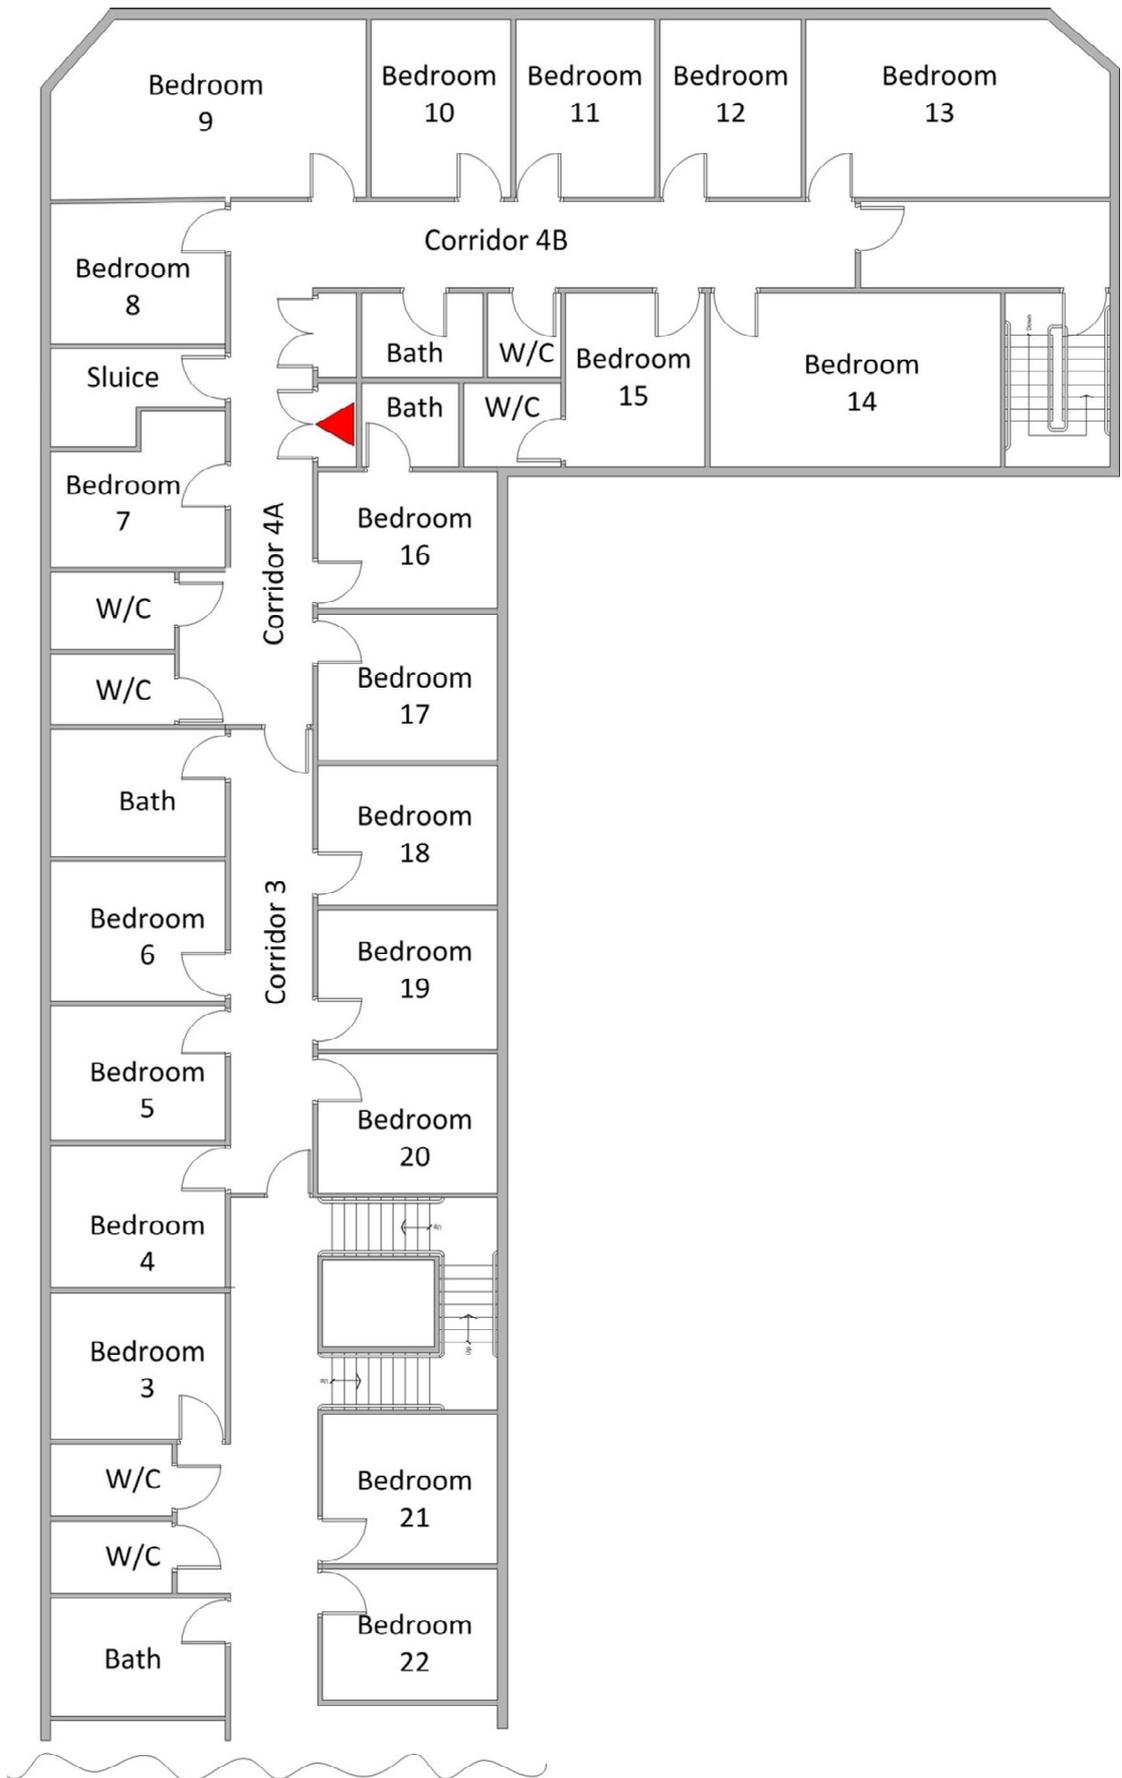
The layout of the portion of Rosepark Care Home affected by the fire is shown in Figure 28 and a summary of the details of the casualties from the fire is given at Table 13. All of the casualties that died at the scene were located in rooms off of corridor 4 (the corridor in which the storage cupboard where the fire started was situated) and had their doors open (i.e. there were no closed doors separating them from the fire origin). All of the casualties who died some time after being removed from the scene were in rooms that were separated from the fire by one closed door.

Figure 28 – Plan of Rosepark Care Home. Red triangle denotes cupboard where fire started

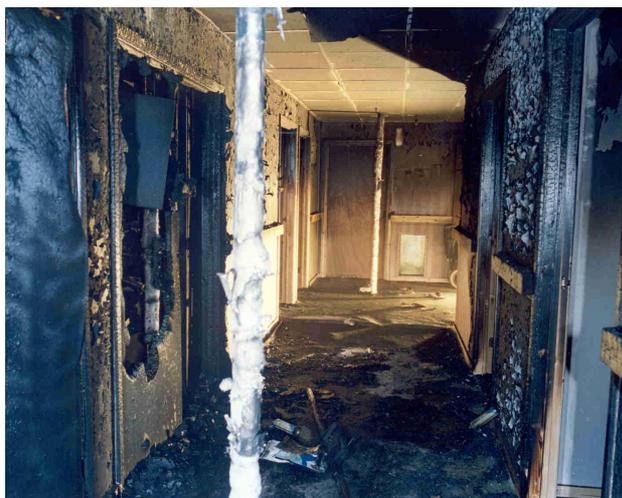
Figure 30 – View of corridor in Rosepark reconstruction rig corresponding with Figure 29, but after the fire

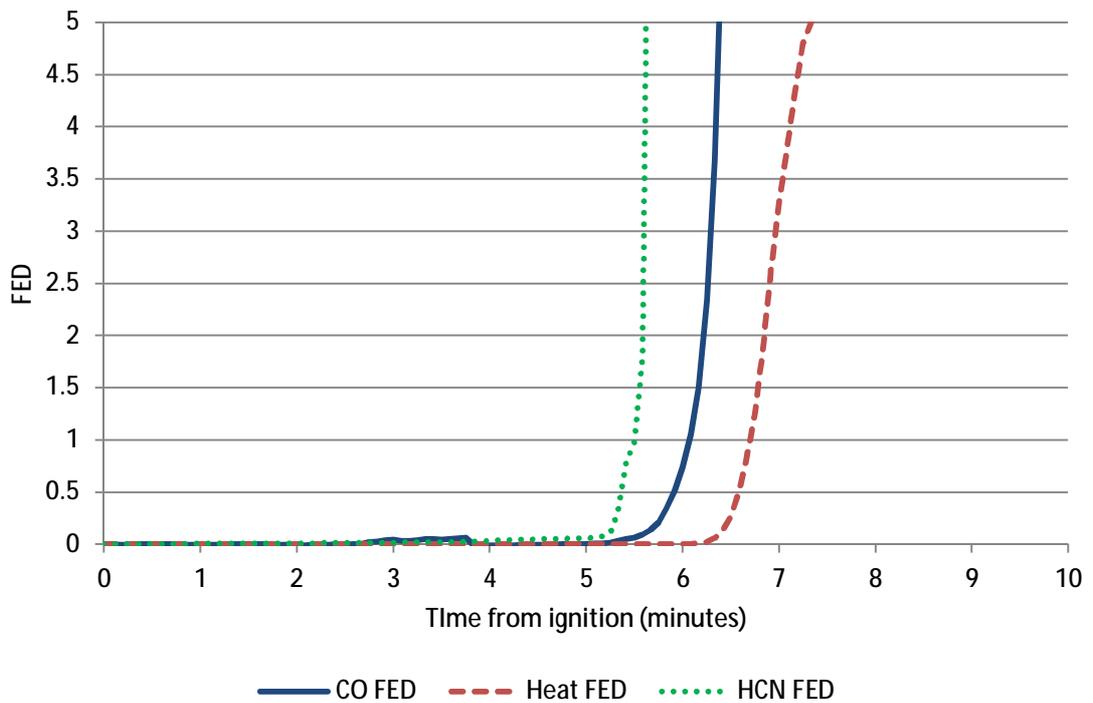
Figure 36 – FED values calculated using ISO 13571 method based upon Rosepark corridor 4B reconstruction data

From the Rosepark data it can be seen that heat only presented a significant hazard in corridor 4B; the corridor in which the fire cupboard was situated. In terms of the hazard from asphyxiant gases, hydrogen cyanide appears to be the dominant contributor to overall toxicity. It is interesting to note that carbon monoxide has a significant impact in both the corridor 4B and open room condition, but that its significance diminishes significantly in corridor 3, whilst the impact of hydrogen cyanide appears to remain significant. No equivalent comparison could be made for the closed room condition as hydrogen cyanide sampling was not carried out here.

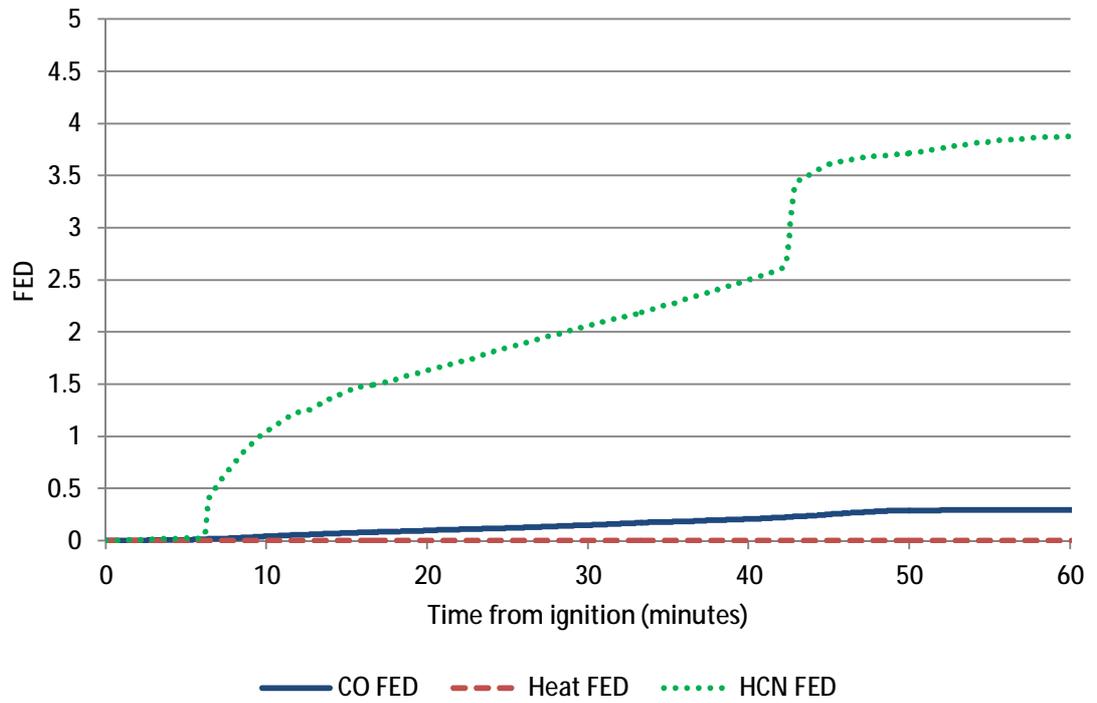
Figure 37 – FED values calculated using ISO 13571 method based upon Rosepark corridor 3 reconstruction data

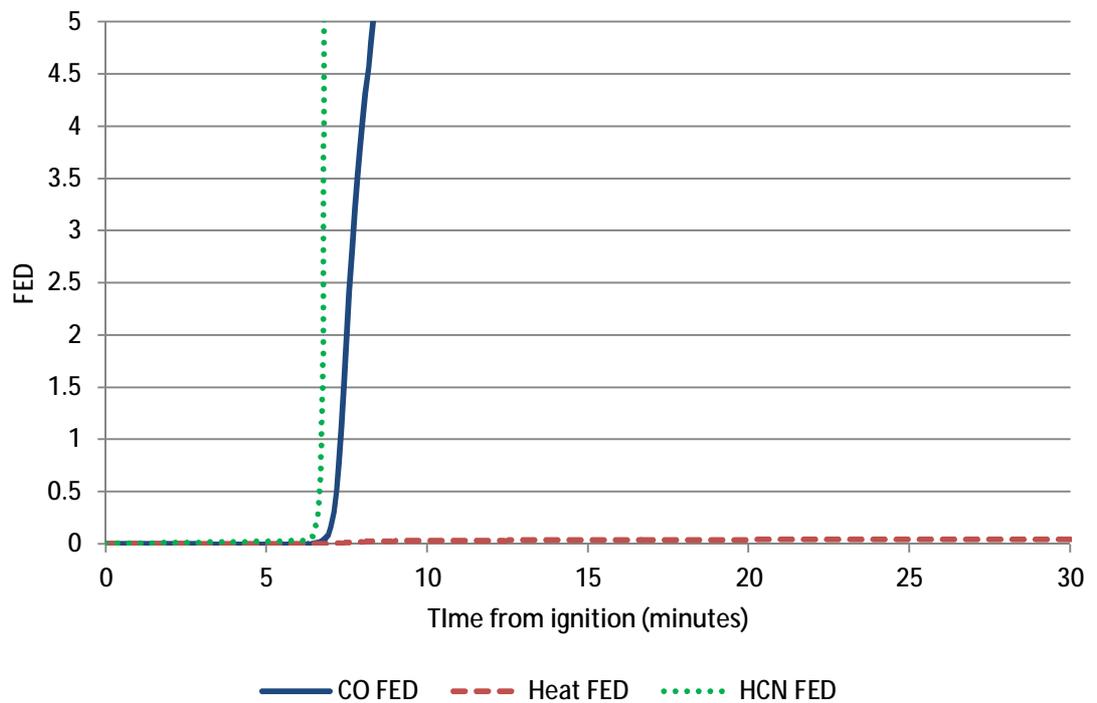
Figure 38 – FED values calculated using ISO 13571 method based upon Rosepark open room reconstruction data

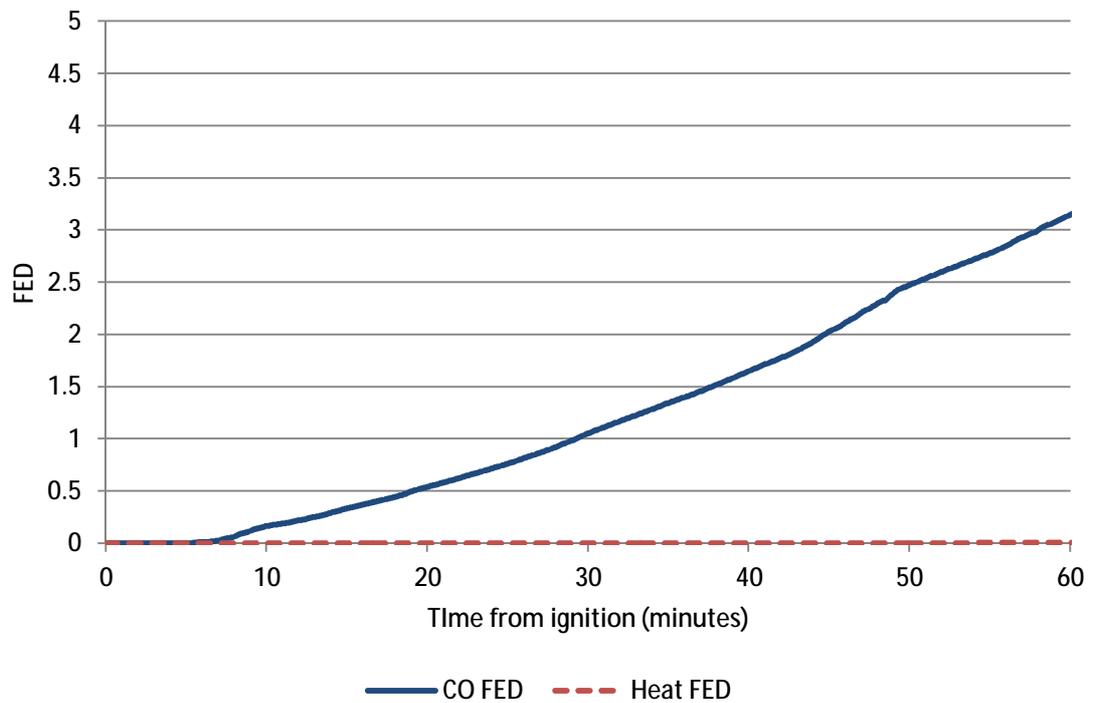
Figure 39 – FED values calculated using ISO 13571 method based upon Rosepark closed room reconstruction data

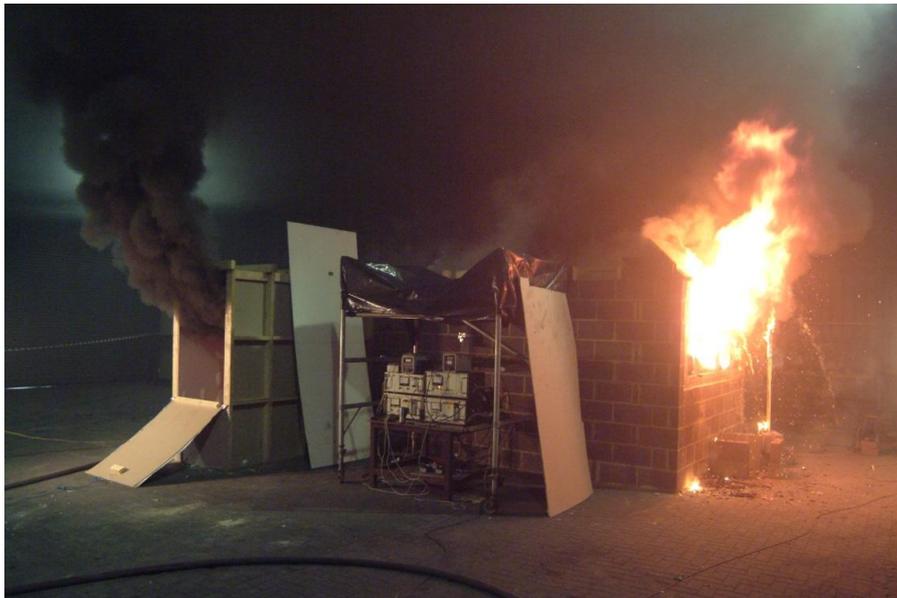
Figure 41 – View of outside of reconstruction rig during fire, showing venting out of window and into corridor¹³⁸ (see Appendix A)

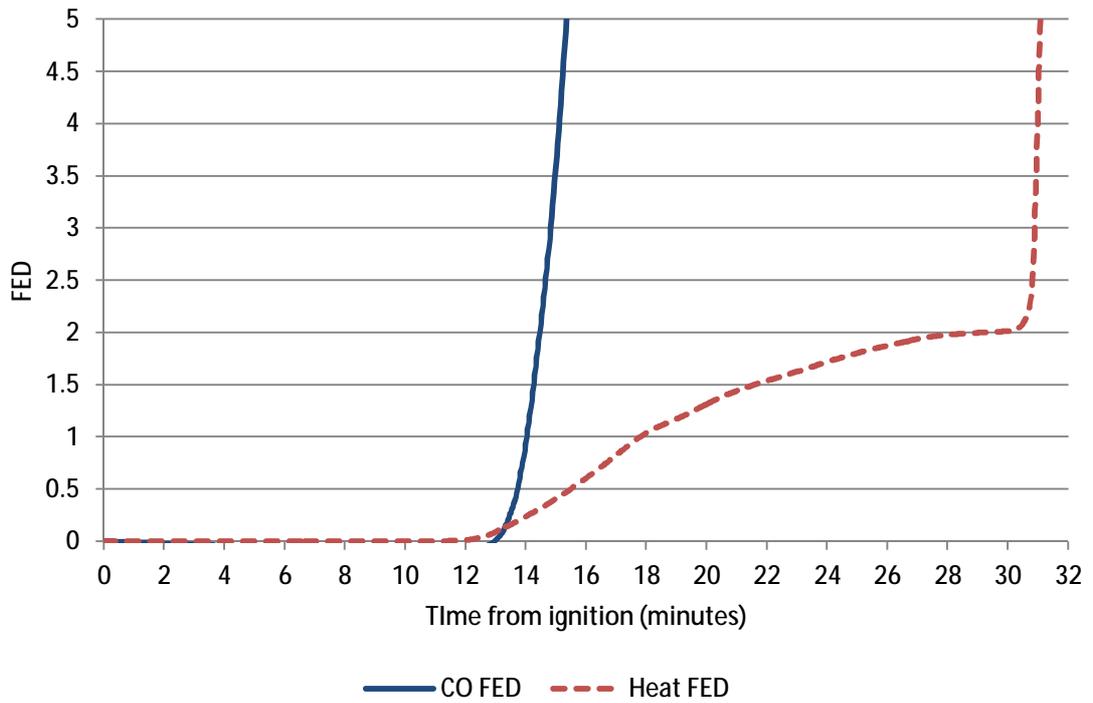
Figure 46 – FED values calculated using ISO 13571 method based upon Harrow Court reconstruction data standing up measurements

The hazard analysis for this incident shows clearly the two key points during the course of the incident; the point at which conditions become untenable for the occupants of the flat due to the fire gases, and the point at which conditions become untenable for the fire fighters due to the sudden increase in temperature. Given the nature of this fire, in particular the mixture of fuel materials for the fire afforded by the domestic setting (wood, foams, moulded and extruded plastics, fabrics, etc.), it would be extremely difficult to assign the properties of any one of these items to the way in which conditions developed. Indeed, it is far more likely that the prevailing wind movements and the overall fire development within the compartment were responsible, therefore thermal insulation by the structure and global equivalence ratio governed by the availability of air through openings into the compartment were probably the deciding features here.

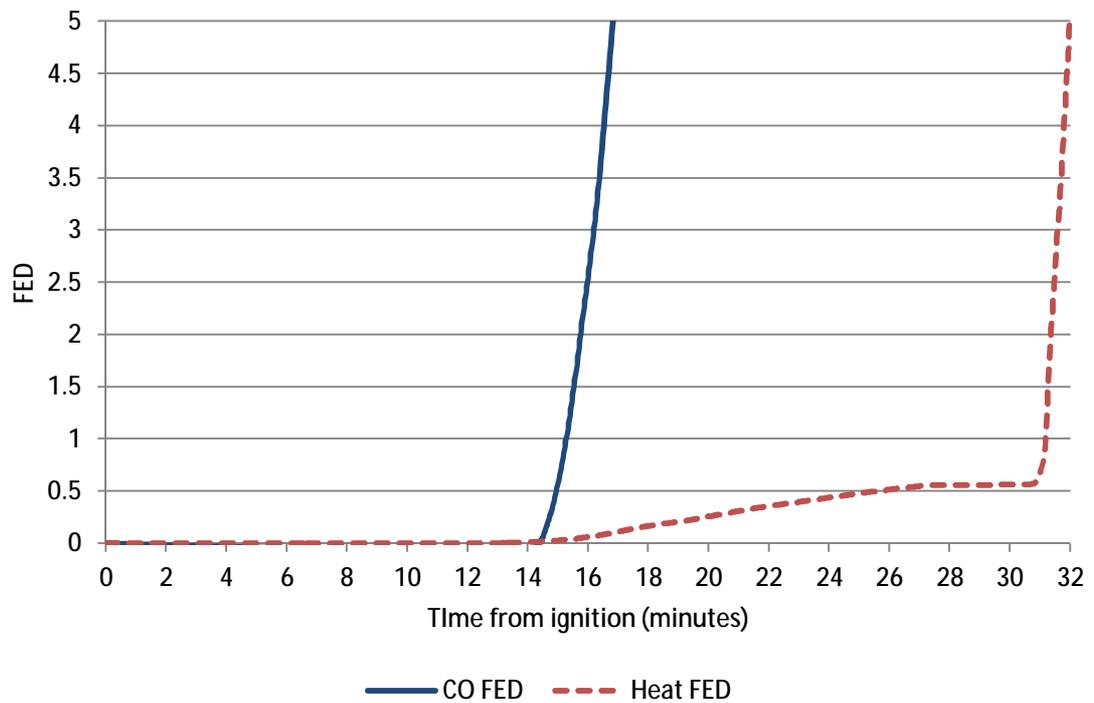
Figure 48 – FED values calculated using ISO 13571 method based upon Harrow Court reconstruction data lying down measurements

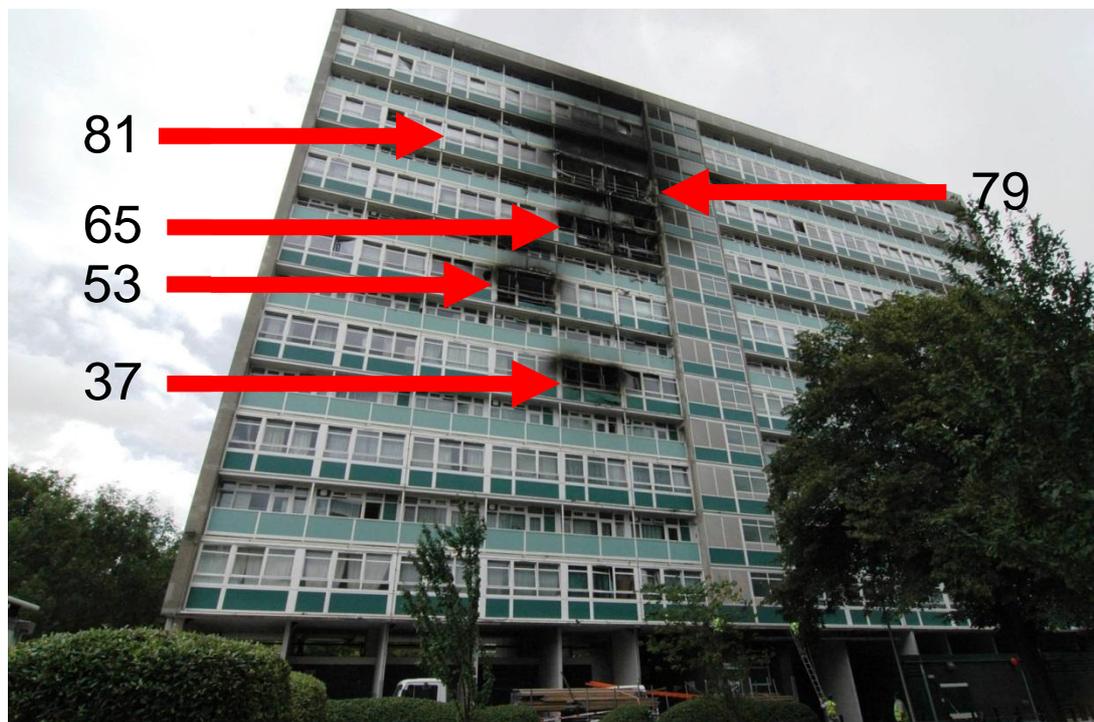
Figure 50 – West face of Lakanal, showing locations of flats involved in the fire¹⁴⁰

The fire started in Flat 65 on the 9th and 10th floors. The fire spread and involved Flat 79 directly above, on the 11th and 12th floors, and subsequently the communal corridor on the 11th floor. Fire also spread to Flat 37 on the 5th floor and Flat 53 on the 7th floor. Six lives were lost during the fire; of these one was in the upper floor of Flat 79 and five were in the bathroom of Flat 81; the flat adjacent to Flat 79. The positions of these flats and overview of the extent of the fire spread in Lakanal can be seen in Figure 50.

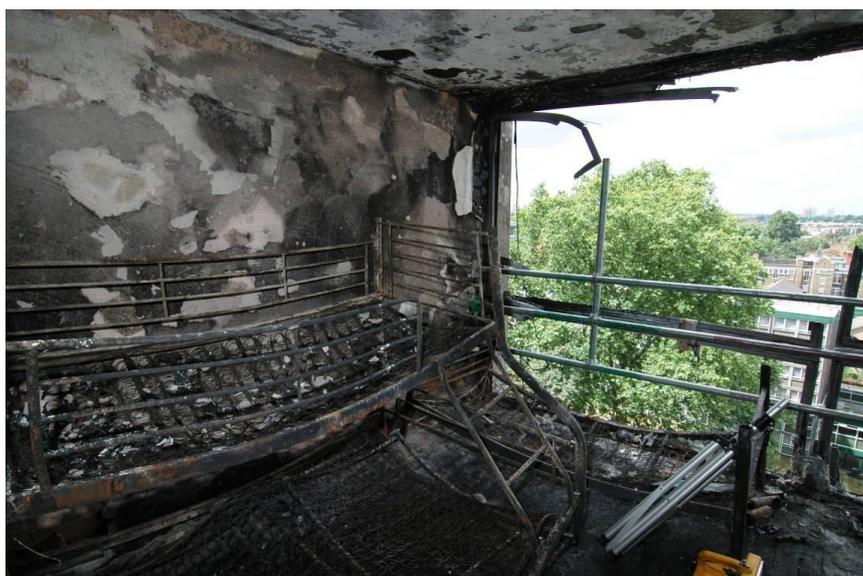
Figure 51 – Bedroom 1 of Flat 65, showing bunk bed and single bed ¹⁴⁰

Bedroom 1 appears to have contained a high fuel load. In addition to the television, there was a large bunk bed (double width lower level, single upper level) and a single bed, plus lightweight canvas furniture filled with clothing, Figure 51.

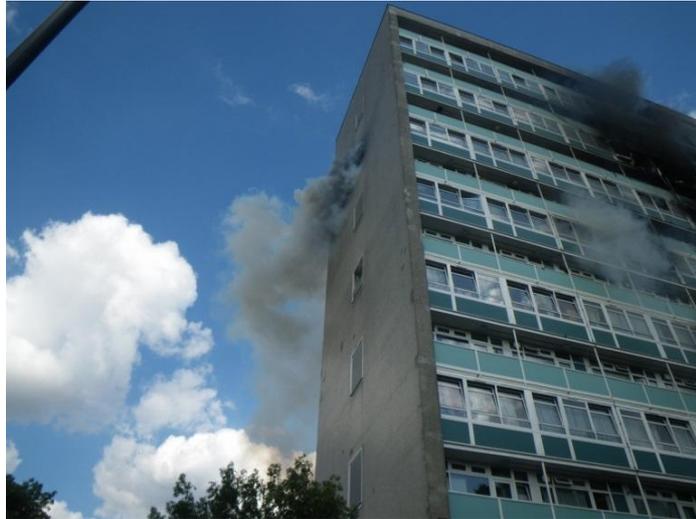
Figure 52 – Smoke emitting from the end of the 11th floor corridor at 17:22:15 during the incident¹⁴⁰

Following the failure of the front door to Flat 79, fire spread into the north corridor and is believed to have involved both the suspended ceiling and the vinyl floor tiles. Fire appears to have then been pulled/pushed through the length of the corridor on the 11th floor by the prevailing wind passing through fixed vents, and appears to have caused flaming throughout the full height of corridor, evidenced by charring to flat doors (discussed later). The fire is known to have fully involved the corridor by 17:22:15, as seen on Figure 52.

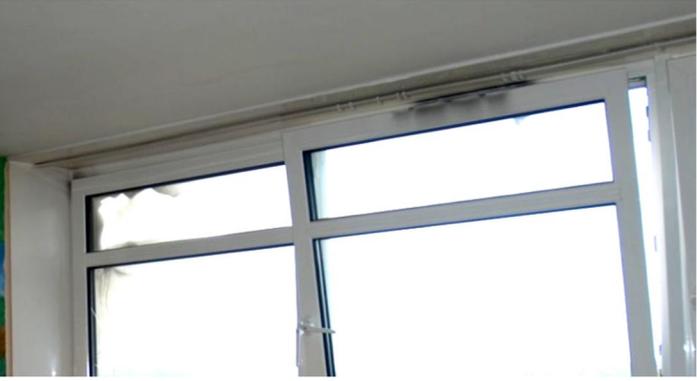
<p>DSC_0102 taken by Whitmore (LFB photographer, see Appendix C)¹⁴⁰</p>
Bedroom 2	<p>No smoke staining or smoke deposits on surfaces</p>

Room/space	Evidence of fire	Reference
Bedroom 1	<p>Window cracked in corner</p> <p>Slight smoke staining near trickle vent</p>

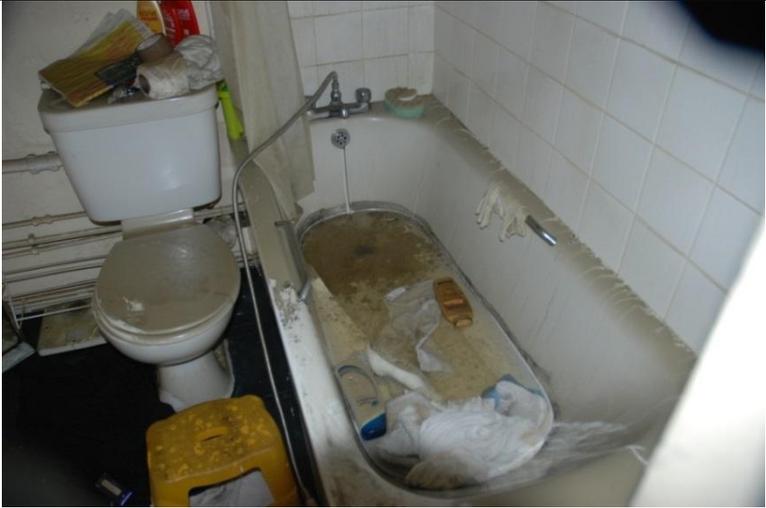
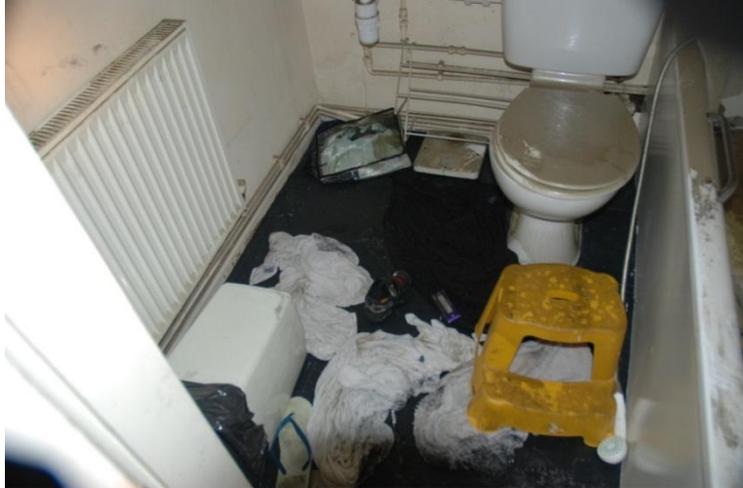
<p>Bathroom</p>	<p>Precipitated smoke on horizontal surfaces</p> <p>Smoke stains on ceiling around cupboard and door frame</p> <p>Smoke in ventilation duct</p>

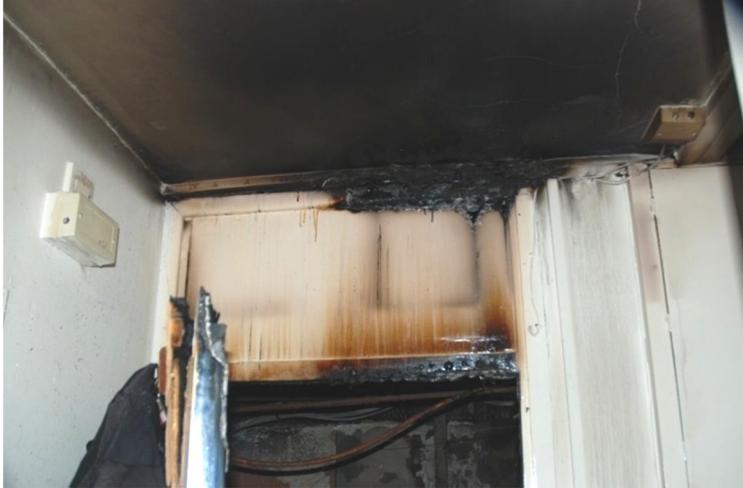
<p>DSC_0104 taken by Whitmore (LFB photographer, see Appendix C)¹⁴⁰</p>

<p>DSC_0040 taken by Whitmore (LFB photographer, see Appendix C)¹⁴⁰</p>
<p>Hall</p>	<p>Fire damage to top edge of front door, top of door panel</p>

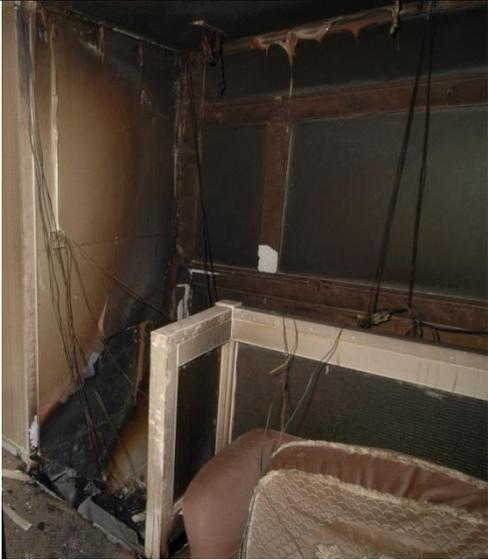
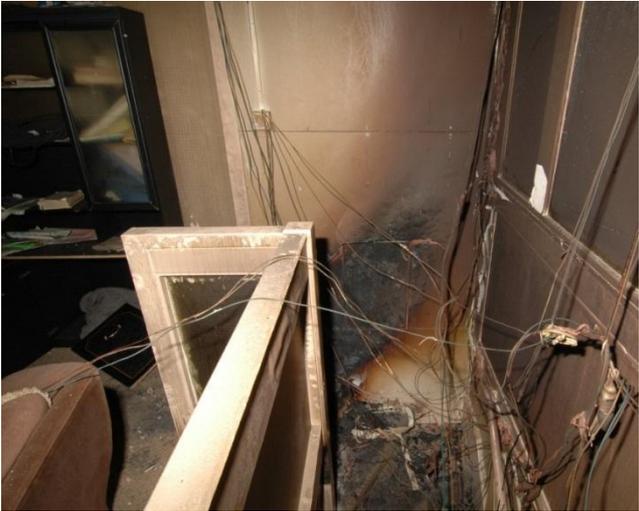
<p>Stairs</p>	<p>Burnt through at after turn, heat damage in stair well, glass panel to kitchen cracked</p>

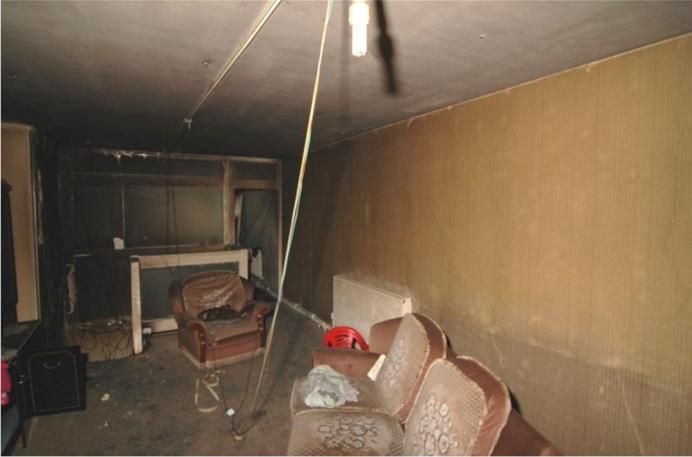
<p>DSC_6830 taken by D Crowder¹⁴⁰</p>

<p>DSC_6829 taken by D Crowder¹⁴⁰</p>
<p>Living area</p>	<p>Smoke staining at ceiling and walls precipitated soot on horizontal surfaces. Tarry deposits on glass surfaces</p>
