**Hazards presented by pyrolysis and combustion
products during laboratory experiments and real
incidents**

A thesis submitted in partial fulfilment for the requirements for the degree of
Doctor of Philosophy at the University of Central Lancashire in collaboration
with the Building Research Establishment

January 2015

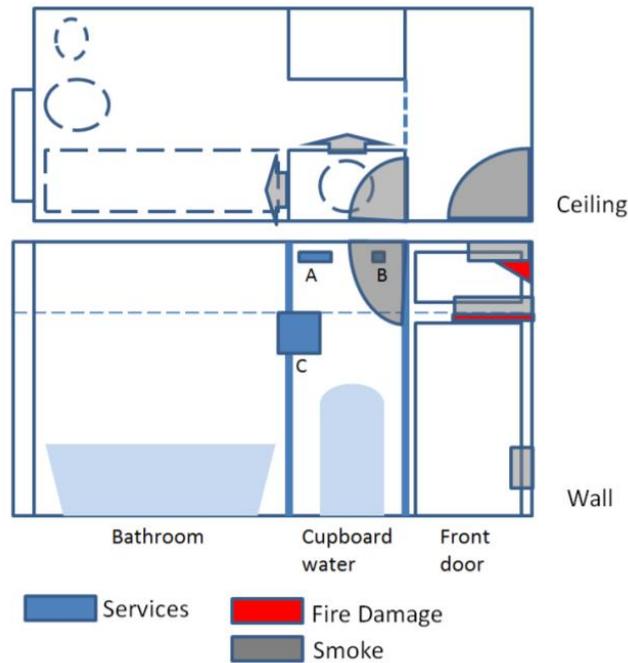
All the flats have a number of service openings between the corridor and the flat in the area between the front door and the bathroom. This space originally contained part of a hot air heating system. In Flat 81 this had been replaced by a hot water tank with immersion heater. At ceiling level, there are a number of openings where services (current and disconnected) pass through into the void above the corridor. Figure 53 shows a schematic view of the wall between the flat and the corridor as seen from inside the flat and the bathroom/hall ceiling, including areas of smoke staining and fire damage.

Figure 53 – Flat 81 Bathroom and hall services and smoke staining¹⁴⁰

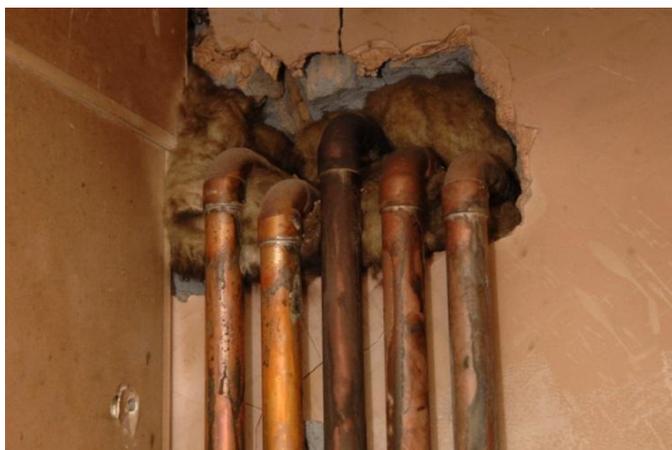
There are three areas shown on Figure 53 where services pass through the wall between the flat and the corridor. At location “A” five copper pipes pass through the wall (see Figure 54). The space around the pipes was packed with mineral wool on the flat side and showed no signs of smoke penetration.

Figure 54 – Copper pipes passing through wall at location A (MPS Photo VF10027, see Appendix B)¹⁴⁰

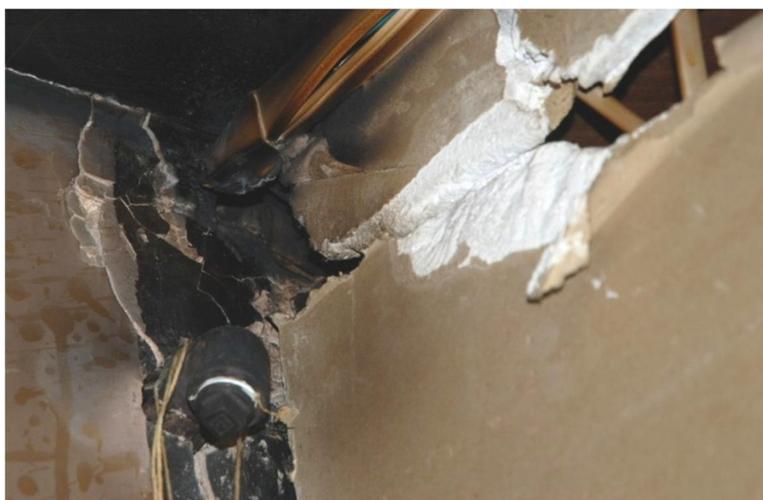
At location “B” two unused pipes passed through the wall, these are for a disused system and terminate close to the wall inside the water tank cupboard. The inner plasterboard sheet of the wall between the cupboard and hall is broken in the top corner near location “B” and shows some of the heaviest smoke staining in the bathroom area (see Figure 55).

Figure 55 – Disused pipes passing through wall at location B (DSC_0010 (cropped) taken by Whitmore LFB photographer, see Appendix C)¹⁴⁰

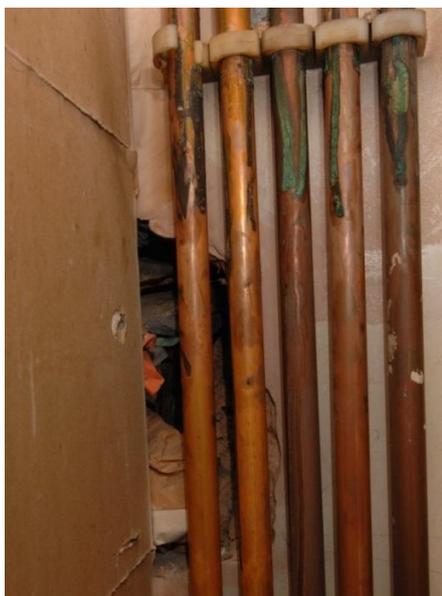
At location “C” there was an opening about 150mm square that had been used for part of an old heating system. On the flat side this was filled with paper (see Figure 56) and partly covered by the bathroom tiles, in the corridor the gap had been plastered over and excavation showed the space was filled with a honeycomb material (see Figure 57). There were no traces of smoke having entered the bathroom at this location.

Figure 56 – Flat side of filled disused ventilation opening at location C (MPS Photo VF10030, see Appendix B)¹⁴⁰

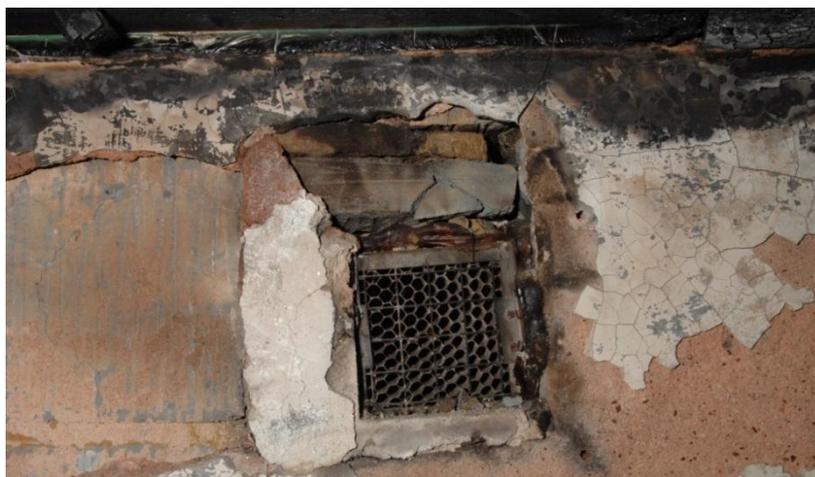
Figure 57 – Corridor side of filled disused ventilation opening at location C (MPS Photo VF10016, see Appendix B)¹⁴⁰

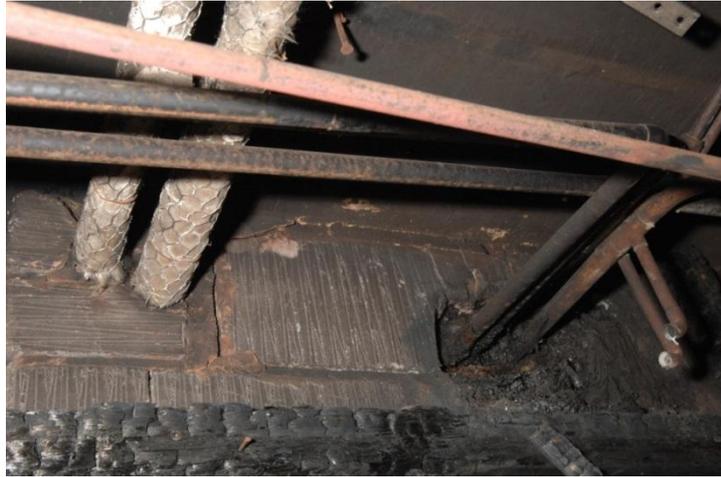
The pipes at locations “A” and “B” can be seen from the corridor in Figure 58. At “A” the gaps seem to have been stopped with a plastic material that has melted and/or burnt (see Figure 59). The pipes at B had been lagged with mineral wool held securely in place by chicken wire.

Figure 58 – Corridor side of pipe penetration points at locations A and B (MPS Photo VF10018, see Appendix B)¹⁴⁰

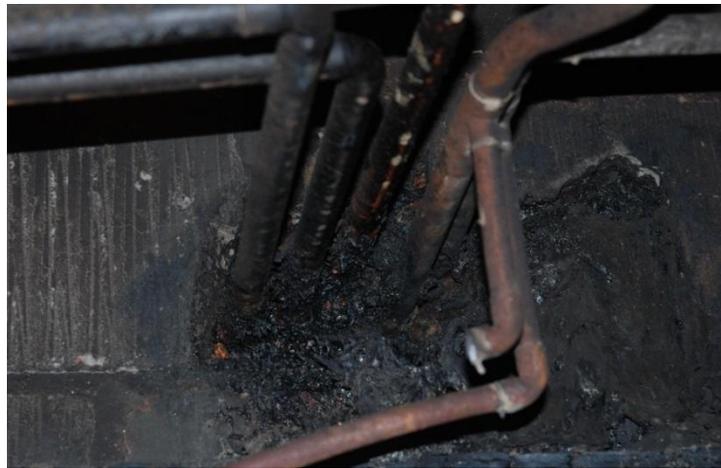
Figure 59 – Close-up of corridor side of pipe penetration point at location A (DSC_0114 (cropped) taken by Whitmore LFB photographer, see Appendix C)¹⁴⁰

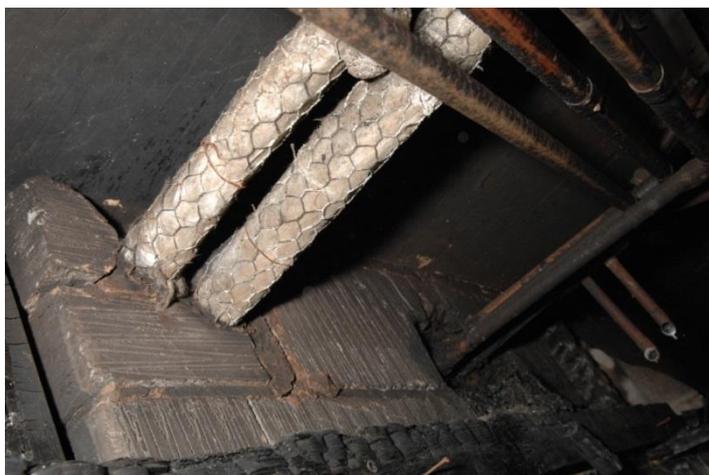
Figure 60 shows a gap between the doorframe and the blockwork wall in the corridor near location “B”. This would provide a path for smoke into the cavity of the stud wall between the bathroom cupboard and the hall and thereby into the bathroom. This appears to be the principal route for smoke entering the bathroom after the bathroom ventilation grille had been sealed.

Figure 60 – Close-up of corridor side of pipe penetration point at location B showing gaps in brickwork above pipe (MPS Photo VF10020, see Appendix B)¹⁴⁰

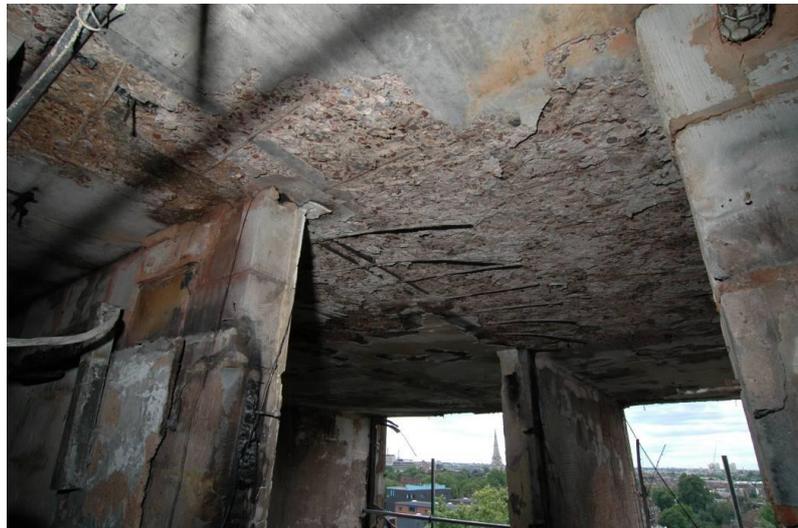
Figure 64 – Ceiling of Flat 79, lower (11th) floor. Note exposure of steel reinforcing bars due to extensive spalling of concrete¹⁴⁰

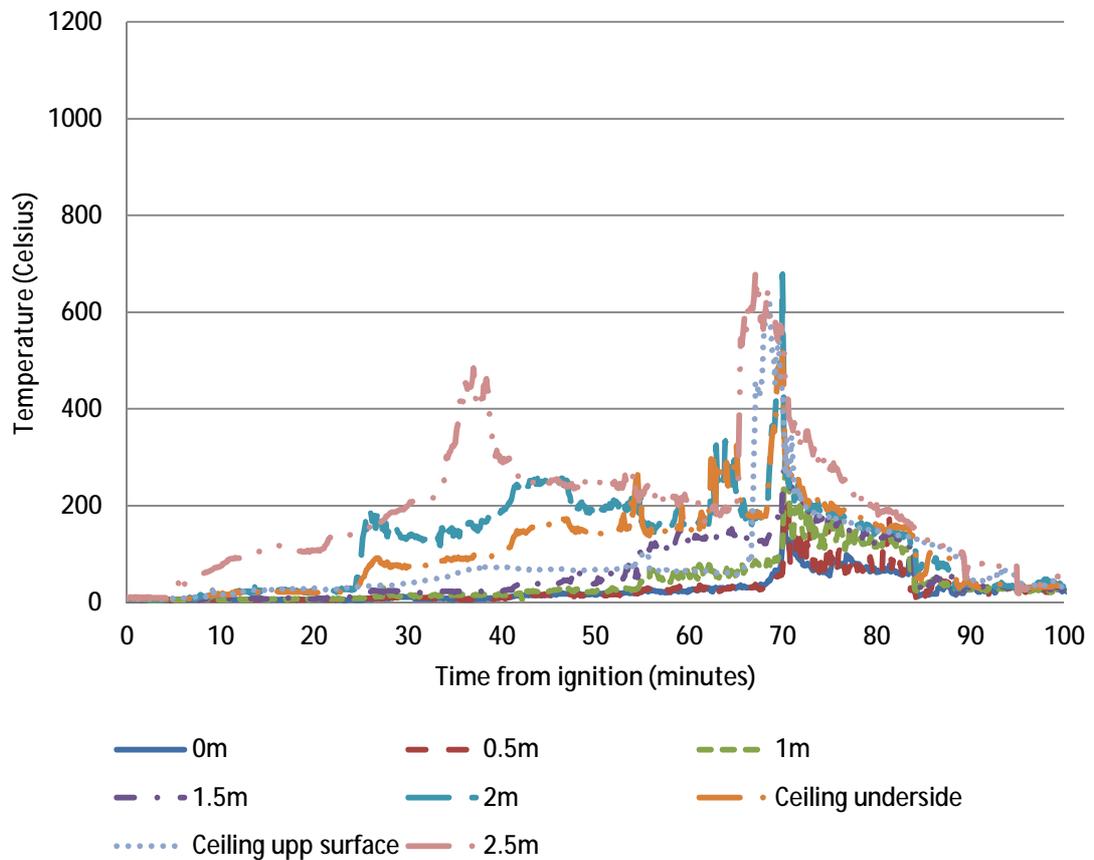
Figure 80 – Temperature data at thermocouple tree F¹⁴⁰

Thermocouple tree F in the corridor (Figure 80) near the escape door measured temperature increases at high level within the corridor and suspended ceiling void that correspond well with

the fire events that occurred on door E and the ceramic box beneath the stairs. In particular, temperatures in the ceiling void approached 700°C around the time when well-developed flaming is seen in the vicinity of the ceramic fibreboard box.

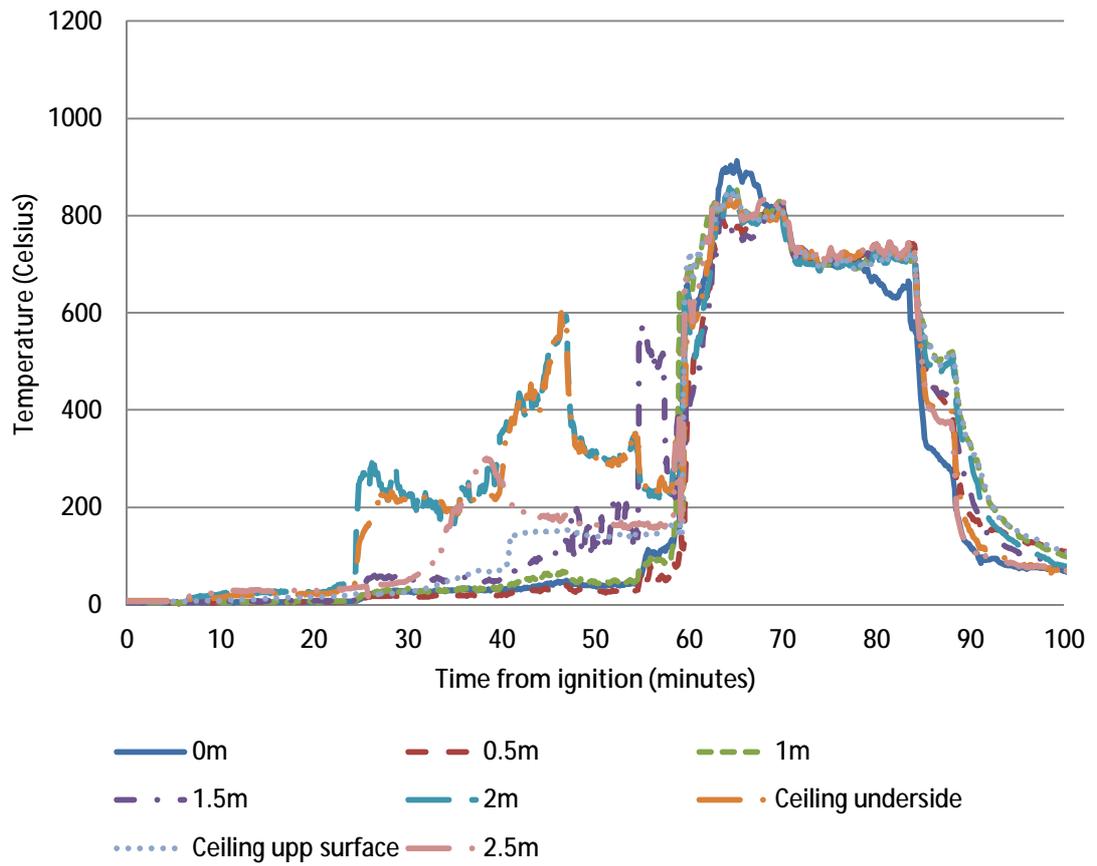
Figure 81 – Temperature data at thermocouple tree G¹⁴⁰

Thermocouple tree G, outside the front door (Figure 81), shows how fire penetration through the front door and panel affected the temperatures in this area. Temperature increased at high level within the corridor occurred shortly after the door began burning on its outer (corridor) side, going through an initial gradual increase and decay, followed by a sudden increase to 800-900°C when the door and frame collapsed into the corridor. The temperature measurements in the ceiling void follow a similar trend, although the initial temperature rise corresponds to the flaming that is seen in the void around 38 minutes into the reconstruction.

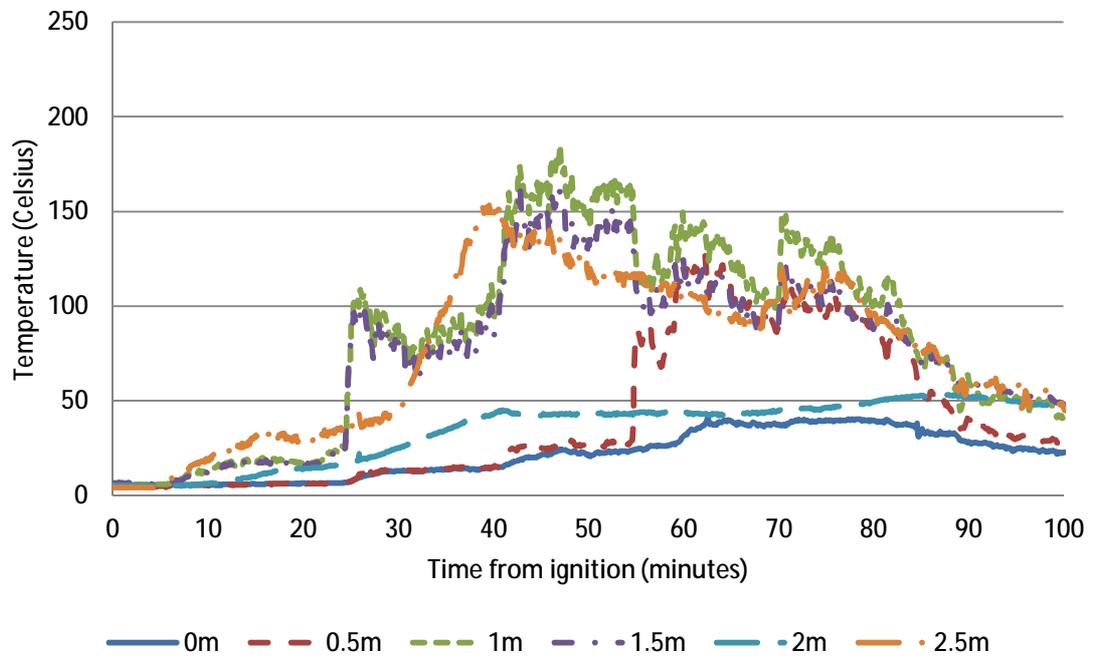
Figure 82 – Temperature data at thermocouple tree H¹⁴⁰

Temperatures measured at thermocouple tree H near the corridor extract (Figure 82) remained relatively low throughout the test, although there are minor peaks associated with the fire involvement and collapse of doors mentioned earlier.

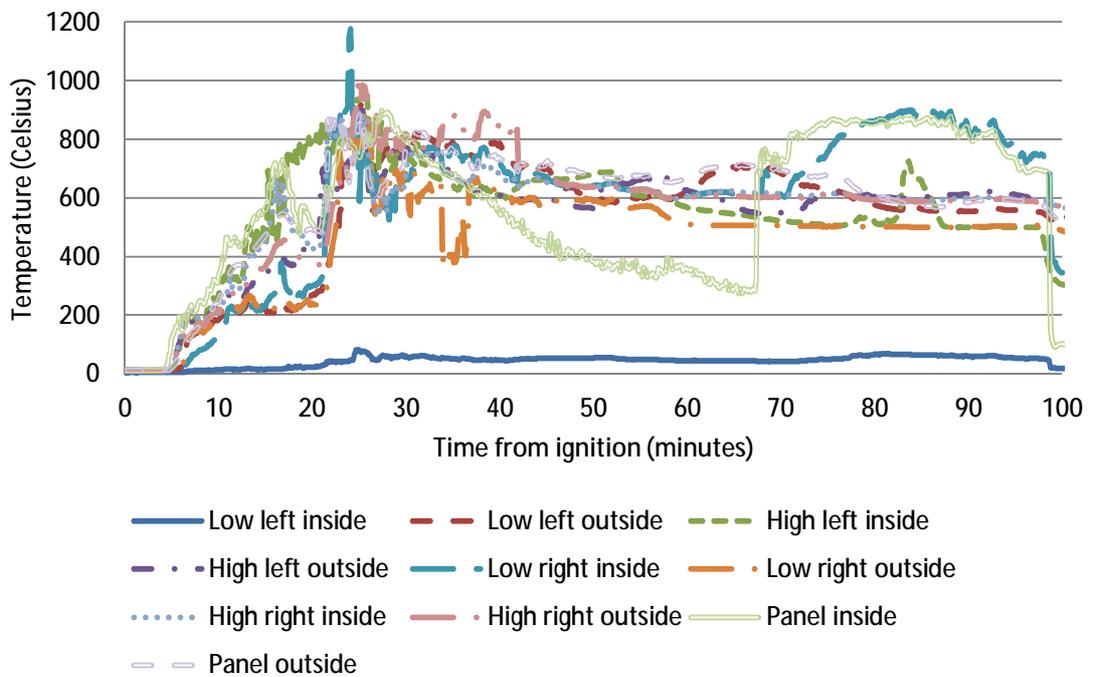
Figure 92 – Temperature data at thermocouple positions on door A ¹⁴⁰

The temperature data obtained from door A are very similar to (but noisier than) the temperature data obtained from thermocouple tree D in Figure 78. This is likely due to the two being near to one another, but the thermocouples on door A were in close proximity to a number of fuel beds (door A itself and the bookcase) meaning that these are exposed to direct flame impingement at various points throughout the test. It is worth adding that at some point, door A was fully consumed by the fire so will have collapsed, leaving the thermocouples to fall to the floor.

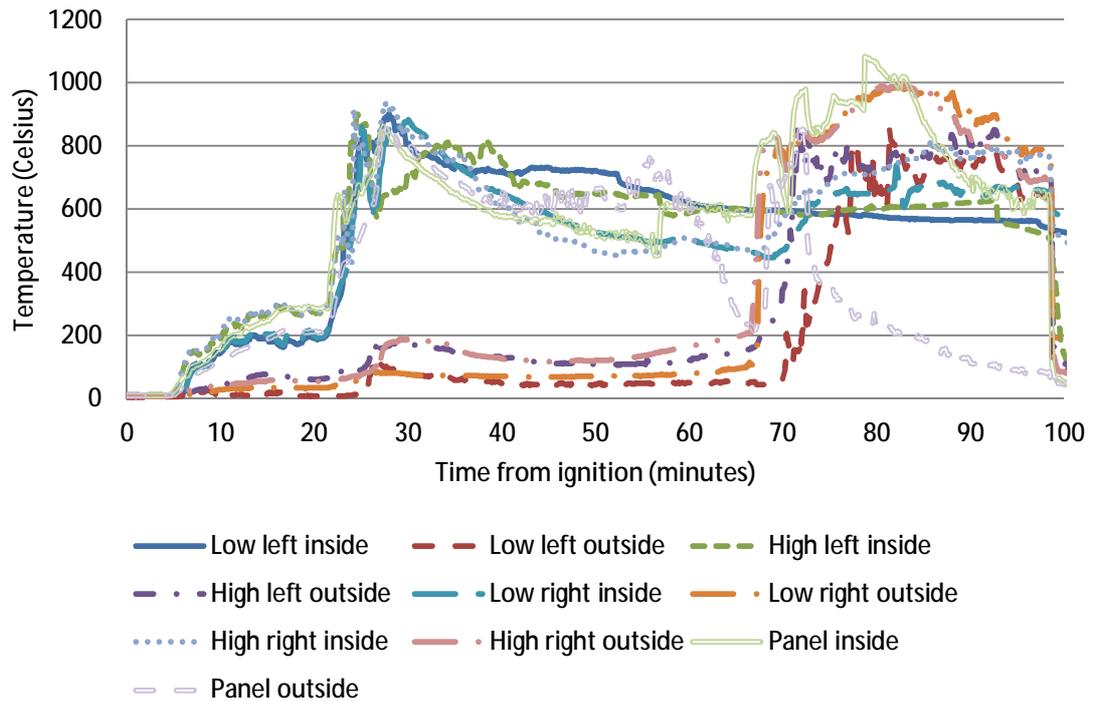
Figure 93 – Temperature data at thermocouple positions on door B¹⁴⁰

According to the interior surface thermocouples, doors B and C experience a gradual temperature increase to around 300°C during the first 20 minutes of the reconstruction. At this time the stairs become involved and they become exposed to fire temperatures in excess of 800°C around five minutes after this. Door B, the chipboard door, appears to retain its integrity for approximately 45 minutes following the increase in temperature, at which time the external thermocouples measure temperature increases from less than 250°C to more than 750°C. Door C, the hollow core door, fails during the five minutes after becoming exposed to the fire associated with the involvement of the staircase.

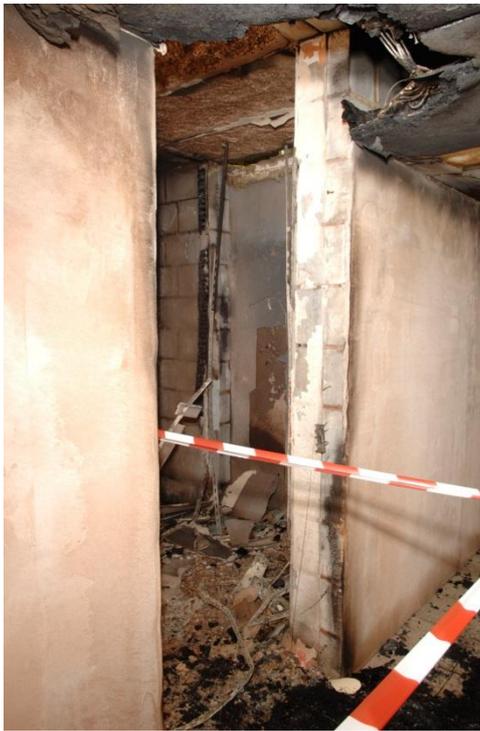
Figure 95 – Space formerly occupied by door D; the flat front door, following the reconstruction fire. Note severe damage to suspended ceiling panels, but no self-sustaining ignition of panels¹⁴⁰

Door D, the timber block front door, was exposed to a very similar temperature regime to doors B and C, although the internal surface of the panel above the door reaches over 550°C during this time, probably due to the surface being combustible (unlike the glazed panels above doors A, B and C) as well as being high up in the hot gas layer caused by the fire. This door became involved on both surfaces within five minutes of the staircase becoming involved. From the video footage it can be seen that this is a result of fire penetrating through both the letter box in the door and the gaps between the door and frame, then spreading across the painted surface of the door. The door burned in situ for approximately 30 minutes, during which time the fire it was producing attacked the suspended ceiling of the corridor, before collapsing with its frame into the corridor itself (a total of approximately 55 minutes since ignition). The damage caused to the corridor suspended ceiling outside this door can be seen in Figure 95.

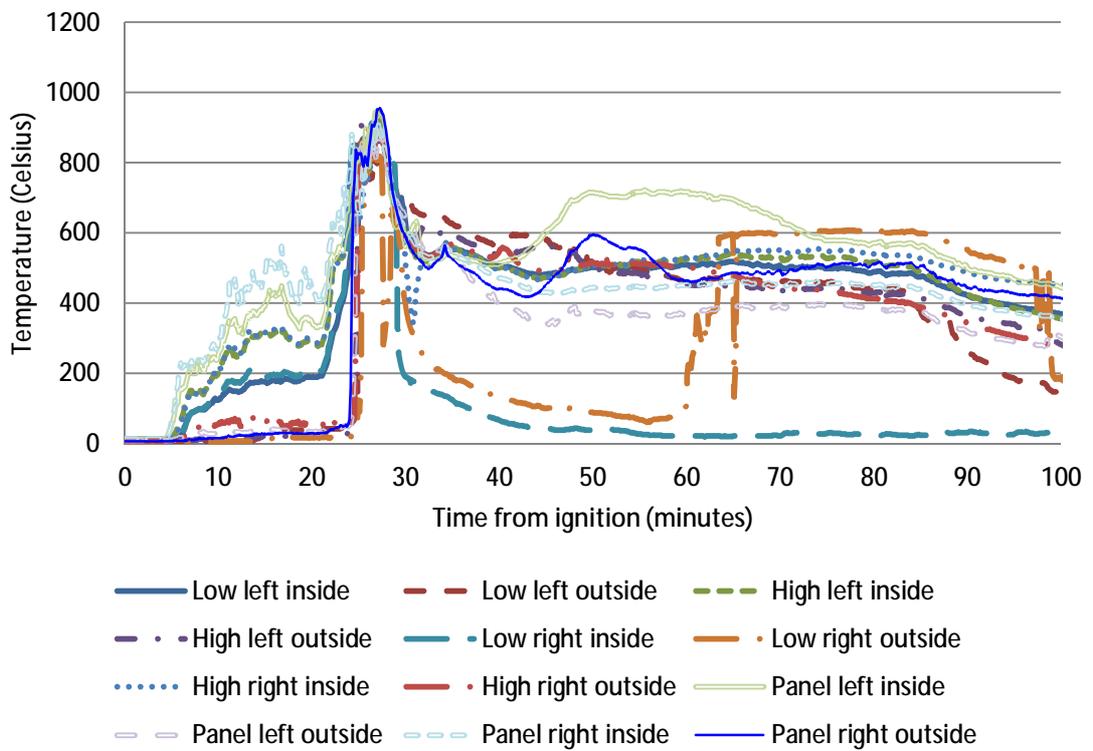
Figure 96 – Temperature data at thermocouple positions on door D¹⁴⁰

The panel above the front door appeared to fail (indicated by sudden increase in outside surface temperatures) approximately 20 minutes after inside surface temperatures exceed 200°C, and approximately four minutes after the involvement of the staircase.

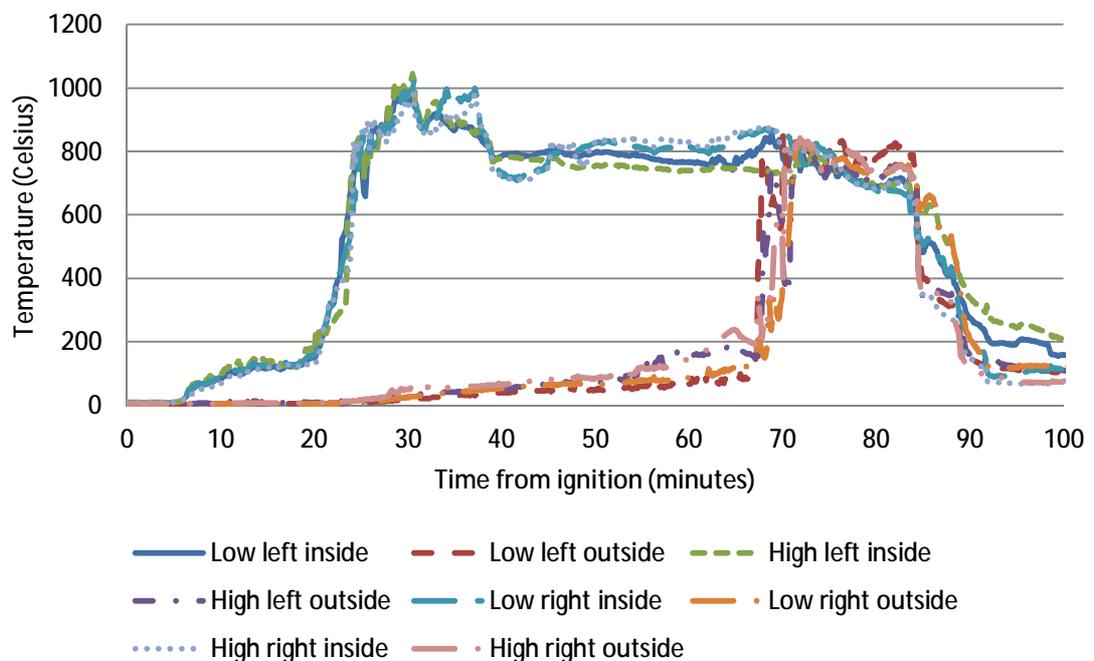
Figure 97 – Temperature data at thermocouple positions on door E¹⁴⁰

The temperatures recorded for door E indicate that it was somewhat shielded from the heat of the fire, temperatures only attaining 150°C until the staircase became fully involved. Flaming was seen at the gap between the door and frame 5-10 minutes after the involvement of the stairs, which continues to burn and propagate until it spreads to involve the entire outer (corridor) surface of the door around 67-68 minutes into the reconstruction (46-47 minutes after the involvement of the stairs). The door collapses (without frame) into the corridor approximately 2 minutes later (a total of approximately 70 minutes since ignition).

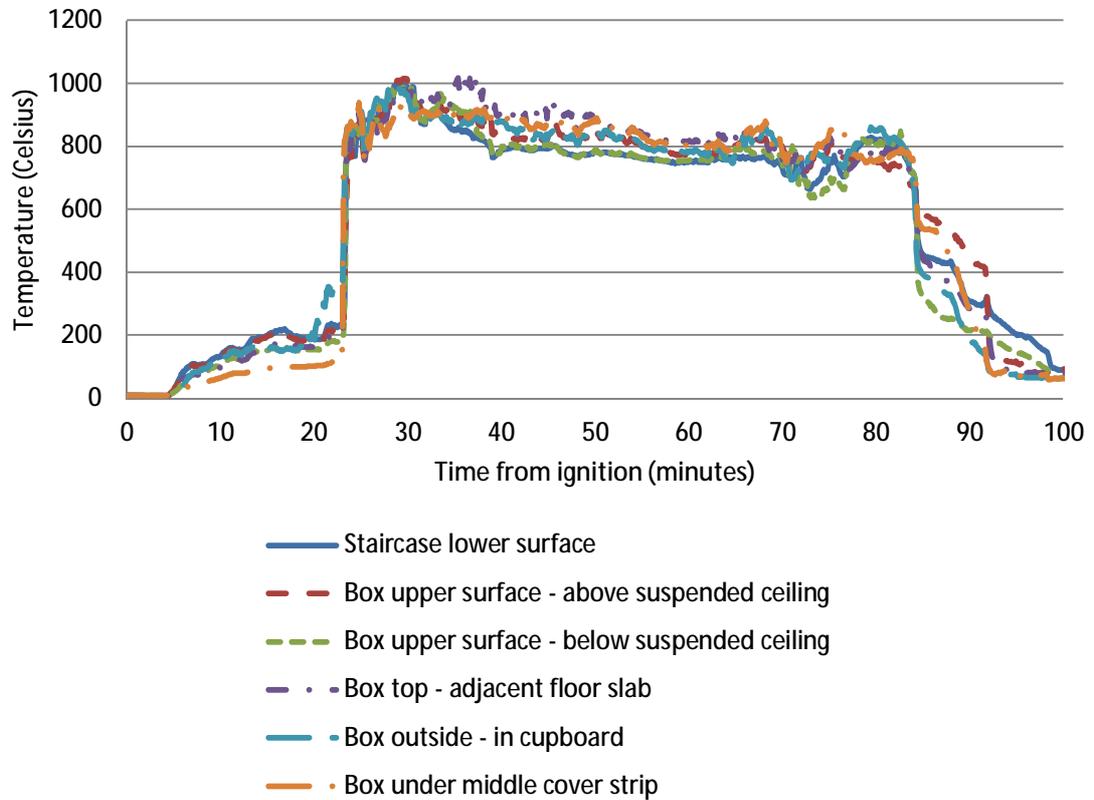
Figure 98 – Temperature data at thermocouple positions on stair box structure¹⁴⁰

Temperature data obtained from the ceramic fibreboard box beneath the stairs, Figure 98, indicate that it fails approximately 2-3 minutes following ignition of the staircase. Failure is treated as the rapid increase in temperatures at all measuring locations on the ceramic box from around 200°C to around 800°C because visual confirmation of the mechanism of failure from the video footage was not possible due to smoke logging within the suspended ceiling. This is prior to any flaming penetrating the escape door below. Temperatures at thermocouple tree F (Figure 80) above the suspended ceiling exceed flame temperatures approximately 10 minutes

after this failure (34 – 35 minutes into the reconstruction). The video footage of the escape door and ceramic fibreboard box indicate well developed flaming in this area (above and below the suspended ceiling) from around 45 minutes into the reconstruction.

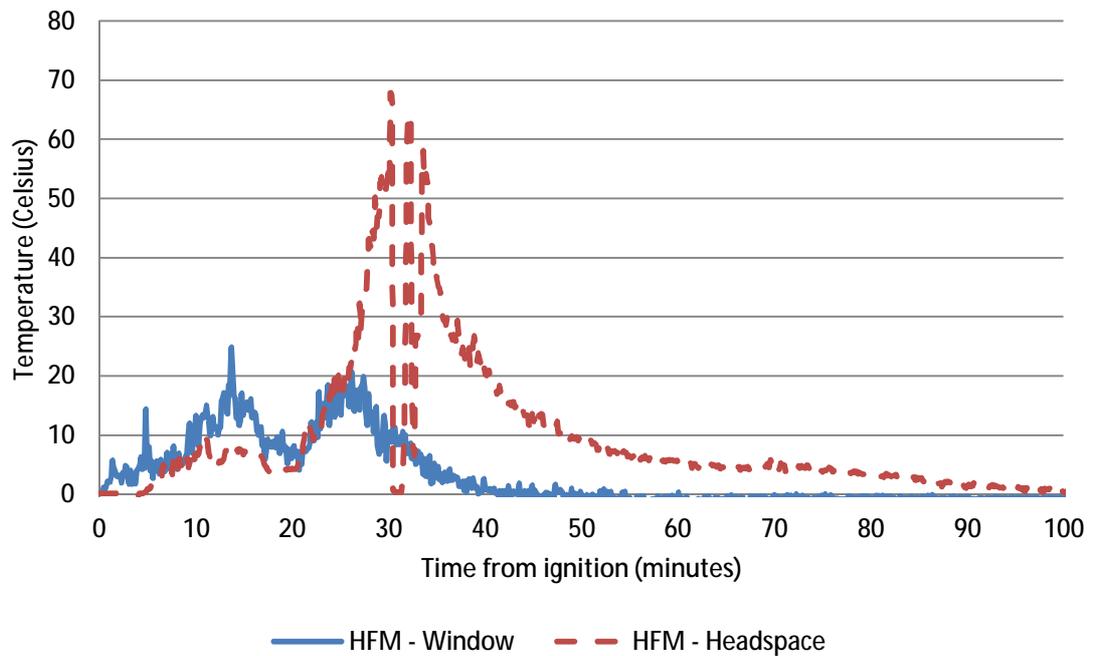
Figure 99 – Heat flux meter data from window and headspace¹⁴⁰

Of the three heat flux meters that were installed in the reconstruction rig, the corridor heat flux meter developed a fault shortly into the test. Data from the corridor heat flux meter are removed from Figure 99 for ease of viewing. Fortunately the suspended ceiling did not contribute significantly to the fire so any heat fluxes measured here would not have contributed to the analysis of the reconstruction.

The heat flux meter close to the windows on the upper level measured two peaks corresponding with the periods of flaming at upper level mentioned earlier. Heat fluxes here peak at around 20kW/m^2 . Performance of the window panels is discussed later within the computer modelling chapter. The heat flux meter in the headspace peaks at 65kW/m^2 around 30 minutes into the reconstruction.

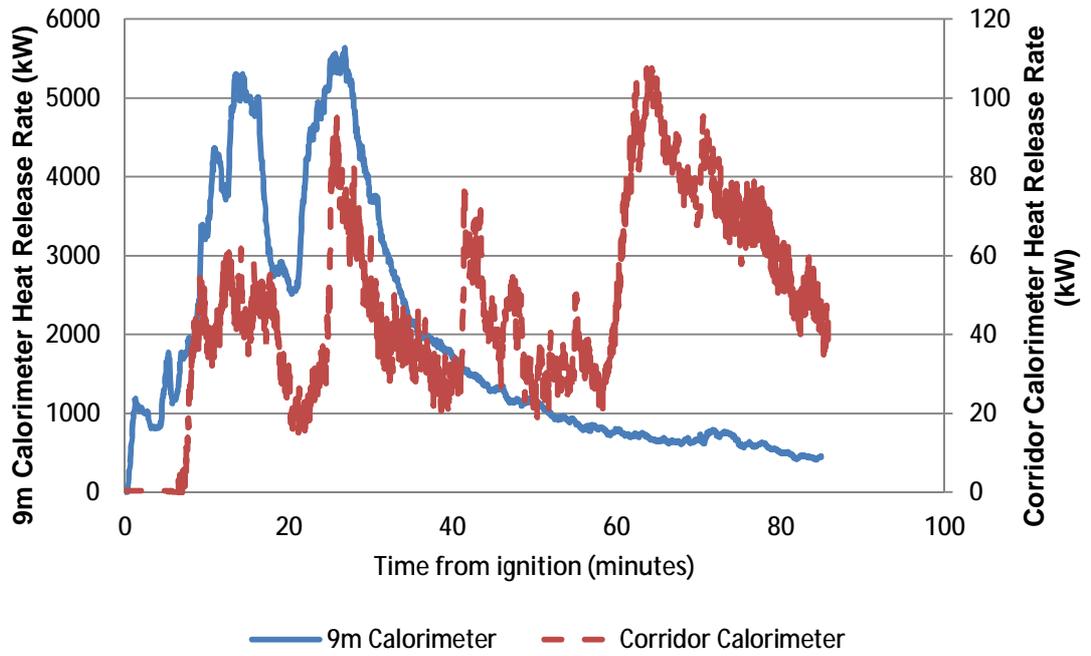
Figure 100 – Calorimetry data for the two calorimeters collecting smoke during the reconstruction fire¹⁴⁰

The calorimetry data collected from the reconstruction reflect the findings detailed so far. The peaks on both calorimeters are accounted for by the preceding involvement of significant components of the reconstruction rig. The heat release rate plots for both calorimeters are shown in Figure 100. The gas concentrations measured by the 9m calorimeter and corridor calorimeter are shown in Figure 101 and Figure 102 respectively.

Overall, the 9m calorimeter, measuring heat release from smoke exiting the window of the rig, registered two peaks of 5.0 to 5.5 MegaWatts. The corridor calorimeter peaked at close to 110 kiloWatts (0.11 MegaWatts). The difference in magnitude of these peaks highlights that the fuel load in the corridor of the reconstruction rig did not contribute to the reconstruction fire to any significant extent.

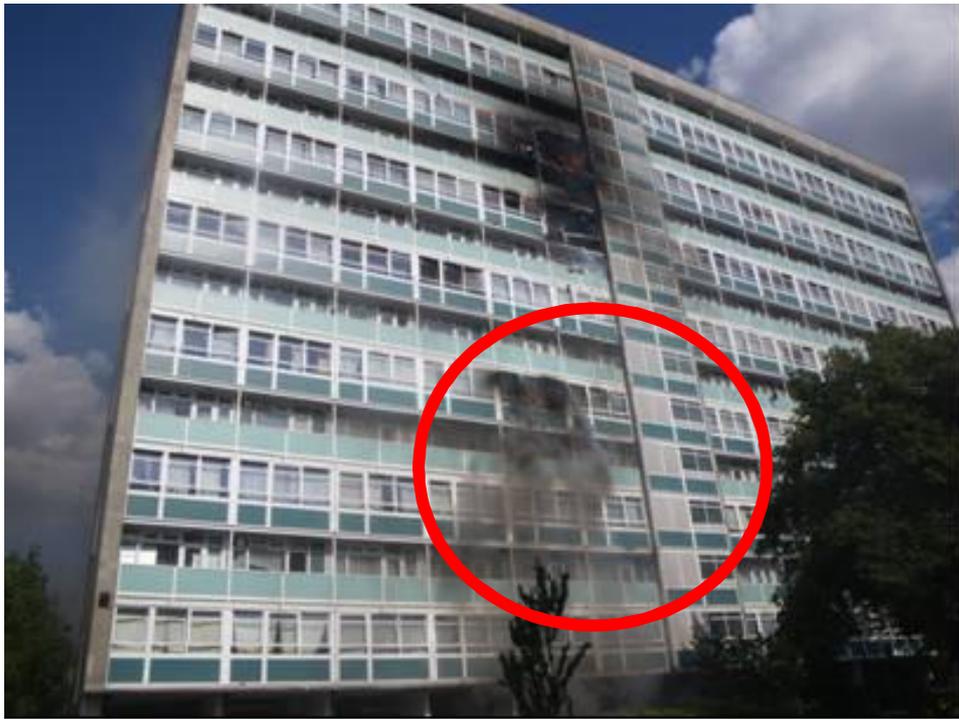
Figure 104 – Smoke moving down the face of the building . Image courtesy of LFB¹⁴⁰

There was evidently a complex air movement pattern around Lakanal house during the incident. One of the features of the video clips of the fire incident was the movement of smoke down the west face of the building; the smoke would normally be expected to go up. This is presented in Figure 104.

This simulation indicates that an airflow down the west face of the building would not be unusual when the wind comes from the west.

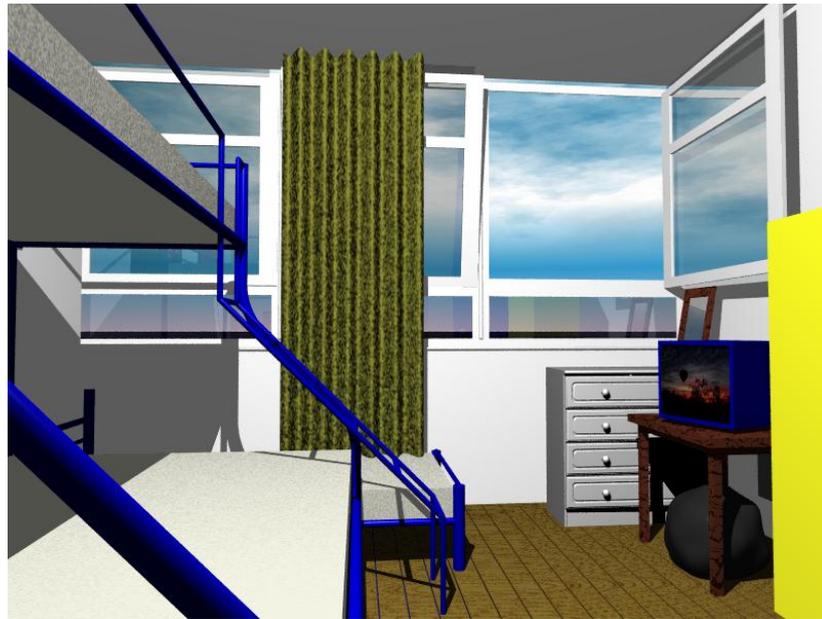
Figure 109 – Bedroom 1 Flat 65 view of windows and location of television set¹⁴⁰

The fire in Flat 65 is understood from LFB and MPS to have started in bedroom 1 at a television set located near the dwarf door to bedroom 2. The right hand (as seen from inside the flat) window was fully open and the centre window in the tilt position, Figure 109.

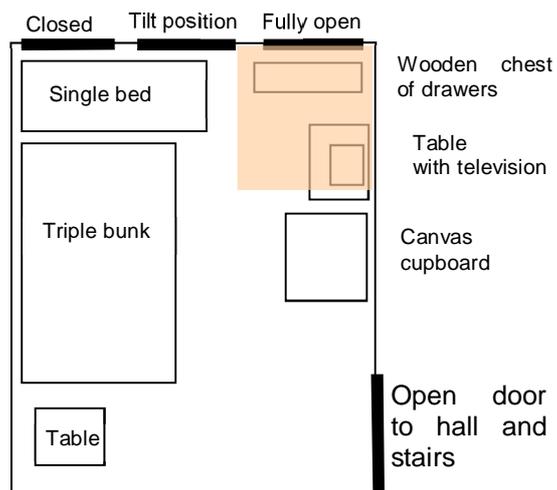
Figure 110 – Bedroom 1 Flat 65 showing location of fire when first observed¹⁴⁰

From the witness statements the fire was first seen in the corner of bedroom 1 extending from the centre of the windows to the canvas cupboard (~1.5m by ~1.5 m) with flames reaching halfway up the walls. This was about four minutes after an observation when the witness entered the room to retrieve her phone and was not aware of any fire. Figure 110 shows the layout of the room (as described in statements) with the fire area shown as an orange rectangle. Statements indicate that the door to bedroom 1 is left open as the occupant evacuates.

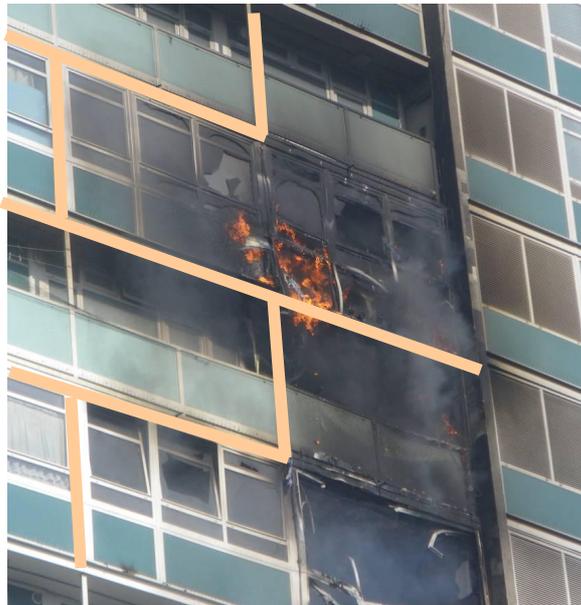
Figure 120 – IMG5569 (cropped) taken at 16:41:05¹⁴⁰

Figure 120 shows the west elevation of Flats 65 and 79 during a gust of wind, which had temporally cleared the smoke. At this time fire fighting had just started in the lower floor of Flat 65. The outer panes of glass in the windows of bedroom 1 and bedroom 2 of Flat 79 are broken indicating exposure to a significant quantity of heat. The window panel in Flat 79 bedroom 1 has either burnt away or fallen away as a result of loss of the panel's structural rigidity due to burning. The balcony panel opposite the kitchen of Flat 65 is in place and shows some smoke staining and blistering, but less damage than to the windows and panels of Flat 79 bedroom 1. This suggests that the flaming that caused the damage to Flat 79 came from the upper level (kitchen) of Flat 65 and not the lower level (bedroom 1).

There is still a significant fire in the kitchen or kitchen balcony of Flat 65; the source of fuel may be the freezer in the kitchen of Flat 65 and/or the panel to the side of the kitchen door.

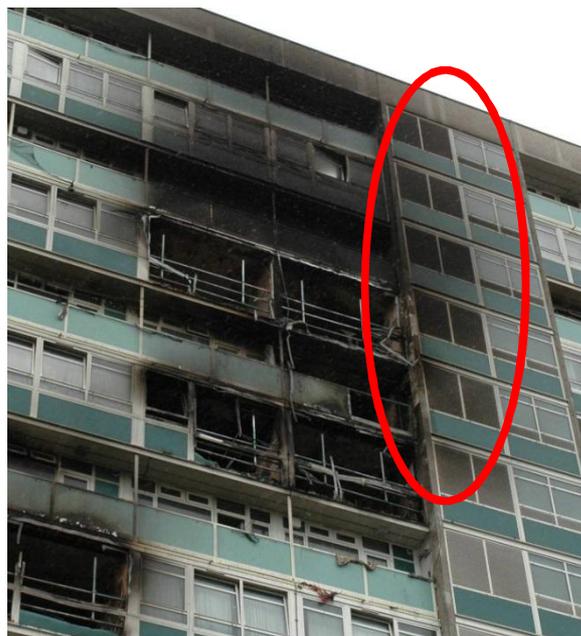
Figure 121 – Post fire image showing smoke staining of ventilation grilles¹⁴⁰

Smoke entering the corridors and stairwell during the early stages of the fire while occupants were evacuating was probably due to wind blowing smoke from Flat 65 (and later Flat 79) back into the building through the ventilation grilles on the central access shaft, Figure 121 shows smoke staining of these grilles.

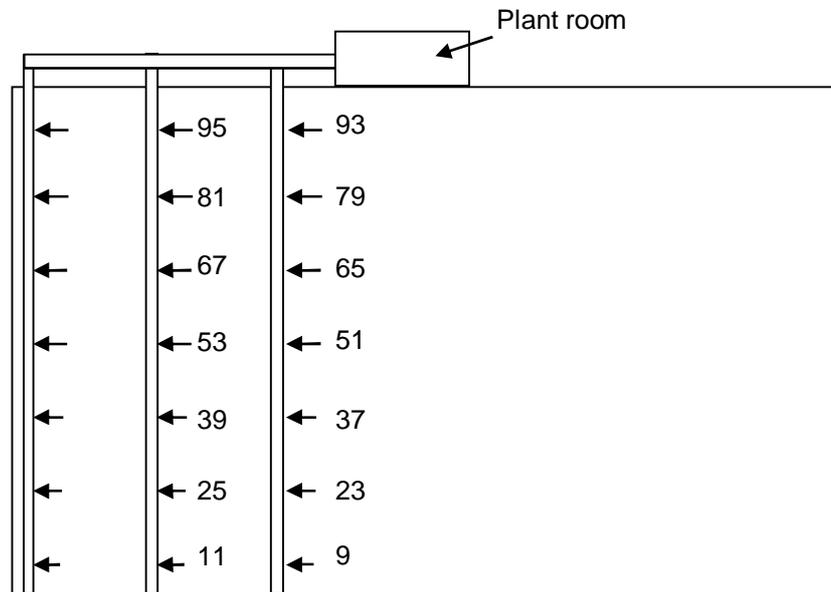
Figure 129 – Network of ventilation ducts viewed from same side of building as Figure 50 (West face)¹⁴⁰

The bathroom of each flat in Lakanal House is provided with a ventilation extract point. The extracts from each flat join a common duct with the flats above and below. These ducts lead to the roof where they join in a manifold, which leads to a large fan in a plant room. See Figure 129.

As seen in Figure 129, Flat 81 is linked to Flat 53 by a vertical duct and this provides a potential route for smoke and hot gases to move between the flats. In addition, a potential further route for smoke spread into Flat 81 is from Flats 37, 65 and 79 via the main roof duct. Figure 130 shows a “standard” bathroom grille leading to the ventilation ductwork.

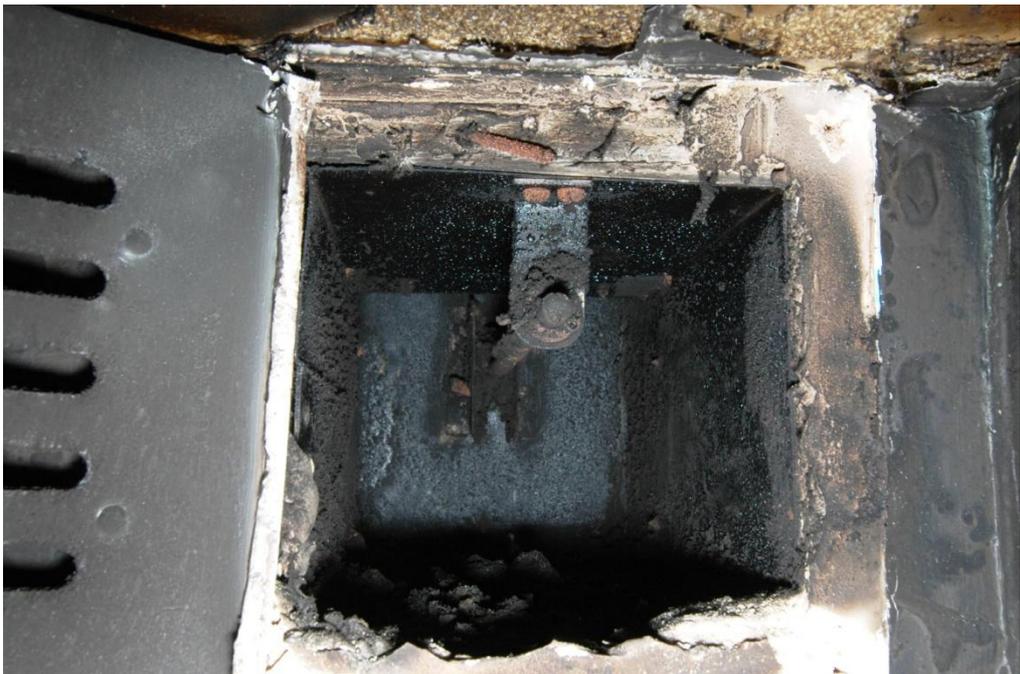
Figure 131 – Duct and damper behind the grille¹⁴⁰

Figure 131 shows the duct behind the grille leading to a damper and the vertical duct.

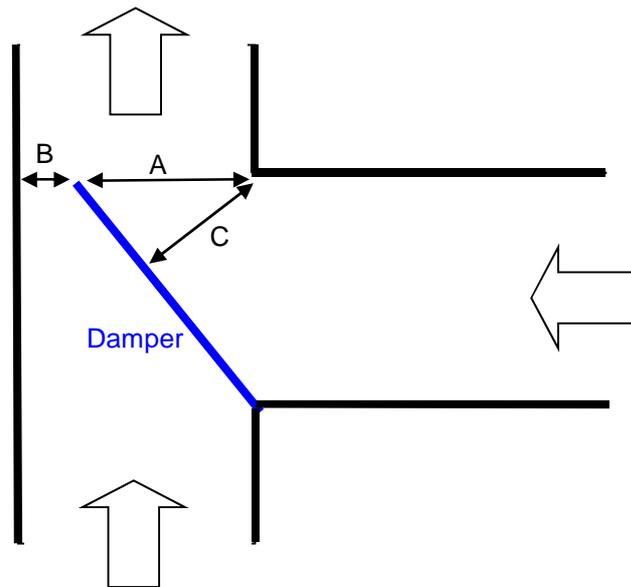
Figure 132 – Cross section of ducts and damper¹⁴⁰

Figure 132 shows a cross section of the junction between the ducts and the location of the dampers. The gap (A) was measured and these values are given in Table 20.

Flat	Damper opening (A) (mm)	Vertical free area (B) (mm ²)	Horizontal free area (C) (mm ²)	Flow	Notes
95	75	11250	10062	Good	Broken damper, extract fan fitted
81	70	12000	9515	Good	
67	10	21000	1497	Poor	No smoke round grille
53	3-5	21750	750	-	-

The damper in Flat 67 was almost closed and there was no visible smoke staining round the grille in the bathroom of Flat 67 indicating that very little smoke entered Flat 67 from the ventilation duct.

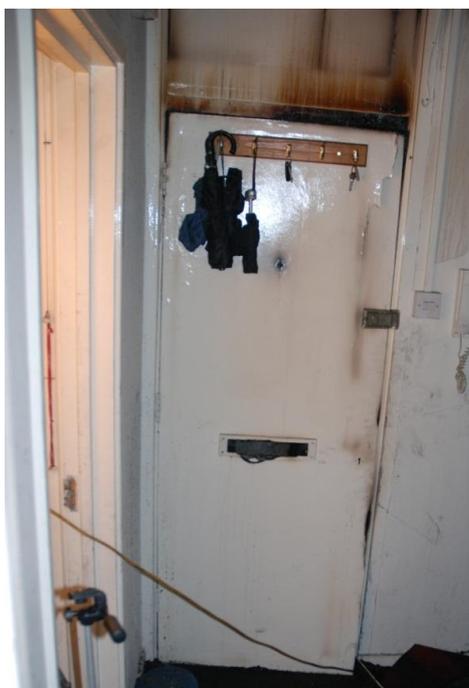
Photographs clearly show that at some time during the incident there was burning inside the flat at the top of the door and the top of the door panel (DSC_0104, Table 15). This may have occurred after most of the oxygen in the flat had been consumed by the stair fire as the fire

damage over the door is not extensive and there is only a small area of smoke staining on the hall ceiling that could be associated with this with burning near the door. Alternatively this damage could have occurred after (or while) the fire fighters entered the flat; there is support for this from Figure 134 which shows a discontinuity in the smoke damage between the top of the door and the frame. There are no signs of smoke penetration at the front door letterbox or spy hole on Figure 134.

Figure 134 – Front door of Flat 81, showing discontinuity of damage between top of door and frame plus lack of damage around letterbox and spy hole¹⁴⁰

The internal surfaces of the front door and panel do not appear to have contributed significantly to the smoke inside the Flat 81. Although the door had almost burnt through, there were no signs of a significant flow of smoke at the door edges.

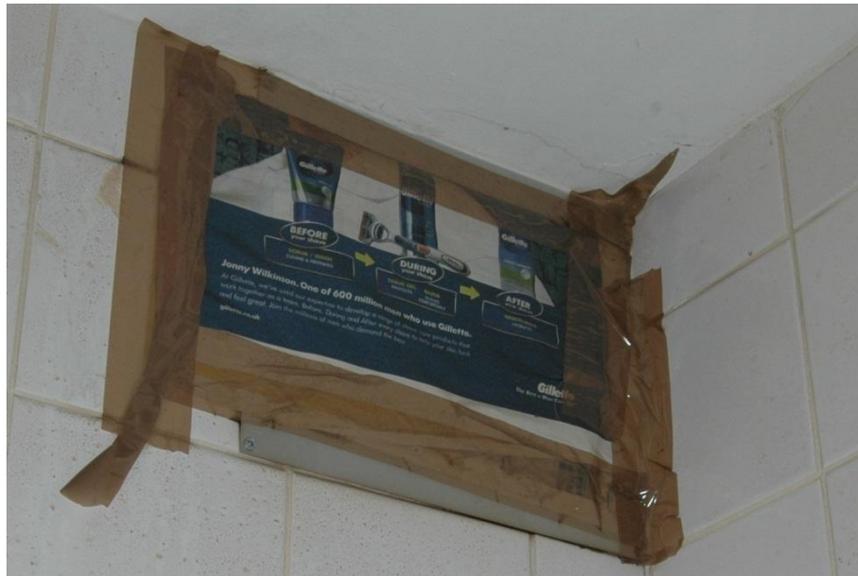
Before the four left Flat 81, two of the nine people are understood to have covered the bathroom ventilation grille with paper from a magazine secured by adhesive (parcel) tape. The paper remained securely fixed until it was removed by fire investigators. The grade of the paper and number of sheets used is not known, but this method of blocking the ventilator grille appears to have been effective in stopping particulate smoke entering the bathroom from the ventilation duct. Photographs show an accumulation of soot on the grill side of the paper but none of the bathroom side (see Figure 135).

Figure 135 – Magazine secured using tape to cover ventilation grille in bathroom of Flat 81¹⁴⁰

Gases such as carbon dioxide and carbon monoxide could have passed through the paper; however this would have been increasingly restricted by the accumulation of soot on the grille side of the paper.

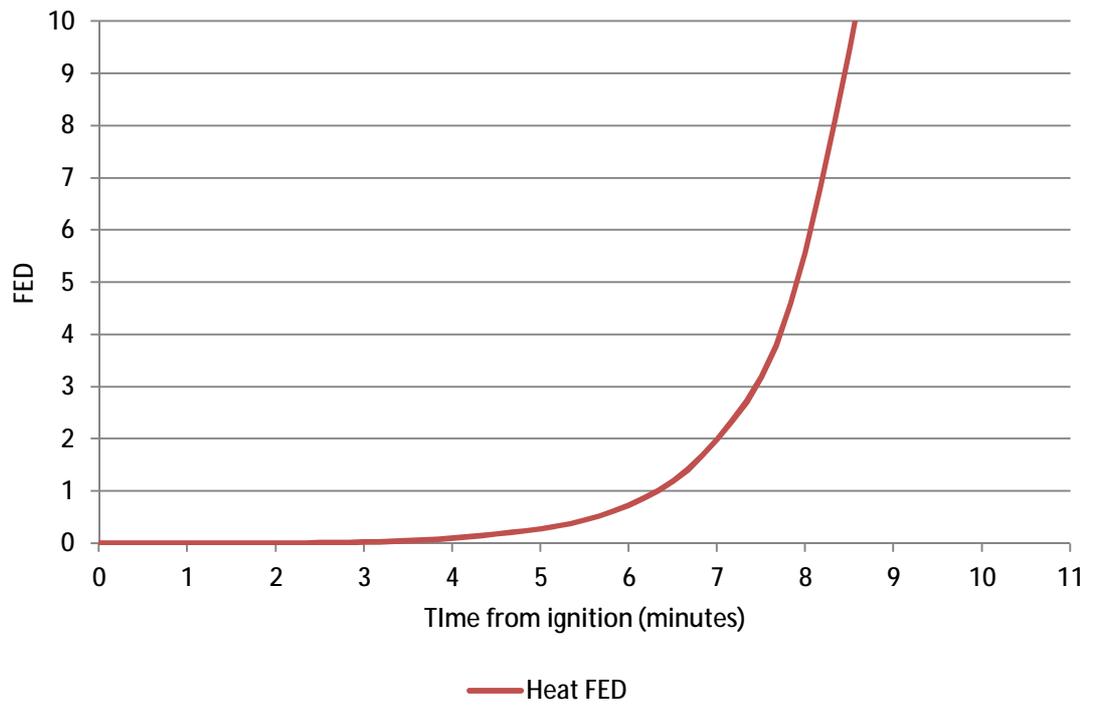
Figure 179 – FED values calculated using ISO 13571 method based upon Atherstone modelling data. Time zero represents the time at which runaway fire spread started

Given the techniques fire fighters are taught to search and wayfind in environments with little or no visibility, the models for hazard analysis proposed in ISO 13571 cannot be considered relevant as it is intended for and built around the capabilities of civilians to deal with restricted visibility environments. The analysis has therefore been limited to that of the effect of heat on the fire fighters. The significance of the FED curve shown at Figure 179 is similar to the curves for Harrow Court (Figure 46 and Figure 48); the sudden increase in hazard in both incidents has obvious implications for fire fighters in those situations. It is interesting to note that the increase in hazard is less marked for Atherstone than it was for Harrow Court; this would tend to indicate that there was a longer timeframe available for fire fighters to effect escape in Atherstone than there was in Harrow Court. However, the size and complexity of the layout of Atherstone in relation to Harrow Court would more than account for the additional time available as it would be required for fire fighters to exit the relevant compartment.
