**Hazards presented by pyrolysis and combustion
products during laboratory experiments and real
incidents**

A thesis submitted in partial fulfilment for the requirements for the degree of
Doctor of Philosophy at the University of Central Lancashire in collaboration
with the Building Research Establishment

January 2015

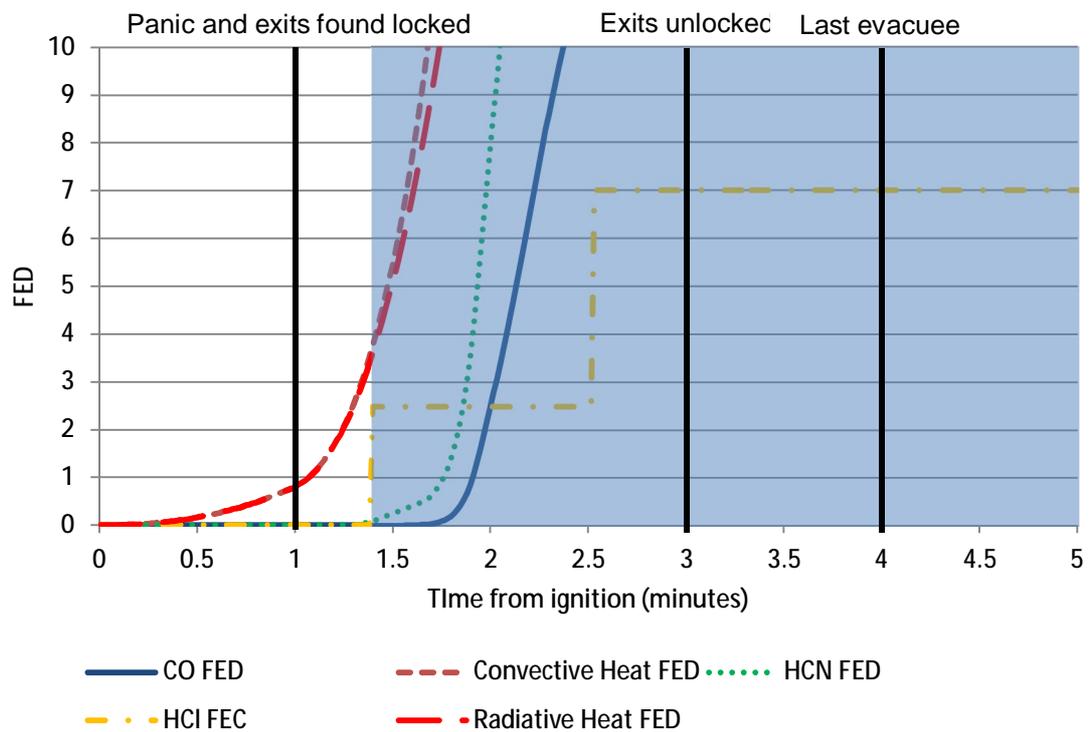
Figure 180 – FED values based upon Stardust reconstruction annex point measurements.

The materials involved in the Stardust fire and the findings from the tribunal provide some indication of the reason why this pattern of fire hazard arose. It is known that carpet tiles were fixed to the walls of the room and these were shown to contribute significantly to the development of the fire, along with the fuel presented by the seating on which the fire started. The seats in the Stardust disco are known to have comprised polyurethane foam covered in PVC, which clearly would have contributed to the quantities of hydrogen cyanide and hydrogen chloride produced during the fire.

Markers have been added to show relevant events. The shaded area indicates where under-ventilated conditions are predicted by CO:CO₂ ratio exceeding 0.1

It therefore appears that the key factors in the Stardust Disco fire were the materials used to line the walls, ceiling and seating contributing to the rapid growth of the fire, and the locking of the exit routes by security personnel, reducing the number of means of escape from the premises. The fire was able to develop and grow extremely quickly as a result of the various fuels that were available for it to do so and the amount of air in the large compartment to support it. Severity of conditions, both heat and concentrations of combustion products, increased rapidly as the fire developed.

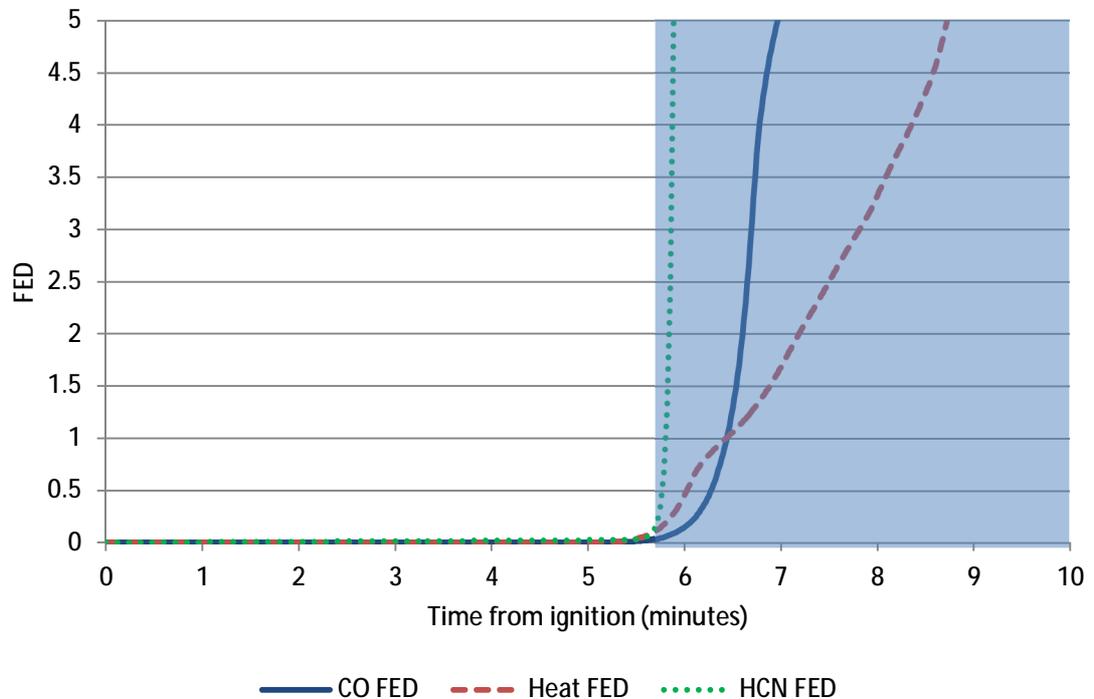
Figure 182 – FED values based upon Maysfield reconstruction data. The shaded area indicates where under-ventilated conditions are predicted by CO:CO₂ ratio exceeding 0.1

The reconstruction of the fire at Maysfield Leisure Centre provided data which appears consistent with the information from the incident, although as with Stardust the incident data is somewhat vague; in this instance accurate to the nearest five minutes. It is therefore difficult to estimate the time during the incident which correlates with time zero on the reconstruction but given that the fire was discovered at 13:35 and there was no sign of fire at 13:30, an ignition time somewhere between the two seems plausible. Evacuation of the building is reported to have started sometime between 13:35 and 13:40, with the fire brigade arriving at the scene at 13:40 and casualties starting to be brought out at 13:45. Therefore the entire period from ignition, through discovery/evacuation and fatal conditions being achieved took less than 15 minutes. This is supported by the FED plot which shows conditions changing from “safe” to fatal in a matter of seconds, largely driven by the contribution of hydrogen cyanide to the overall toxicity in the space, see Figure 182.

The key factors in the fire at the Maysfield Leisure Centre were the materials involved in the fire and the doors in the building (in particular the door to the store room) being left open by the occupants, allowing the products of combustion to be dispersed throughout the building and air to get into the fire, so that it could continue to grow.

The fire was able to grow to flashover, at which point the toxicity of the environment, in terms of both asphyxiant gases and heat, increased considerably. The ultimate cause of death of all of the casualties of this fire was the inhalation of toxic gases and smoke. The FED analysis highlighted the significance of hydrogen cyanide in this incident, which once examined more closely (particularly with regards to postmortem interval before blood analysis) highlights the importance of identifying hydrogen cyanide at as early a stage as possible during an investigation.

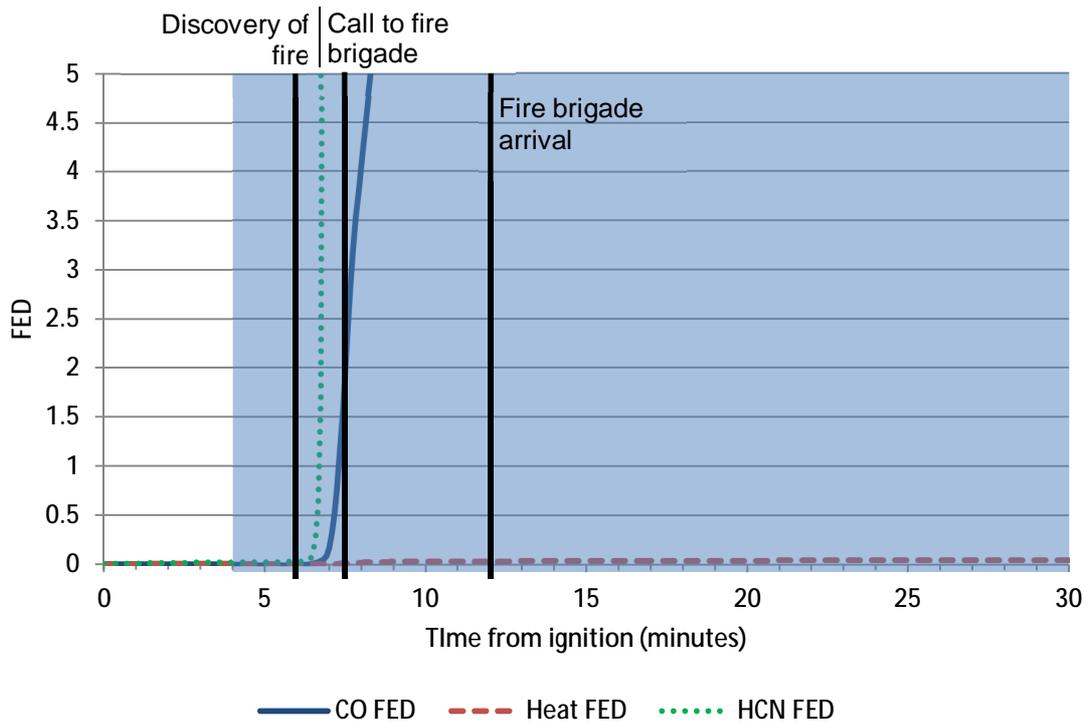
Figure 183 – FED values calculated using ISO 13571 method based upon Rosepark open room reconstruction data. Markers have been added to show relevant events. The shaded area indicates where under-ventilated conditions are predicted by CO:CO₂ ratio exceeding 0.1

Of the fourteen victims of the Rosepark Care Home, ten were in rooms off of corridor 4 with their doors open. All of these people died at the scene. It can be seen from Figure 183 that the delays caused in finding (and therefore confirming) the fire and calling the fire brigade meant that there was little opportunity for rescue of any of these residents prior to them being overcome by the effects of toxic gases in the area. Note that actuation of the fire alarm in the incident occurred approximately 90 seconds before time zero of the reconstruction. There was therefore over 7 minutes available following actuation of the fire alarm when evacuation of the residents could have taken place, of which 3 minutes might have been with the assistance of the fire brigade.

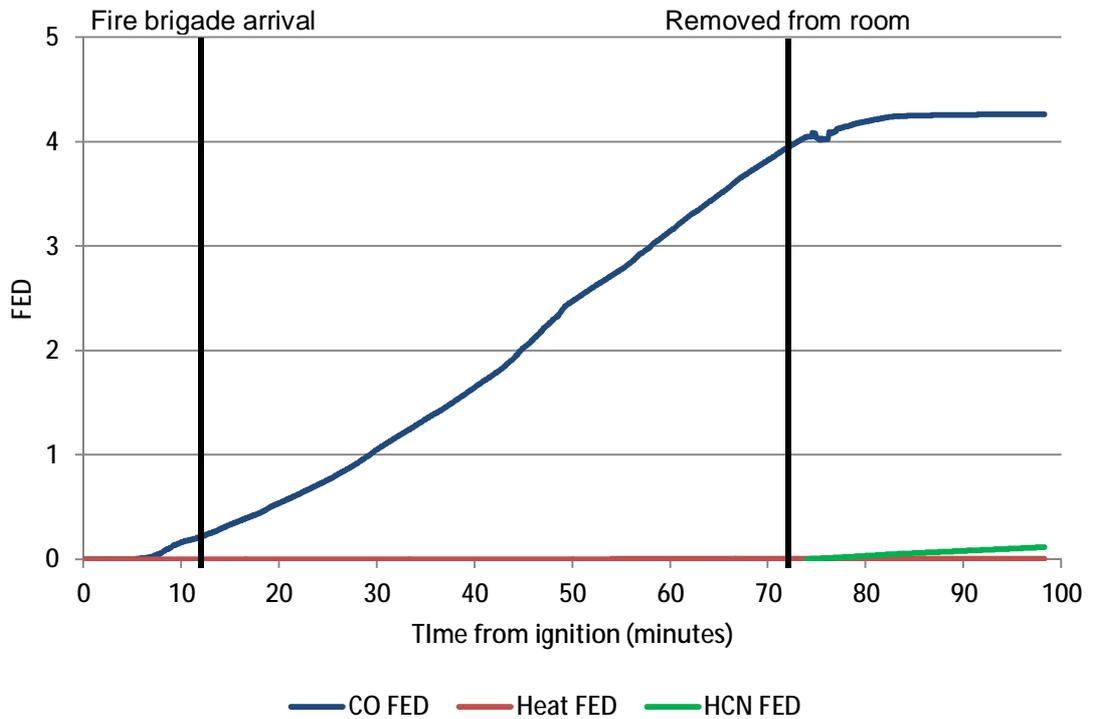
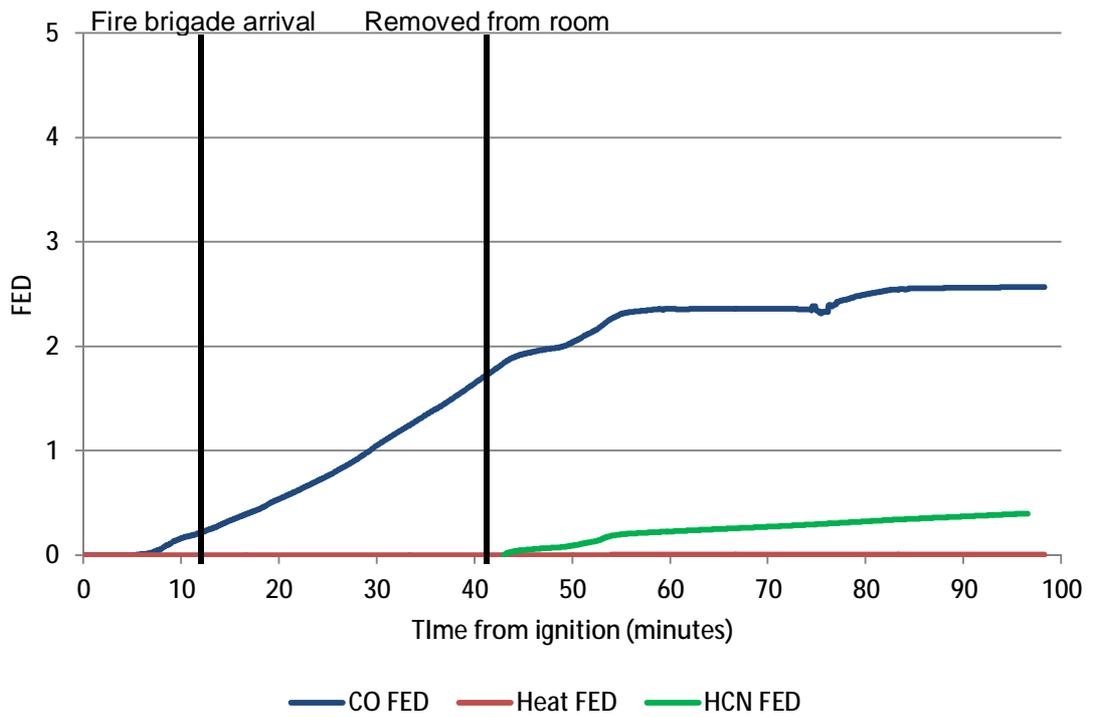
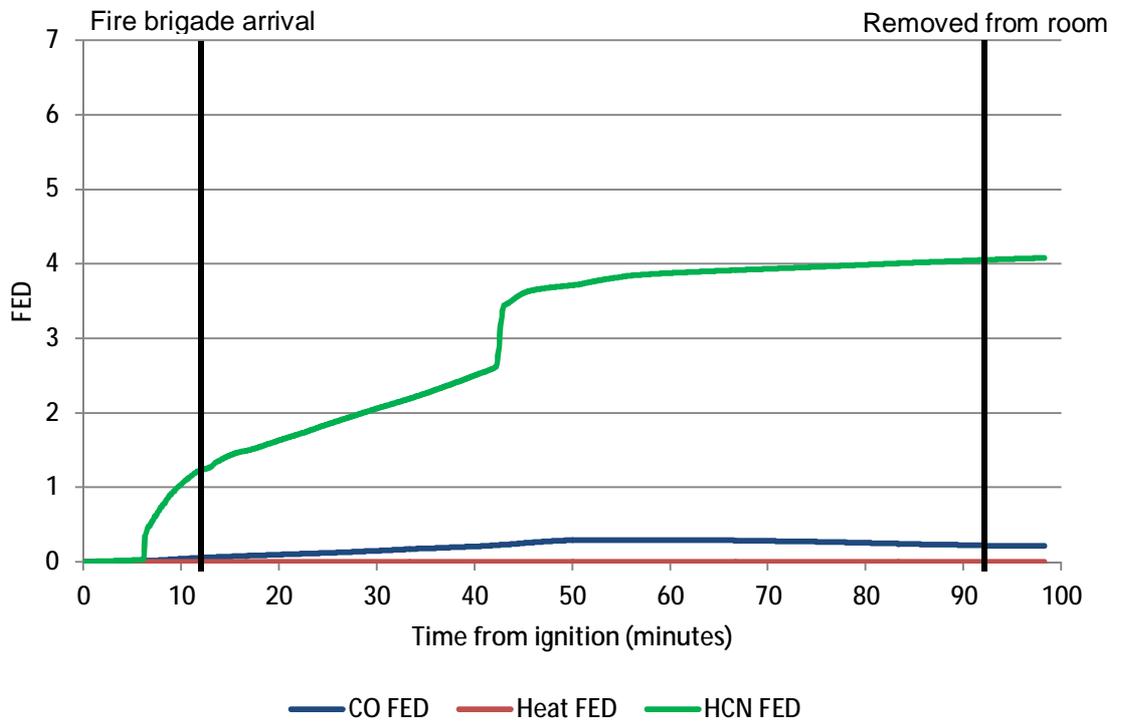
concentrations relevant at the various stages of the incident (i.e. effectively “stitching together” different periods of exposure in different locations/conditions). This has been done in the cases of the victims in rooms 10, 11 and 20; it was not possible for the victim from room 18 as no data existed representing later than 103 minutes after ignition, so this victim can only be considered in relation to corridor 3.

Figure 184 – FED values calculated for Rosepark room 10 casualty. Markers have been added to show relevant events

Figure 185 – FED values calculated for Rosepark room 11 casualty. Markers have been added to show relevant events

Figure 186 – FED values calculated for Rosepark room 20 casualty. Markers have been added to show relevant events

Once this analysis has been carried out, accumulating FED across the route travelled by the victims, it can be seen that the dose they received following their move is actually much less significant than the dose received prior to that time. However it is possible that this additional exposure, although minor, might have been sufficient to cause the death later on, particularly if it involved exposure to acid gases not measured as part of the reconstruction.

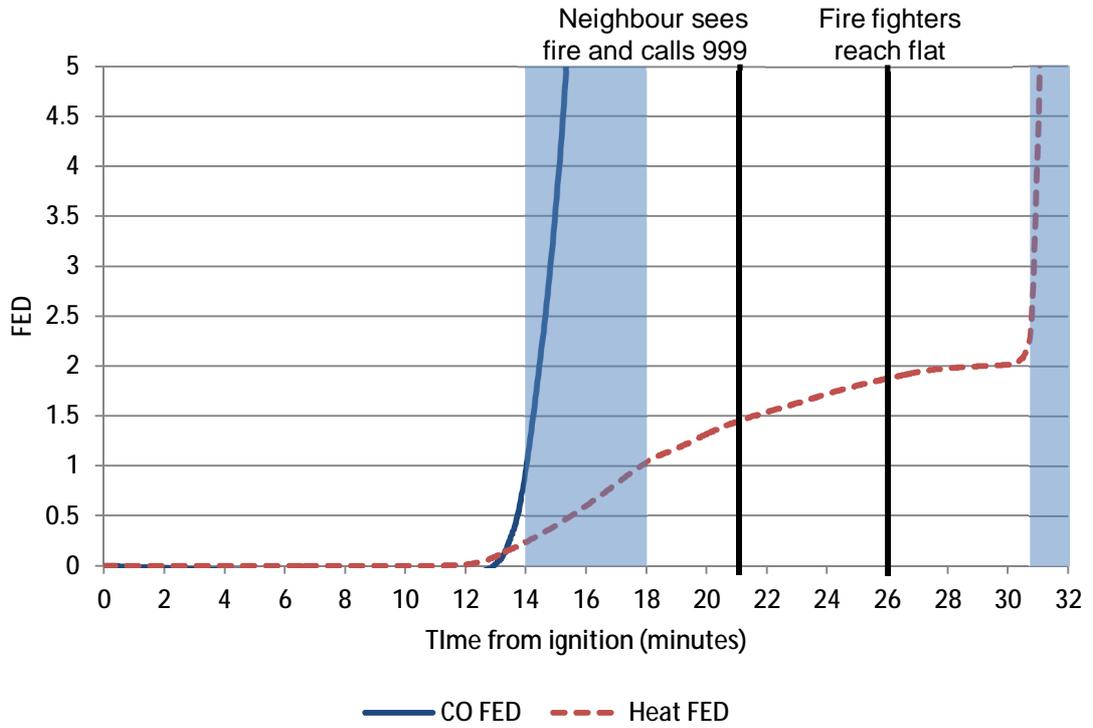
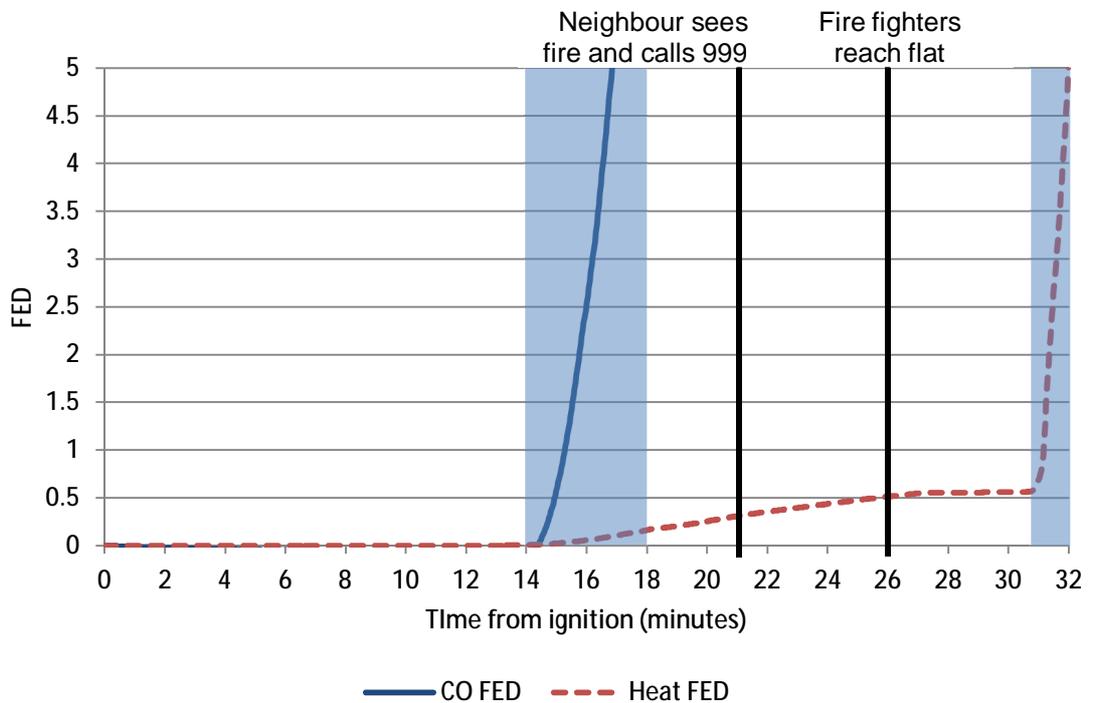
The reconstruction of the fire at Harrow Court indicated a fire occurred which underwent a dramatic change in burning conditions (flashover) with a concurrent dramatic increase in the severity of the conditions to which both the civilians and fire fighters involved in the incident were exposed. It is not known what time the fire actually started during the incident, it was seen by a neighbour who called the Fire and Rescue Service at 02:59. It is known that fire fighters reached the flat at 03:04 and that flashover in the flat occurred at 03:08; approximately four minutes later. Assuming that the reconstruction was an accurate representation of the fire, time zero would correspond with approximately 02:38 during the incident. Markers have therefore been added to Figure 187 and Figure 188 based upon that assumption.

Figure 187 – FED values calculated using ISO 13571 method based upon Harrow Court reconstruction data standing up measurements. Markers have been added to show relevant events. Shading indicates under-ventilated conditions ($CO:CO_2 > 0.1$)

Figure 188 – FED values calculated using ISO 13571 method based upon Harrow Court reconstruction data lying down measurements. Markers have been added to show relevant events. Shading indicates under-ventilated conditions ($CO:CO_2 > 0.1$)

It can be seen from the FED plots that the female resident (female 2) would have been very quickly overcome by the carbon monoxide concentrations in the room. The conclusion from the inquest that she died as a result of inhalation of smoke presumably indicates that she had an elevated COHb concentration in her blood and probably that there were signs of soot in her lungs as well, although this information is not available for confirmation.

The FED plots indicate a dramatic increase in the hazard arising from heat some two and a half minutes after fire fighters reached the flat. Notwithstanding the significant additional risk of fire fighters not having adequate water supplies (the dry rising outlet was locked) and becoming entangled in cables, the sudden increase to an FED of 5 at high and low level in less than a minute is more than sufficient to account for conditions capable of overcoming fire fighters.

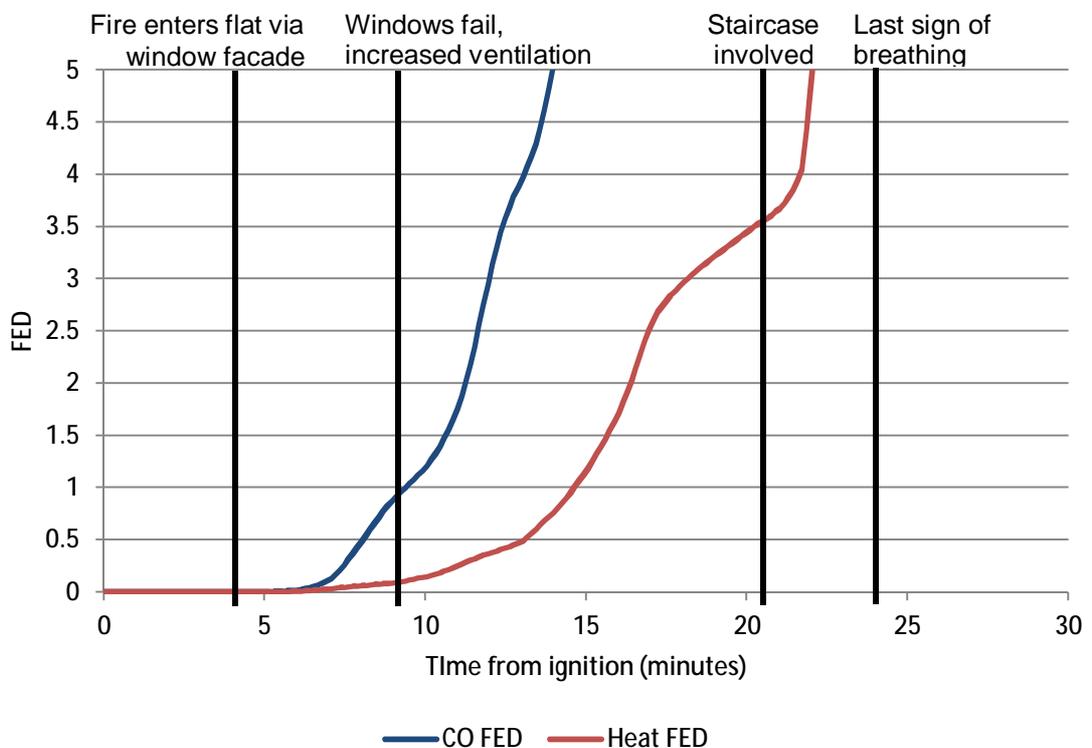
Figure 189 – FED values calculated using ISO 13571 method based upon Lakanal reconstruction data relevant to the fatality in Flat 79

The FED plot shown in Figure 189 is therefore not representative of the severity of conditions but the general trend of the gradient of the lines is indicative of the times when changes in fire conditions changed the rate at which the FED dose was increasing. Notably, the involvement of the staircase in the flat gave rise to a more steep increase in the FED dose which corresponds with the time of death of the victim.

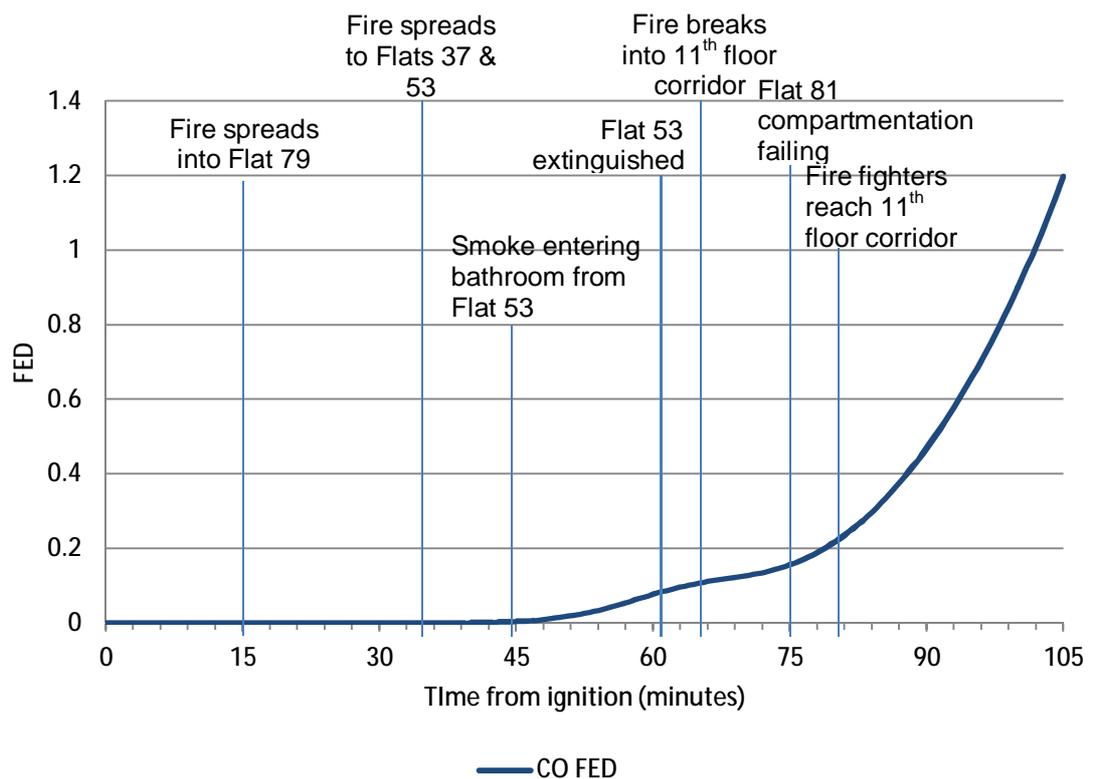
Figure 190 – FED values calculated using ISO 13571 method based upon reconstruction, modelling data and engineering calculations for the bathroom of Flat 81

However, it is interesting to note that the time at which FED exceeds 1 (102 minutes or at 17:57 during the incident), correlates very well with the times of death returned by the pathologist during the inquest, which all fell between 17:45 and 18:05.¹⁴¹

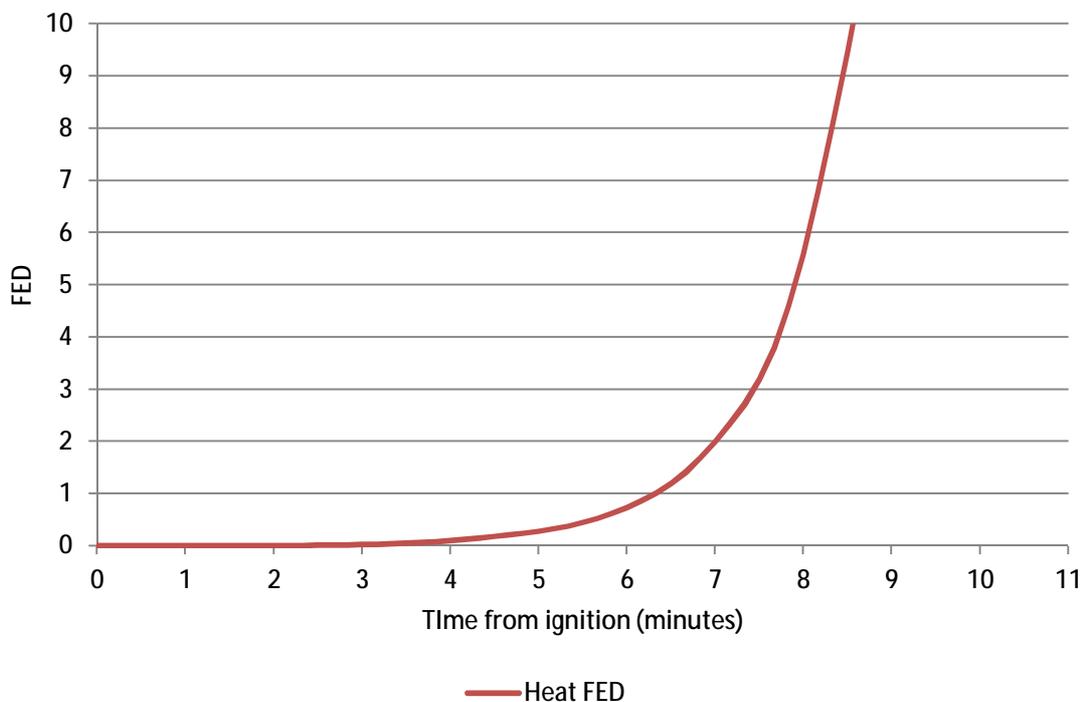
Figure 191 – FED values calculated using ISO 13571 method based upon Atherstone modelling data. Time zero represents the time at which runaway fire spread started

The programme of work indicated that, at some point between 89 and 115 minutes into the incident, a sudden change in the development of the fire resulted in rapid increase in temperatures throughout the very large fire compartment. The FED plot for the area where the four fire fighter victims are understood to have been when they were overcome is shown in Figure 191.

The rapid escalation of FED value combined with the size of the compartment and the knowledge that fire fighters may have become entangled in cables and/or disoriented within the large compartment, provides ample explanation of the way in which the rapid escalation could have resulted in their deaths. However, the FED plot may be further adapted using the work

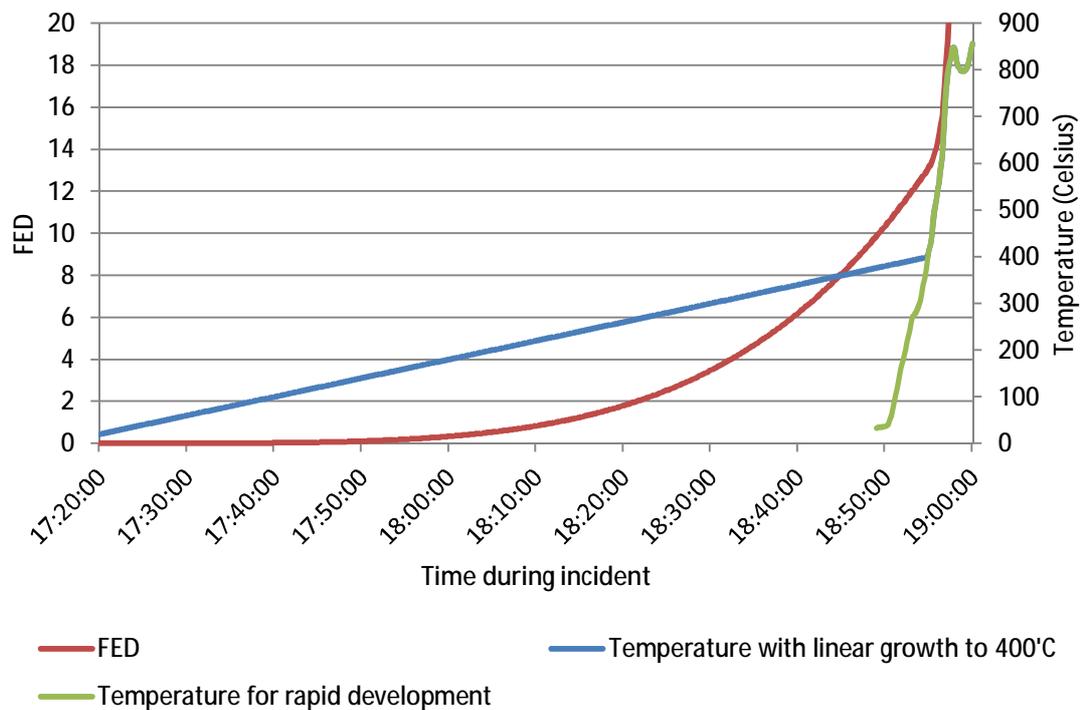
Figure 192 – Temperature profile and corresponding FED values based upon combination of Atherstone modelling data and linear growth

Assuming a linear growth to the critical temperature of 400°C (determined as the threshold temperature for ignition of all combustible surfaces in that environment), a new temperature profile and corresponding FED curve can be developed. This is shown in Figure 192.

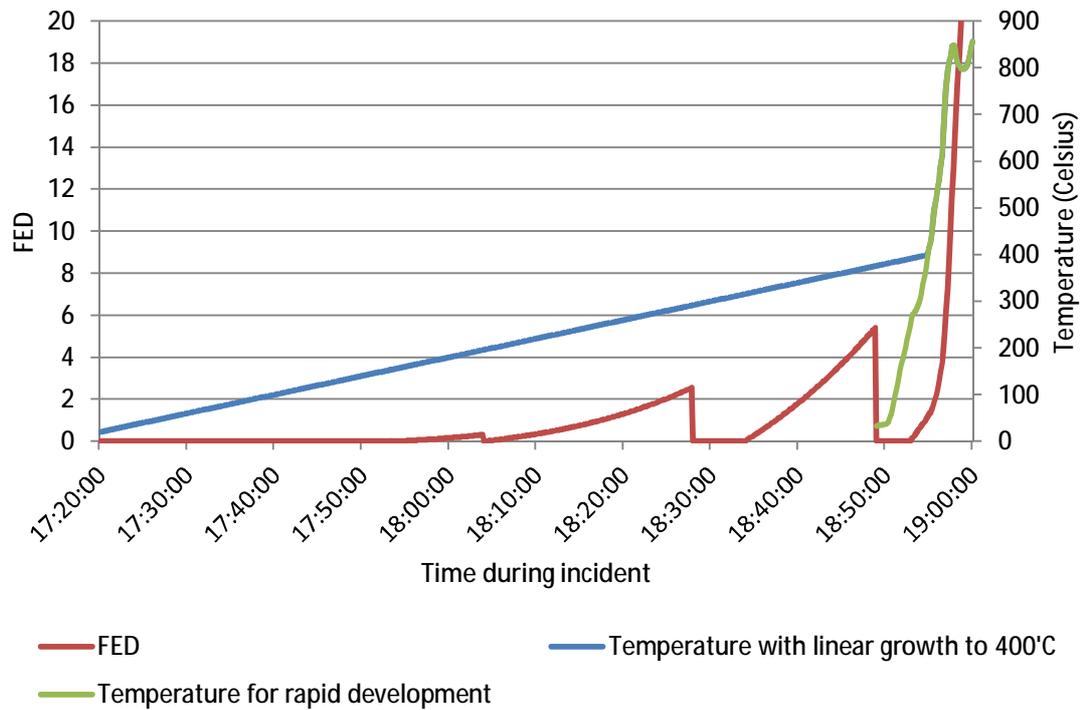
Figure 193 – Temperature profile and corresponding FED values based upon combination of Atherstone modelling data and linear growth, with resetting of FED in line with crew turnovers

Further analysis of the FED plot for the incident, which takes account of the turnover of crews during the course of the incident, provides some insight into the validity of the ISO 13571 approach for fire fighters. For each crew turnover (a fresh pair or team of fire fighters entering then leaving the space) the FED is reset to zero so accumulation of FED only occurs during the period of exposure, as shown in Figure 193.

This analysis indicates that fire fighters are, perhaps unsurprisingly, able to withstand temperatures well above those of fully clothed civilians. The highest ISO 13571 FED value attained by a surviving crew was 5.4, although the time to reach this value (15 minutes) was less than the previous crew; who attained 2.6 over 23 minutes.
