A New Method for Monitoring Gears Surface Failures Using Enhanced Image Registration Approach

Ahmed Onsy and Mohamed Fouad
MTC

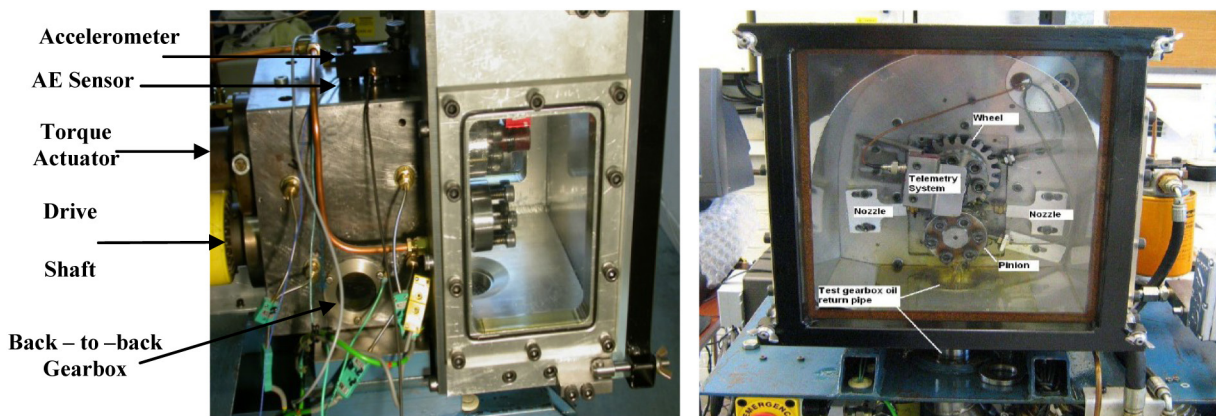
Figure 1. Newcastle University 75 mm centre distance back-to-back gear test rig

A back-to-back gear test rig developed at Newcastle University was used for this research. The rig comprises a 75 mm centre distance back-to-back test gearbox connected to a slave gearbox. The test gears, consisting of a pinion and a wheel, are lubricated by a pressurized spray of oil pumped. The system is driven by a 5.5kW variable speed electric motor controlled by an inverter to provide a speed variation of 0-6000 rpm. Testing torque is generated through a hydraulic mechanism and a slave gearbox is used to apply the load. The rig can generate a load torque on the test gears in the range of 0-600 Nm. The torque is measured using calibrated strain

gauges installed on the wheel shaft and the measured torque values are transmitted to the control program by telemetry in order to provide closed loop torque control of the actual load on the gear itself. The test rig, as shown in Figure 1, is controlled using National Instruments (NI) LabVIEW which consists of a PCI-MIO-16E-4 E series data acquisition card (NI) and 250kps sampling rate. Temperature is monitored using a USB-9211A temperature data acquisition card (NI). Three oil heaters and a water cooler are used to ensure that the running oil is maintained at a constant temperature during the tests. Temperatures were measured at three locations: rig oil tank, test gear bearing and slave gear bearing. Oil pressure and flow rates were also measured. A gear tooth trigger sensor was installed adjacent to the pinion test gear to ensure that tooth failure could be recorded. The input shaft speed and motor current were also monitored as a precaution. The test rig software provided the flexibility to change the control algorithm of the parameters measured according to the test conditions using LabVIEW's scalable architecture features. The test rig sensor-actuation system layout is shown in Figure 2. A pair of

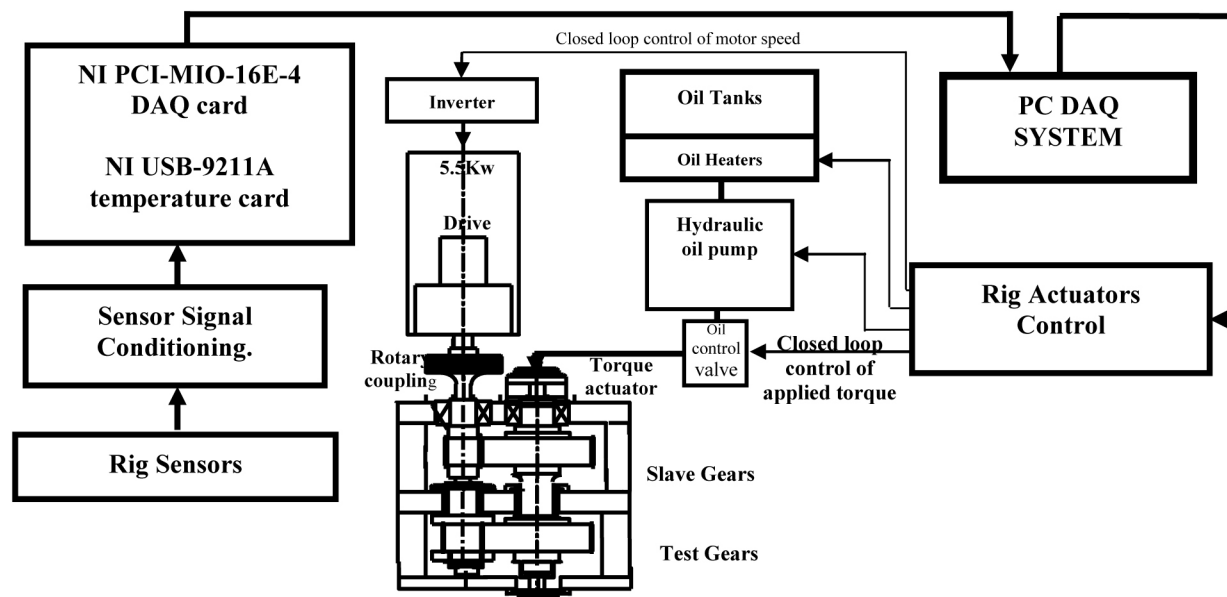
Figure 2. 75 mm test rig sensor-actuation system layout.
