# Machinery Transportation Management: Case Study of 'Plant-trailer' H&S Incidents

# Machinery transportation management: case study of “plant-trailer” H&S incidents

## Abstract

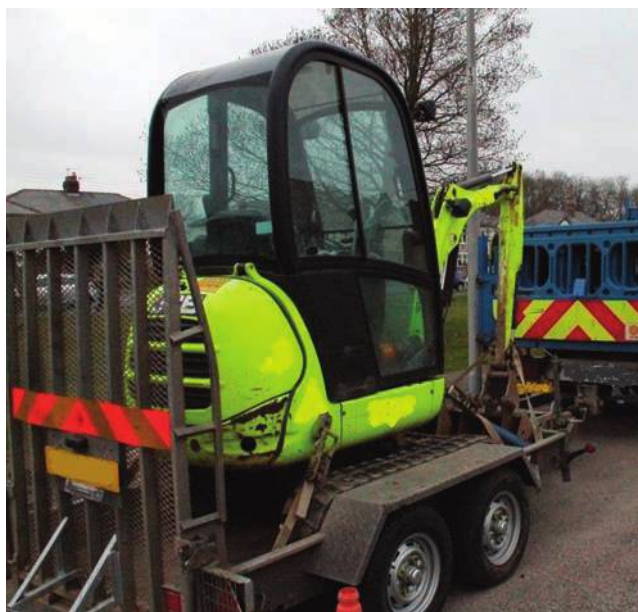
**Plate 1.**  
Typical plant-trailer  
configuration (twin axle)

A particular plant item commonplace within the construction and utility sectors is the “lightweight” trailer – generally referred to in the workplace as a “plant-trailer” (hence, this description is used hereafter for consistency). There are various types (e.g. single or double axle) and configurations of plant-trailer available and often, these are used to transport smaller plant items such as mini-excavators or pedestrian compaction rollers[1]. A typical plant-trailer loaded with a mini-excavator in its towing configuration, is shown in Plate 1. The popularity of these trailers stems mainly from the fact that (within the UK), they can be towed behind a lorry or commercial vehicle on a “standard” driving licence and therefore, help contractors save costs that would otherwise be incurred using larger, or specialist transportation equipment such as a “low-loader”[2].

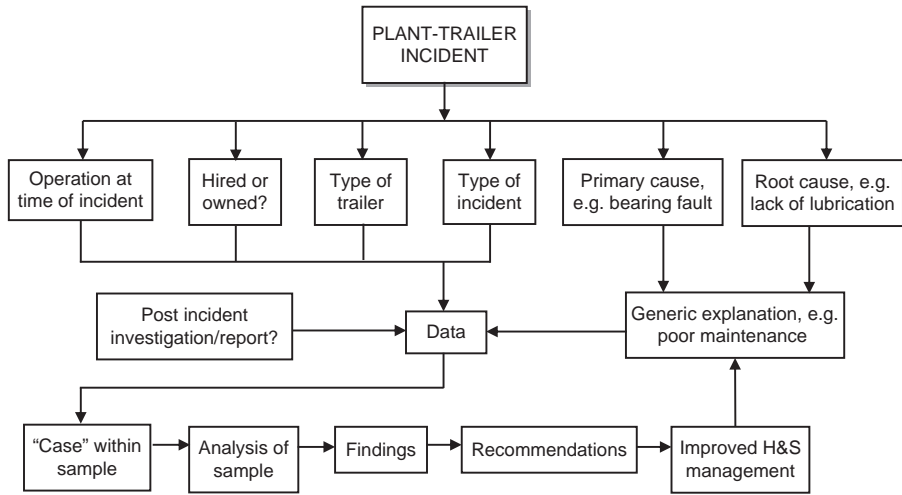
**Figure 1.**  
Relationships among data and methodology

Data were analysed both manually (Saldaña (2013) provides a useful treatise on manual methods) and using a word frequency content analysis technique within N-Vivo qualitative data analysis software (QSR, 2013). Prior to presenting these analyses (and discussion of their findings) in the following section, Figure 1 shows key incident

interrelationships and definitions used. That is, each incident was evaluated in terms of: type of trailer (short description); source (hired or owned); type of work being undertaken at time of incident (e.g. towing on public highway); type of incident (e.g. wheel became loose); whether a post-incident report was available (yes/no); and what were considered (explicit within the data) as primary, incident root causes. The figure also highlights the relationship of how analysis fed into development of outline recommendations, to inform plant-trailer H&S management.

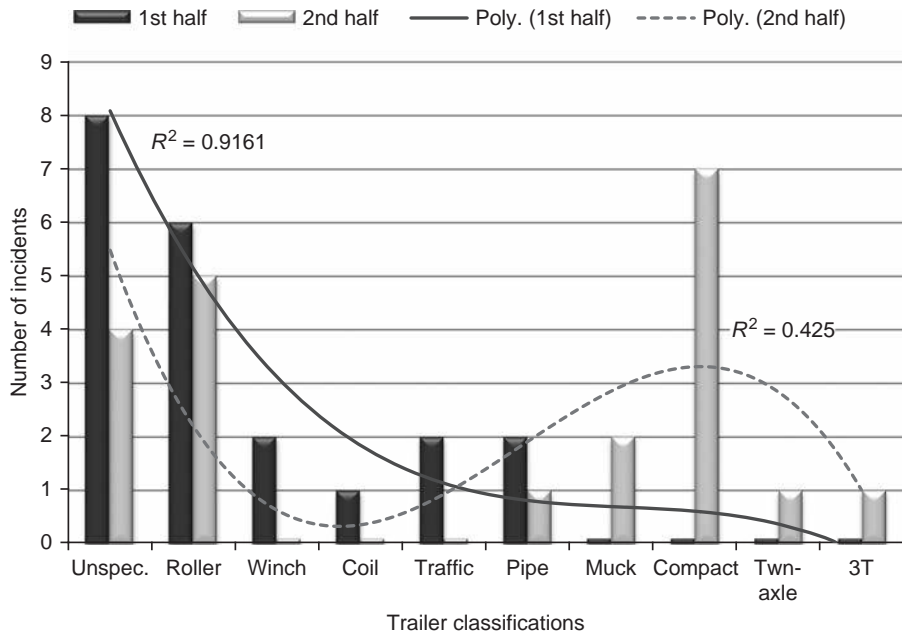
**Figure 3.**  
Incidents per halves of chronological data set

second “time halves” of the data set. Time halves were defined by listing all 42 incidents chronologically and dividing this into two equal sub-samples ( $n = 21$ ). This method of sub-sample composition was employed because of time-skewness among data (refer Table II). That is, if data were delineated by equal first- and second-half time periods, the 2009-2012 sub-sample ( $n = 33$ ) was biased, because there were many fewer incidents ( $n = 9$ ) reported during 2005-2008.

Greater frequency of incidents in the second-half period (Figure 3) suggests either a declining H&S situation (but this needs to be reconciled with any growth in fleet size to assess a worsening or improving situation); and/or more rigid incident reporting. Possibly linked to the last proposition, it is noted that the unspecified group declined in number; which too could mirror more accurate reporting procedures (of late). Incidents among classifications increased in the latter period for: muck trailer, compact excavator trailer, twin axle trailer and 3T trailer; simply because no incidents for these machinery types were reported in the first period. The most marked increase was for compact excavator trailers, perhaps being synonymous with increased usage of compact excavators (especially on utility works) since mid-1990 (Holt and Edwards, 2012). Order three polynomial trend lines[5] show a first period downward trend; and a spike from said excavator trailer incidents (causing the low  $R^2$  value = 0.42) in the second period.

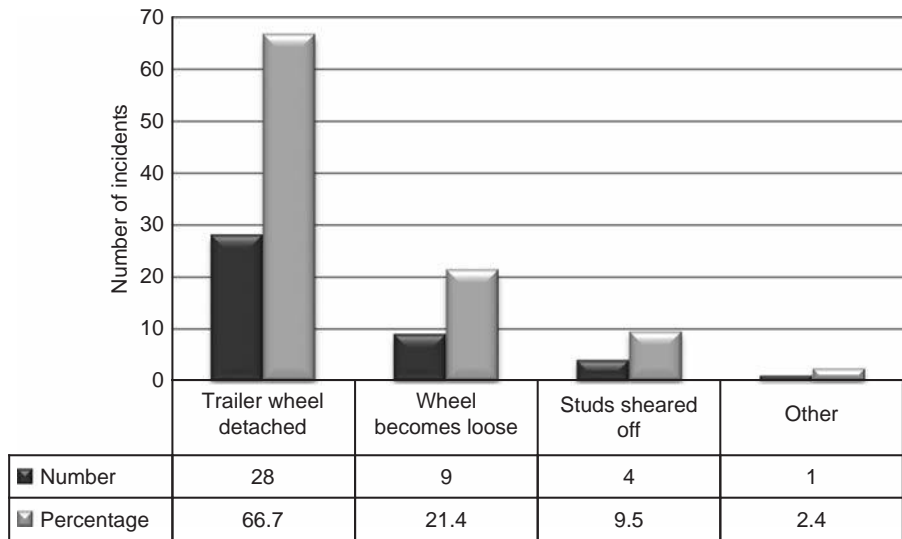
**Figure 4.**  
Types of incident  
among all data

Types of incident are summarised in Figure 4. Wheel detachment (“while traveling” given the previous analysis) is the main incident type (28 cases, 67 per cent). These statistics may vary slightly because “studs sheared off” and “other” did not specify whether this led to wheel detachment or wheel loosening. These incident types are analysed in more detail later.
