Soils and earthworms as a final chapter in the narrative of a steelworks

K.R. Butt & S.M. Quigg

ABSTRACT

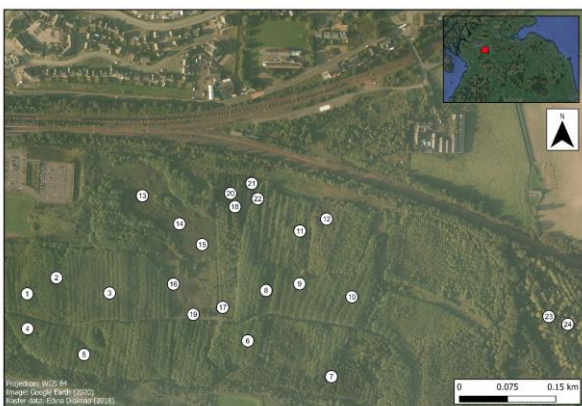
Fig. 3. Aerial view of the 35 ha reclaimed Hallside site, with position of the 2018 sampling sites indicated: 1-12, willow (*Salix* spp.); 13-17, grassland; 18-19, birch (*Betula* sp.); 20, Norway spruce (*Picea abies*); 21, Scots Pine (*Pinus sylvestris*); 22, cherry (*Prunus* sp.); 23-24, aspen (*Populus tremula*). Inset shows position of site in lowland Scotland (EDINA Digimap Service / Google Earth 2020).

During spring 2018, investigations were undertaken within the reclaimed areas from the 1990s, with comparisons drawn from sampling in adjacent areas that were unadulterated. Fig. 3 shows an aerial view of the site and the 24 selected sampling points. Most of these were in the dominant vegetation (willow) but other tree-covered areas were also targeted along with more open grassland.

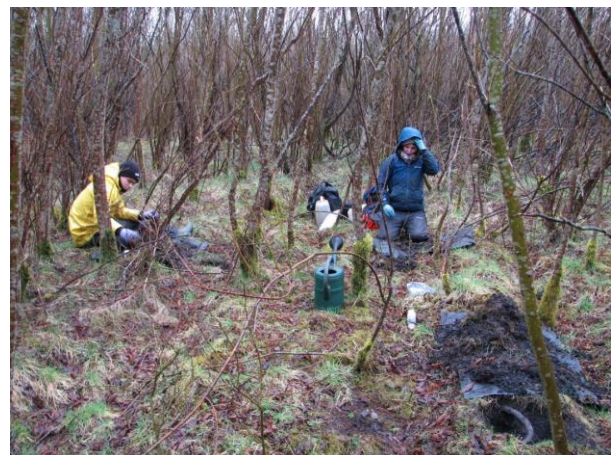
Fig. 4. Sampling for soil and for earthworms among willow at Hallside in 2018. (Photo: K.R. Butt)

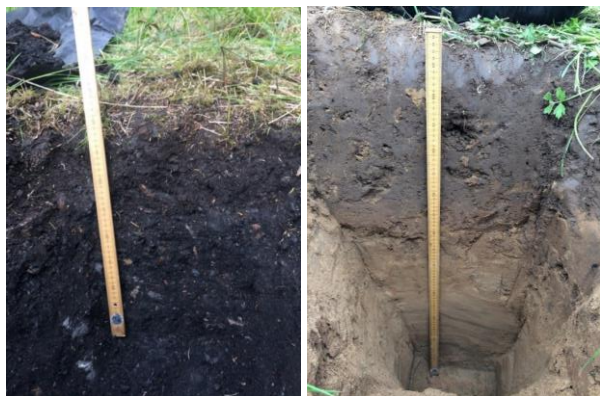
Fig. 5. Soil pits at Hallside. Left: in reclaimed soils below grassland (only possible to 45 cm due to stones and compaction). Right: in unadulterated sandy soil below aspen (to 1 m). (Photo: K.R. Butt)

Soils in the reclaimed areas proved very difficult to dig as they had a high stone content. No pits could be dug further than a depth of 0.45 m and many digging attempts were hampered by large rocks. Fig. 5 shows that above the dark compacted, stone-laden horizon, there was a lighter less stony, organic A-horizon of some 0.15 cm from the soil surface. In control soils away from the reclamation site, major differences were observed (Fig. 5). Here, digging to 1 m was possible, with the upper (0-35 cm) organic layer determined as a grey, sandy clay loam above 35-100 cm of yellow sand. The upper layer held small fragments of colliery spoil as the area had previously been agricultural land and had been ploughed prior to alder planting.

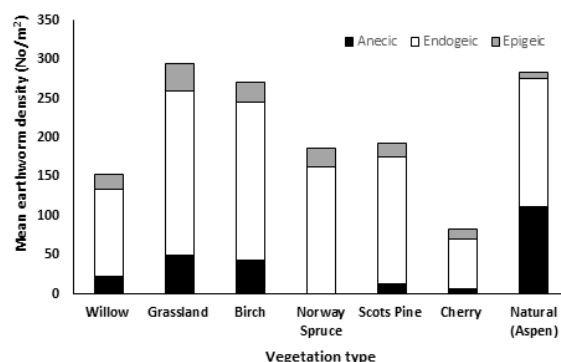
Fig. 6. Earthworm community data (by ecological category) at Hallside from below a variety of vegetation types on reclaimed soils and a more natural adjacent soil.
