## Soils and earthworms as a final chapter in the narrative of a steelworks

K.R. Butt & S.M. Quigg

### ABSTRACT

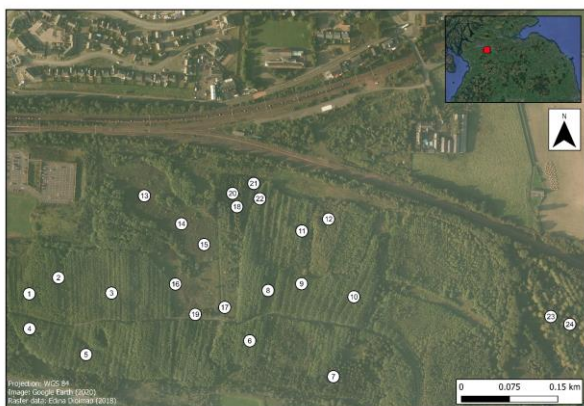
**Fig. 3.** Aerial view of the 35 ha reclaimed Hallside site, with position of the 2018 sampling sites indicated: 1-12, willow (*Salix* spp.); 13-17, grassland; 18-19, birch (*Betula* sp.); 20, Norway spruce (*Picea abies*); 21, Scots Pine (*Pinus sylvestris*); 22, cherry (*Prunus* sp.); 23-24, aspen (*Populus tremula*). Inset shows position of site in lowland Scotland (EDINA Digimap Service / Google Earth 2020).

During spring 2018, investigations were undertaken within the reclaimed areas from the 1990s, with comparisons drawn from sampling in adjacent areas that were unadulterated. Fig. 3 shows an aerial view of the site and the 24 selected sampling points. Most of these were in the dominant vegetation (willow) but other tree-covered areas were also targeted along with more open grassland.

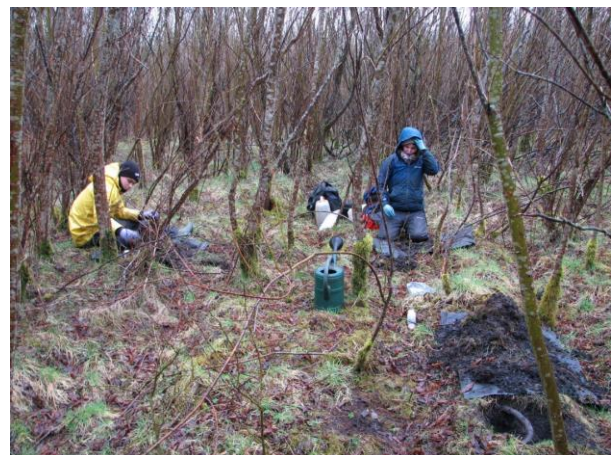
**Fig. 4.** Sampling for soil and for earthworms among willow at Hallside in 2018. (Photo: K.R. Butt)

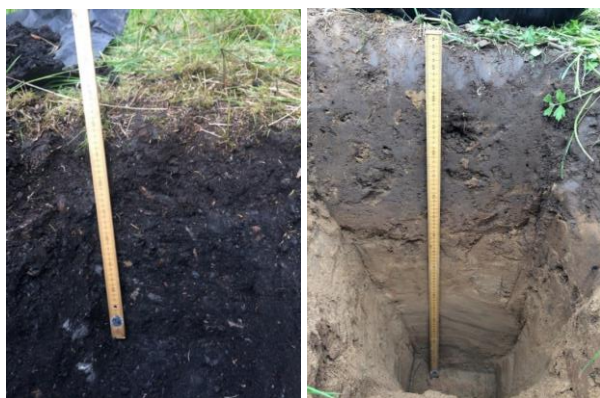
**Fig. 5.** Soil pits at Hallside. Left: in reclaimed soils below grassland (only possible to 45 cm due to stones and compaction). Right: in unadulterated sandy soil below aspen (to 1 m). (Photo: K.R. Butt)

Soils in the reclaimed areas proved very difficult to dig as they had a high stone content. No pits could be dug further than a depth of 0.45 m and many digging attempts were hampered by large rocks. Fig. 5 shows that above the dark compacted, stone-laden horizon, there was a lighter less stony, organic A-horizon of some 0.15 cm from the soil surface. In control soils away from the reclamation site, major differences were observed (Fig. 5). Here, digging to 1 m was possible, with the upper (0-35 cm) organic layer determined as a grey, sandy clay loam above 35-100 cm of yellow sand. The upper layer held small fragments of colliery spoil as the area had previously been agricultural land and had been ploughed prior to alder planting.

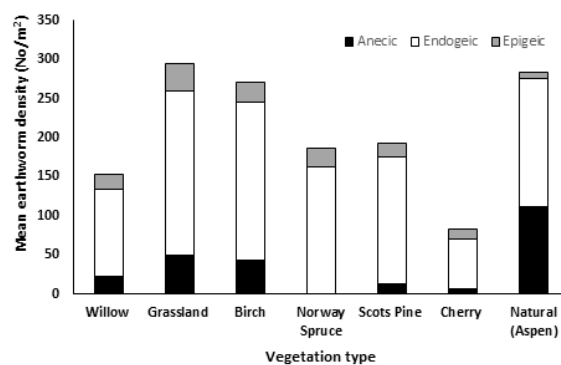
**Fig. 6.** Earthworm community data (by ecological category) at Hallside from below a variety of vegetation types on reclaimed soils and a more natural adjacent soil.
